FIU UNIVERSITY CITY PROSPERITY PEDESTRIAN BRIDGE PROJECT

FIU Pedestrian Bridge Collapse: *Testing of Full-Size Replicas of Failed Connection*

Presented by Gary J. Klein, SE, PE

Presented July 23, 2020
Minnesota Concrete Council

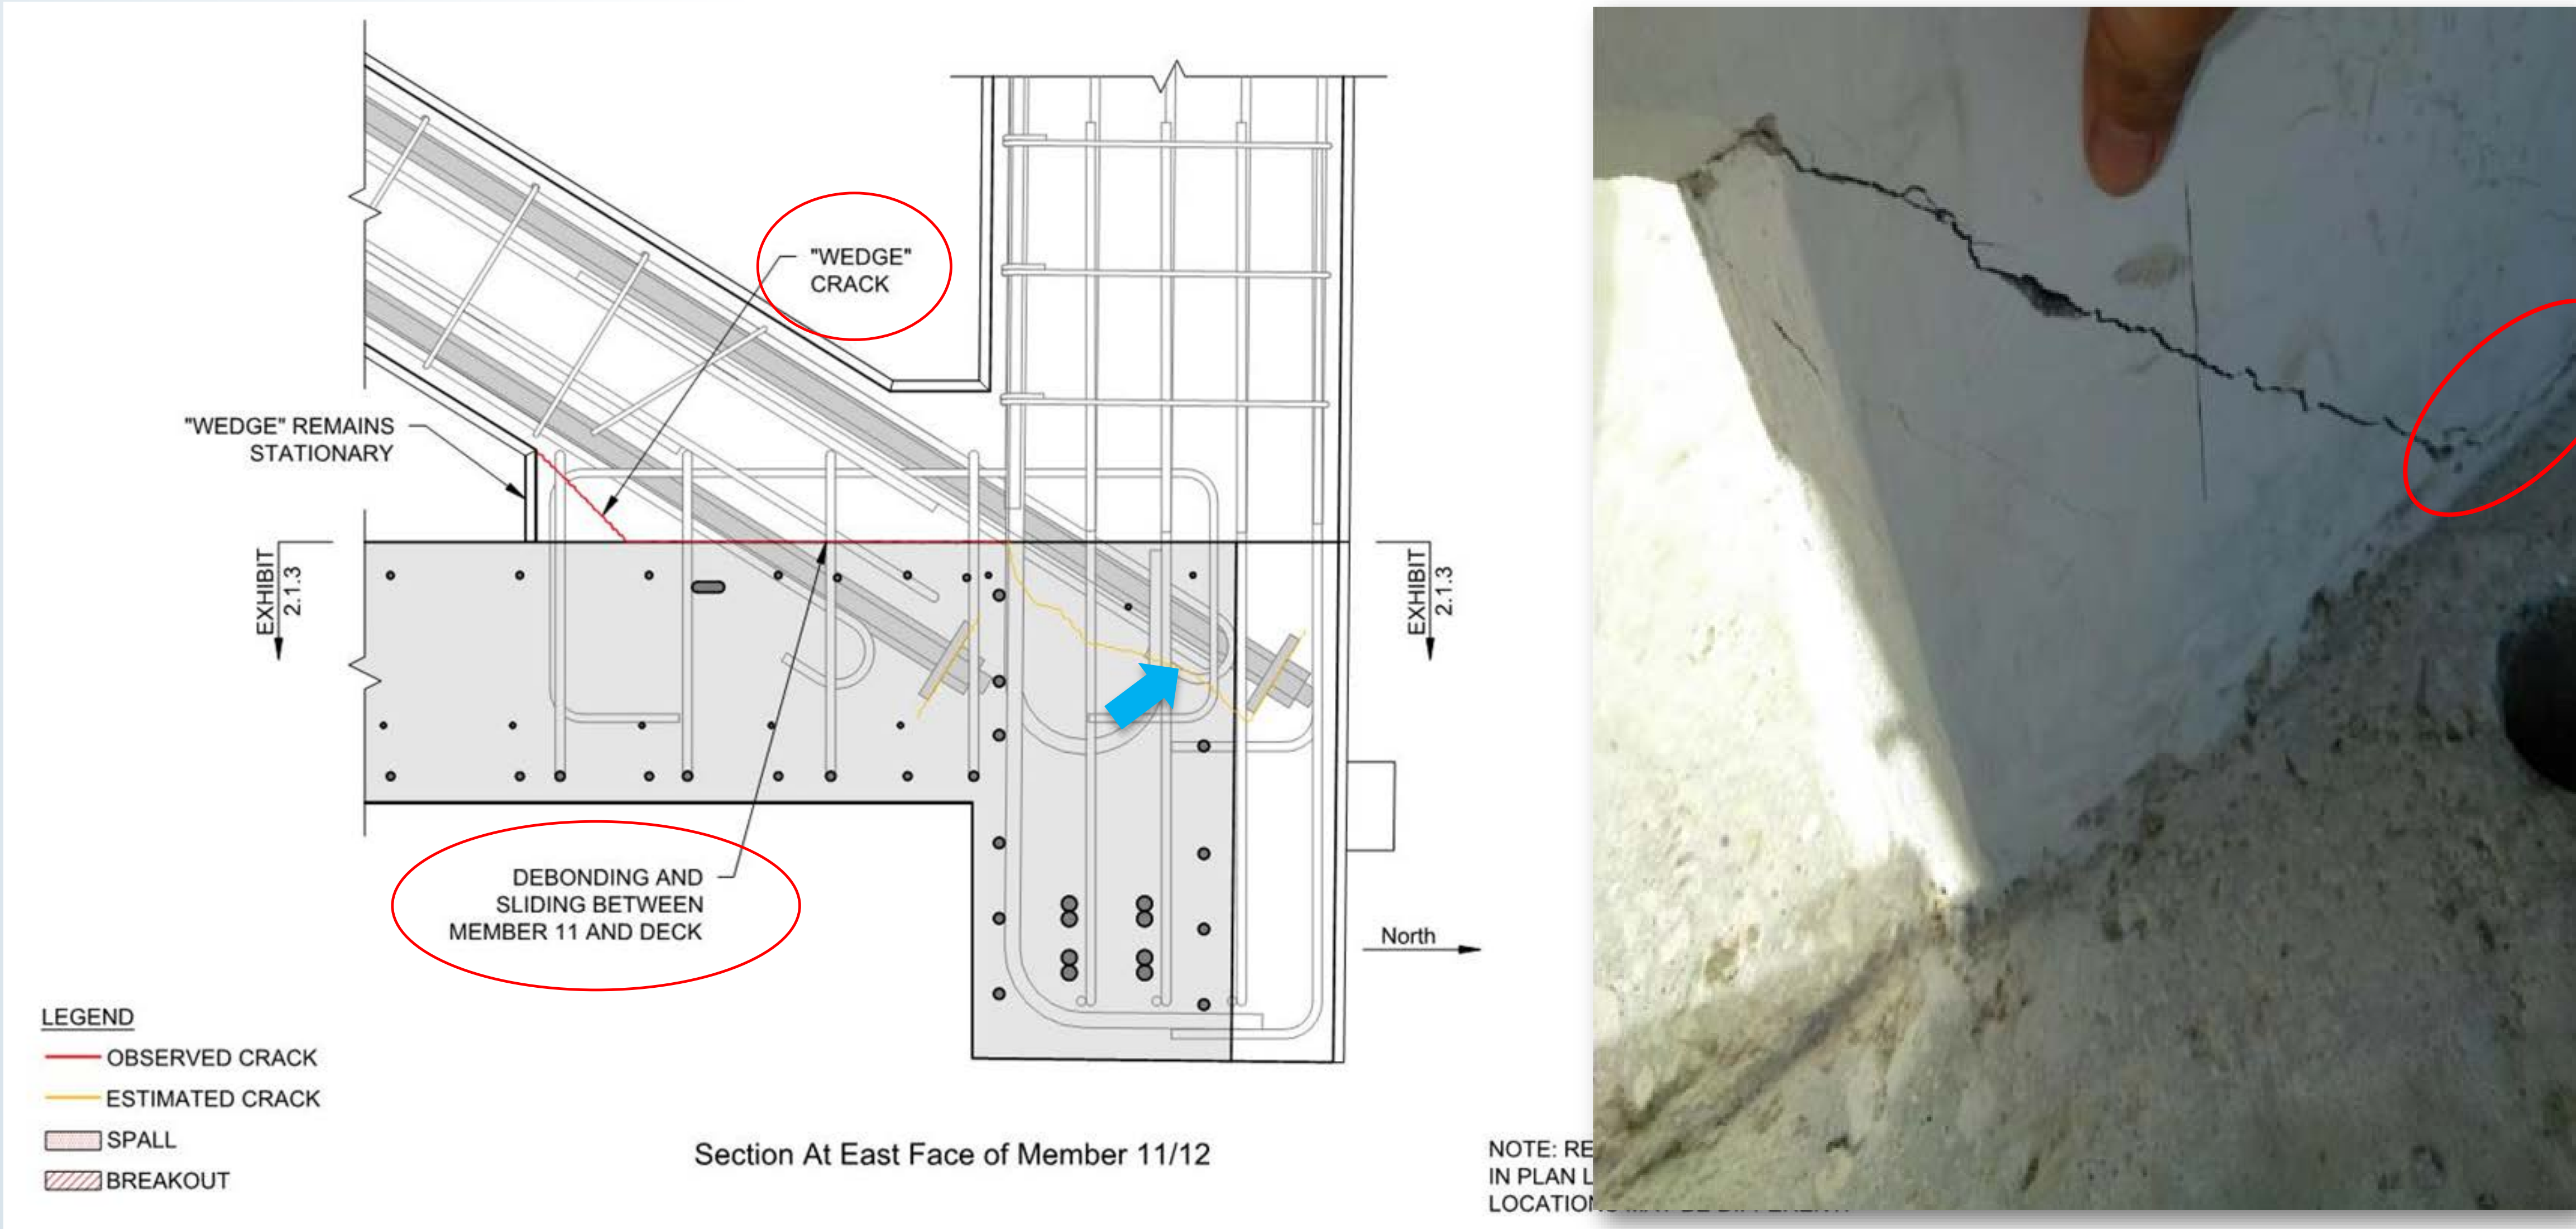
After Shoring Removal and Before Move (February 12-March 9, 2018)

- October 19, 2017 Deck concrete casting
- February 24, 2018 Shoring removal (cracking observed)
- March 10, 2018, 12:30 PM Main span moved into final position
- March 10, 2018, 3:07 PM Very significant widening of cracks observed
- March 15, 2018, 11:49 AM Re-tensioning of member 11
- March 15, 2018, 1:45 PM Main span collapses

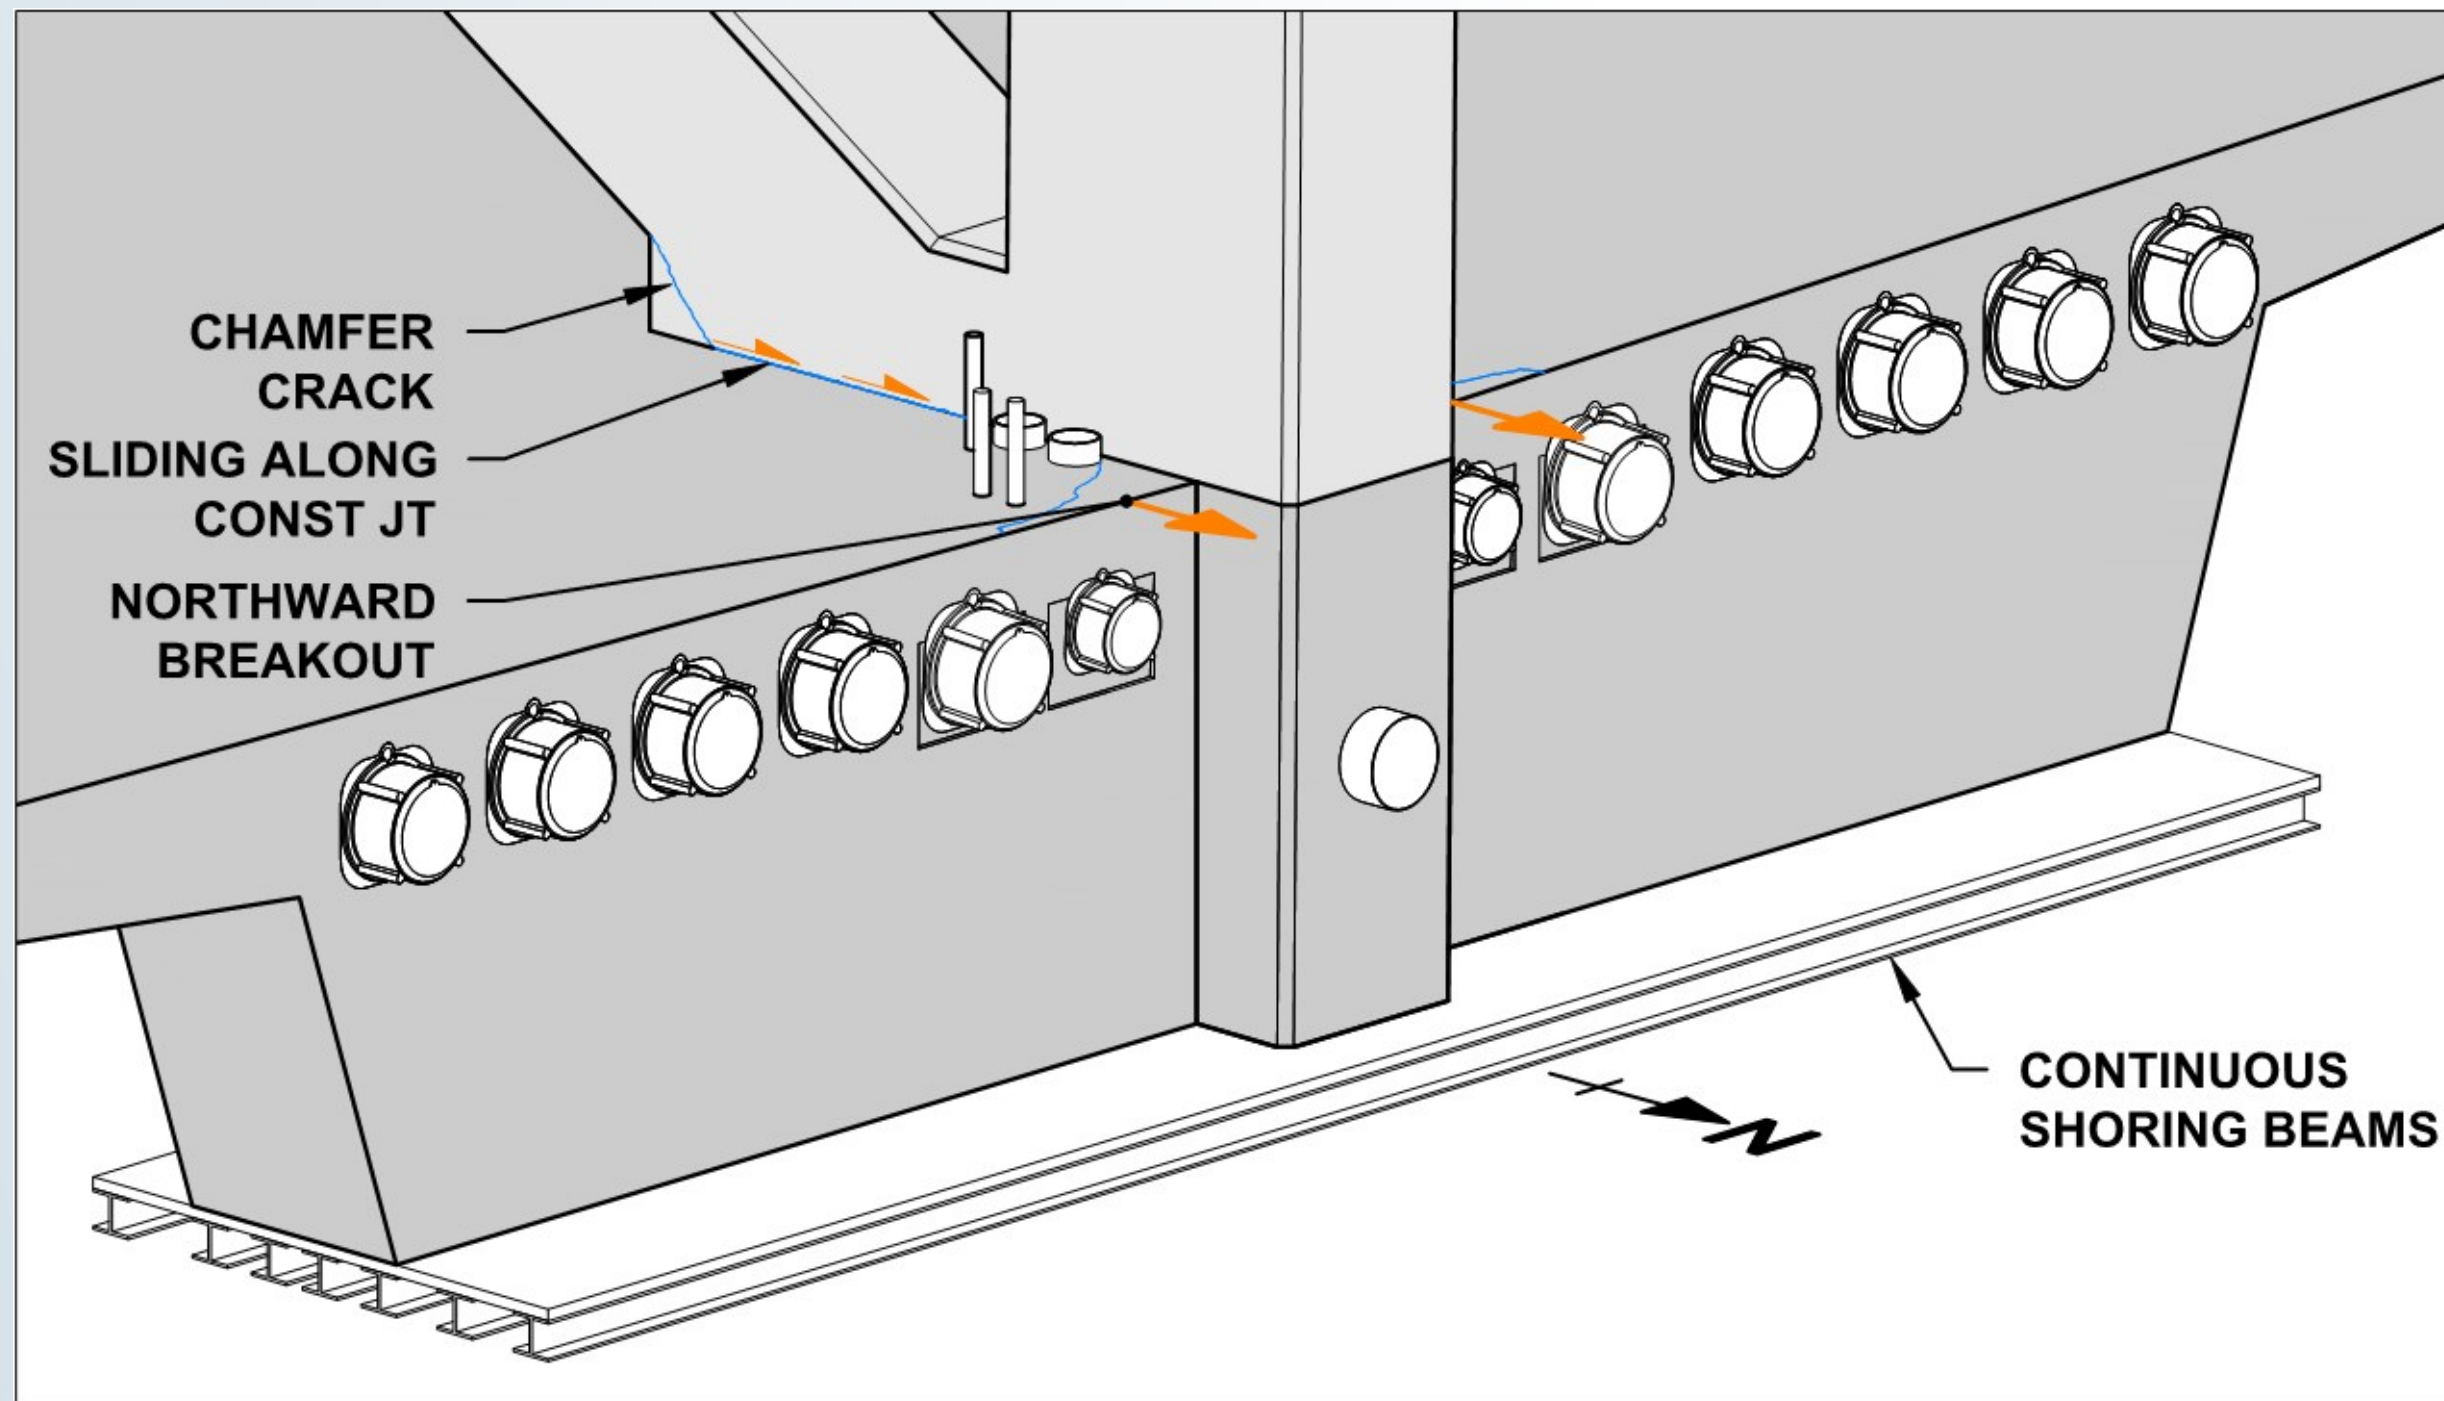
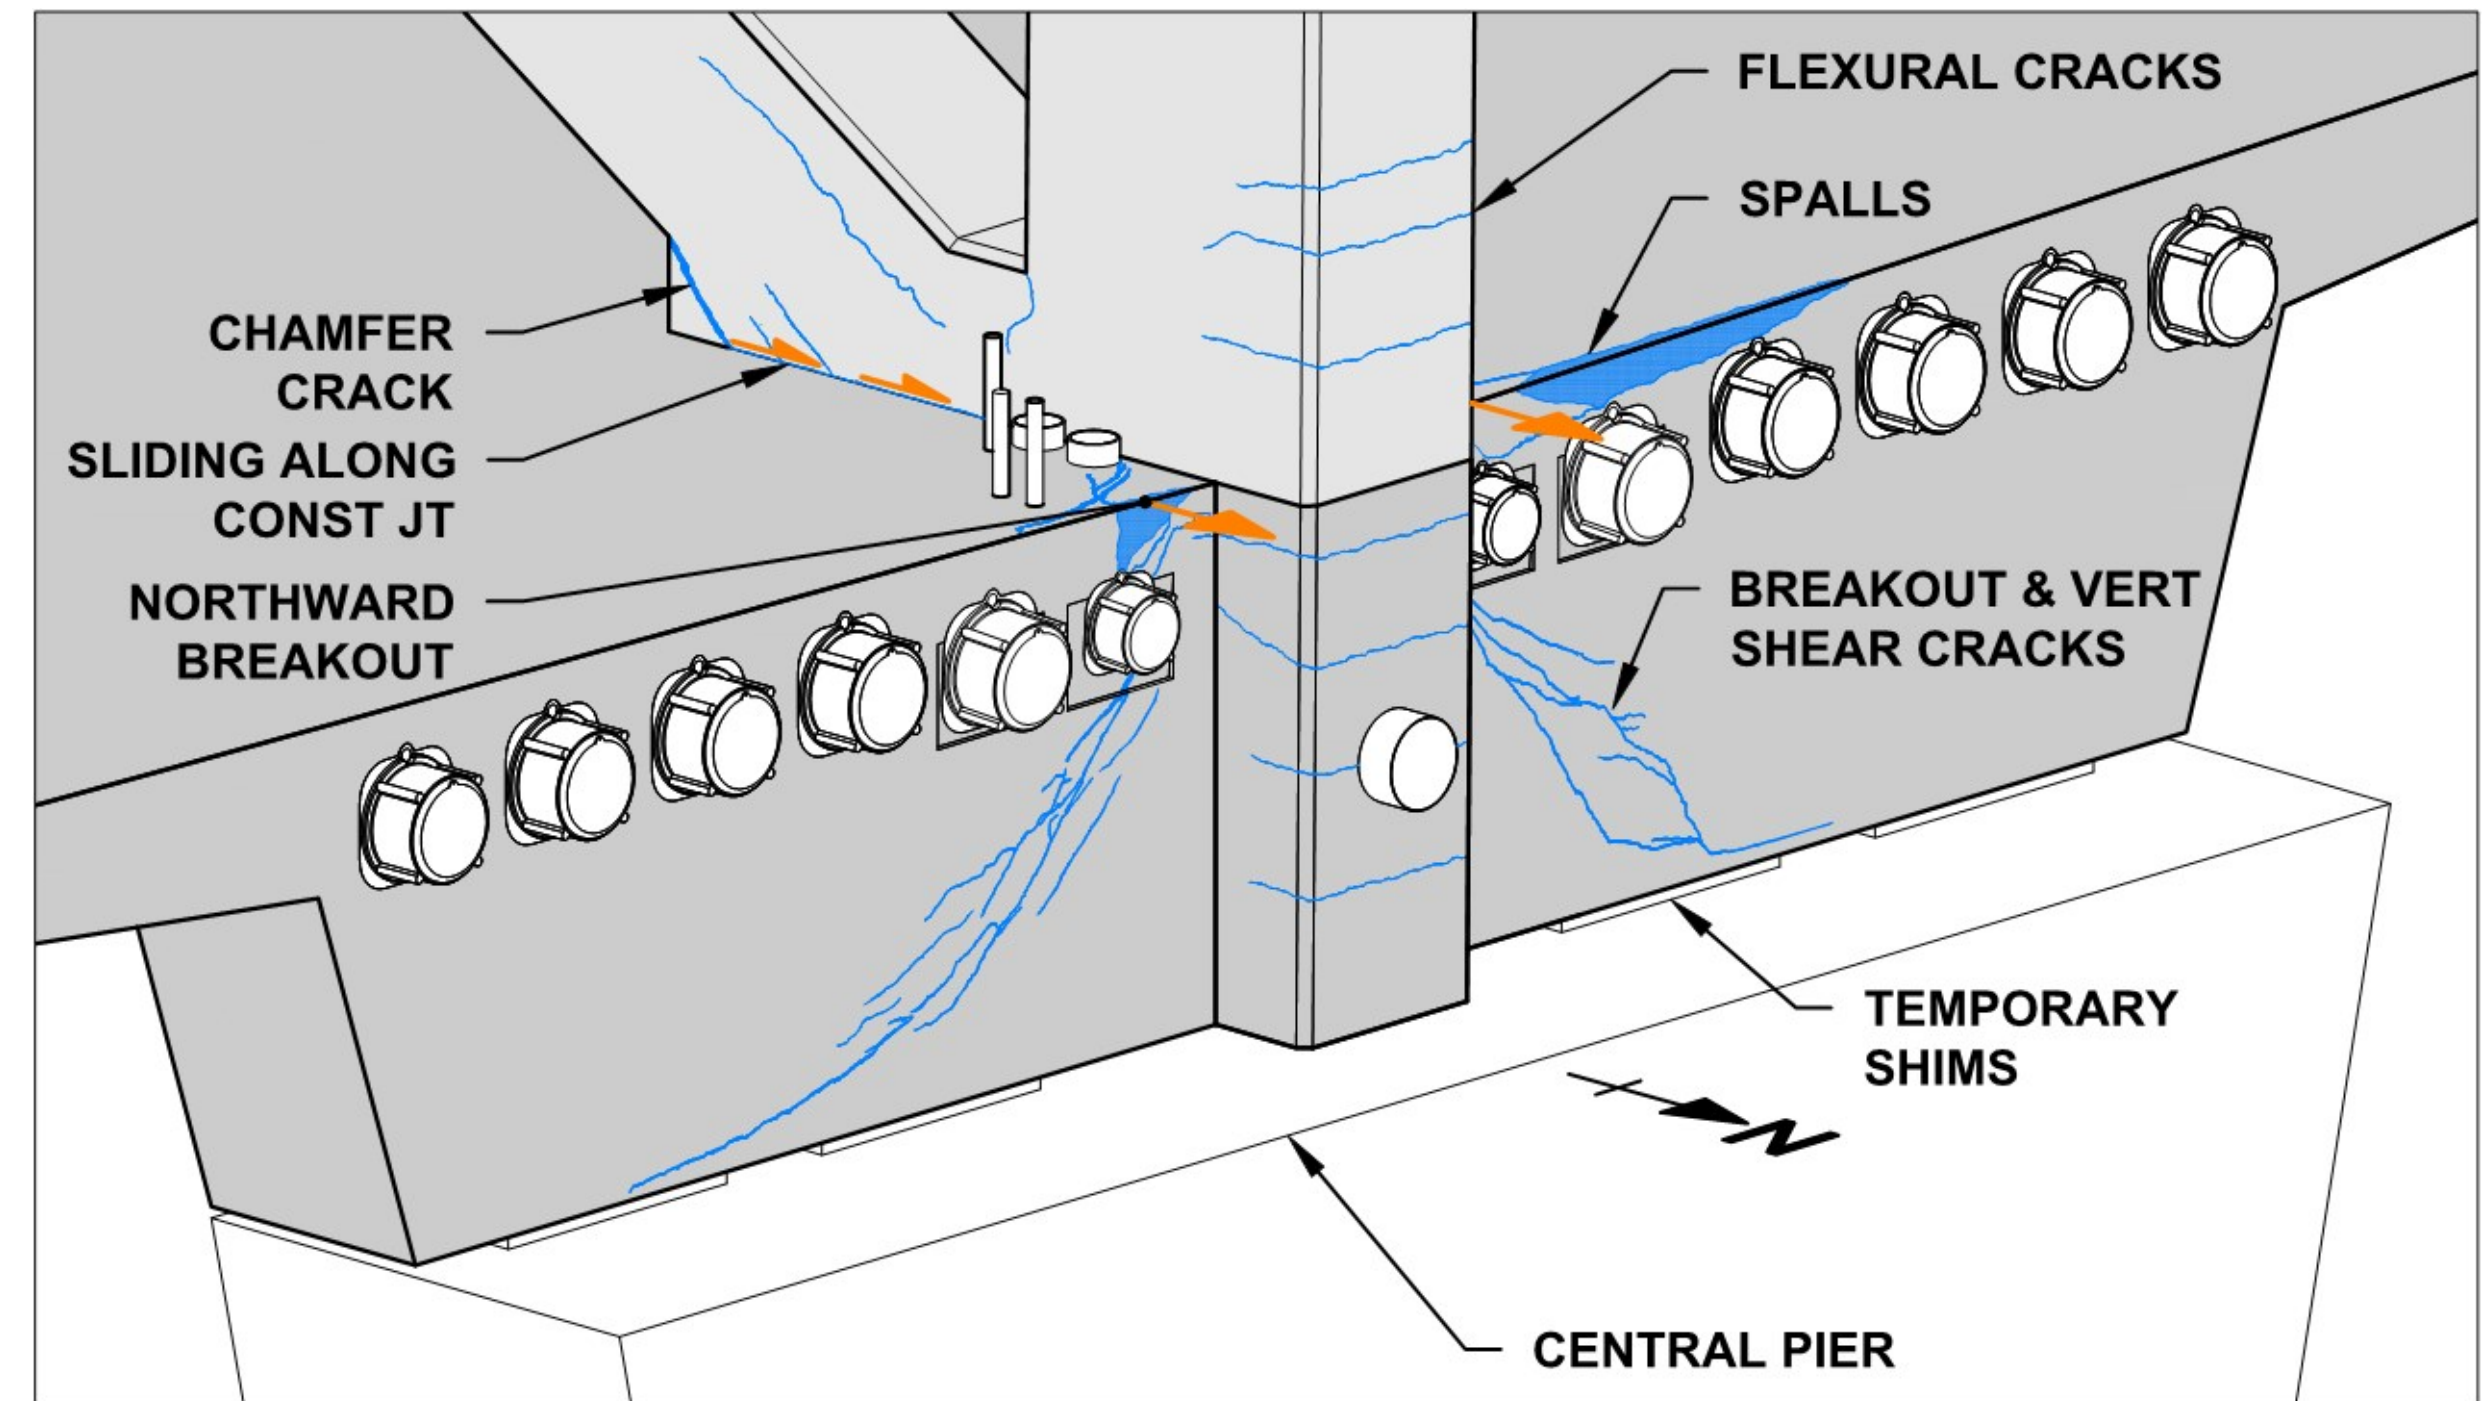
After Shoring Removal: Feb. 24

On Final Supports: March 12

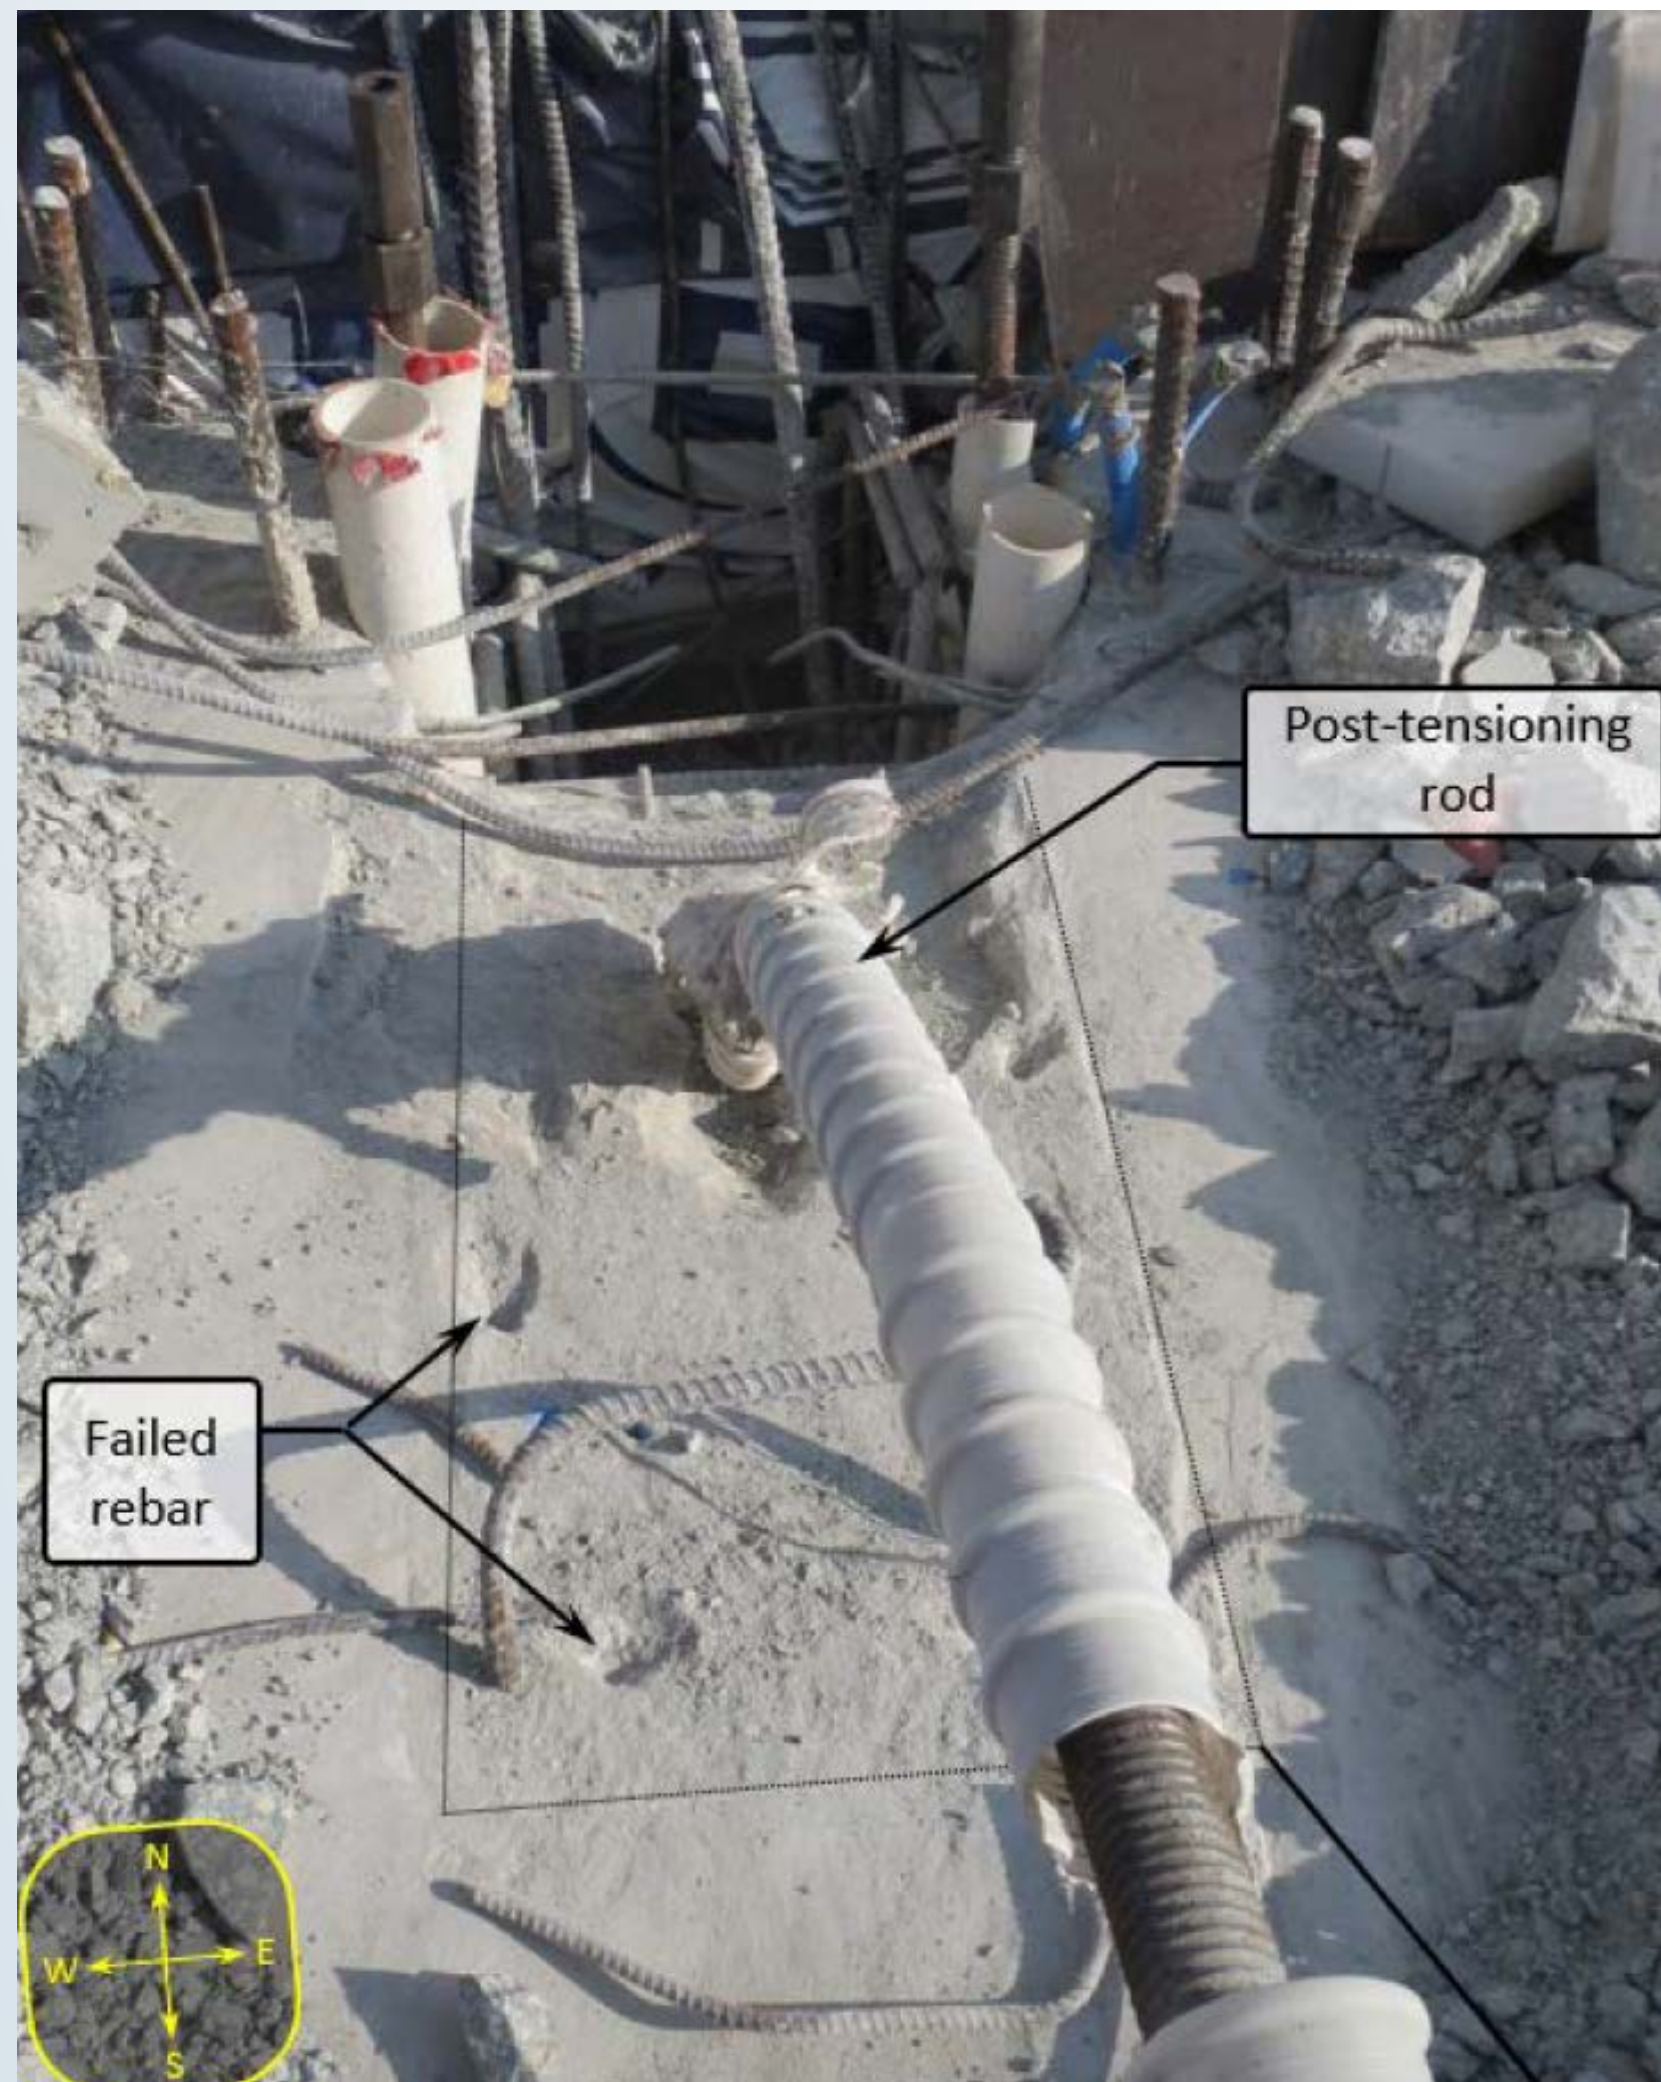
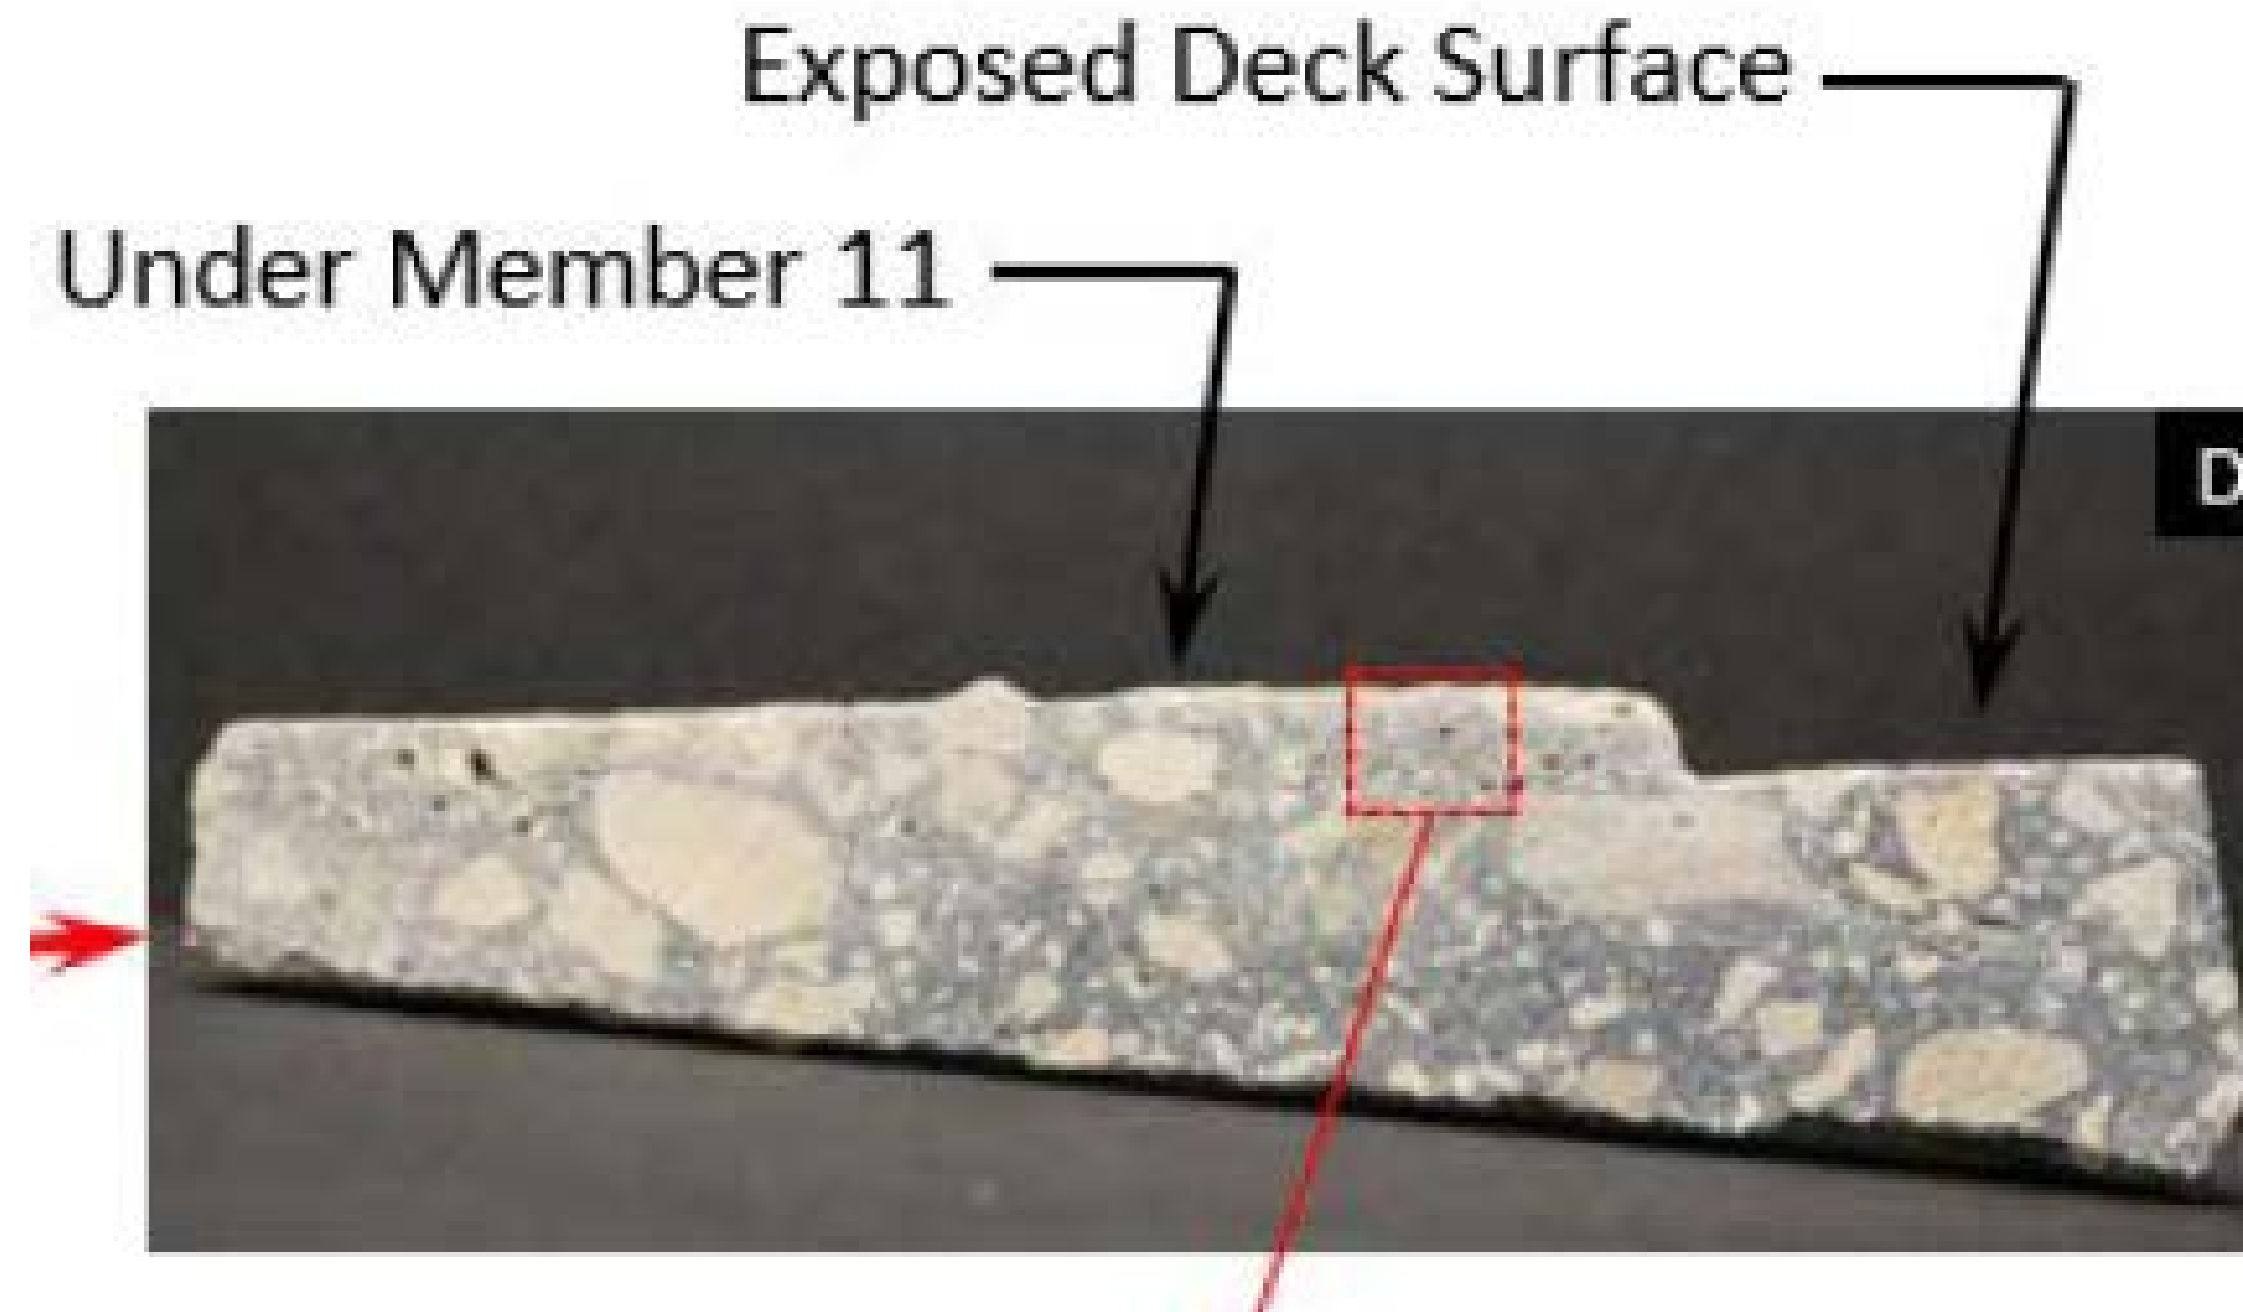
FHWA Report on Member 11/12 Joint

FHWA Conclusion: “The evidence indicates that the failure interface coincides with the original cold joint and that the cold joint was not intentionally roughened.”

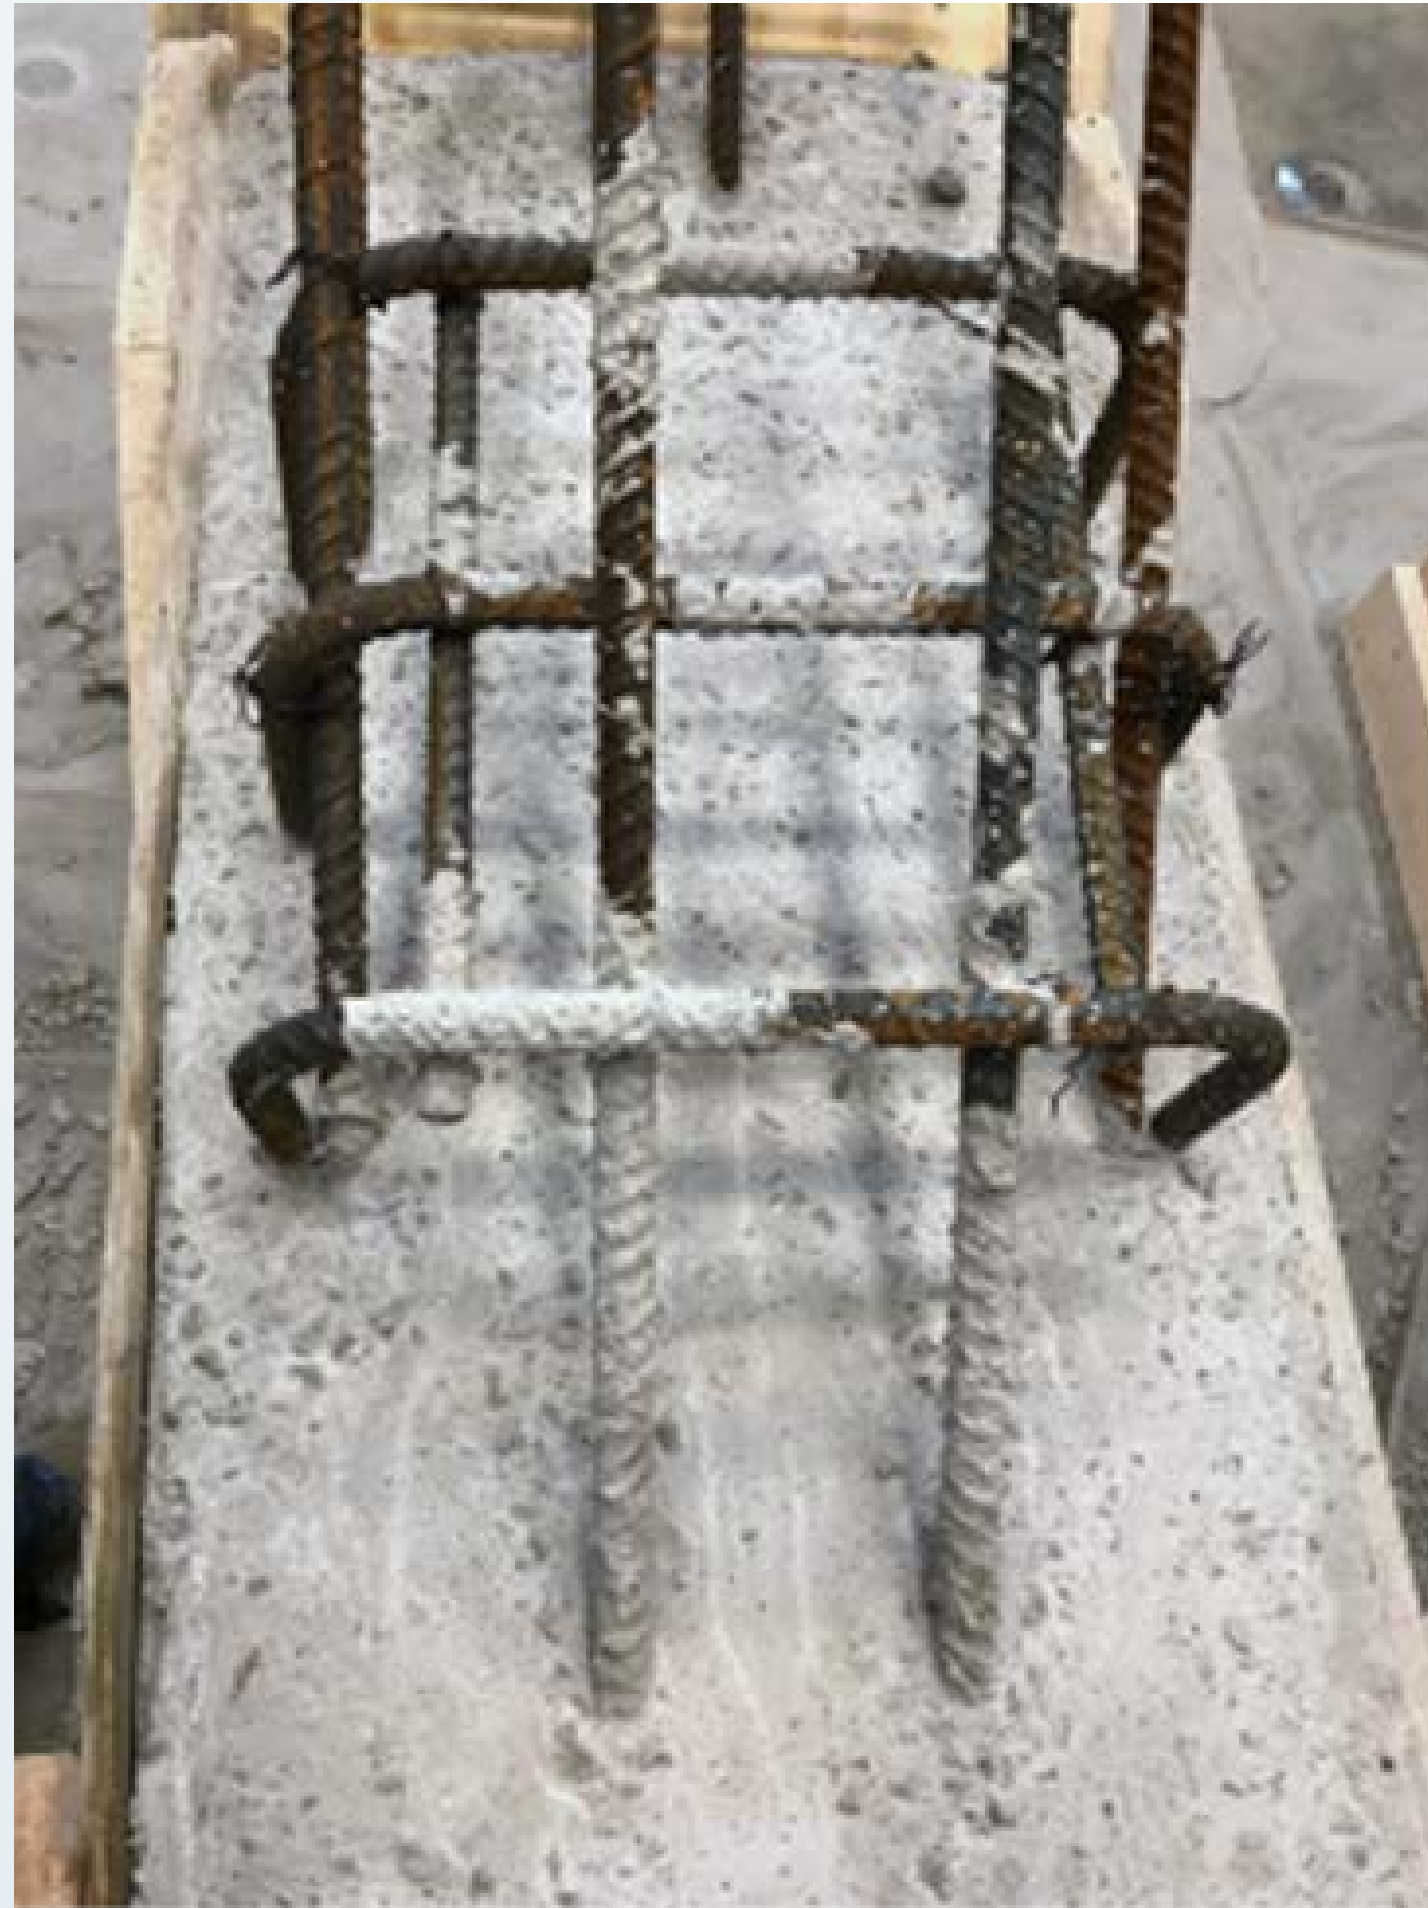
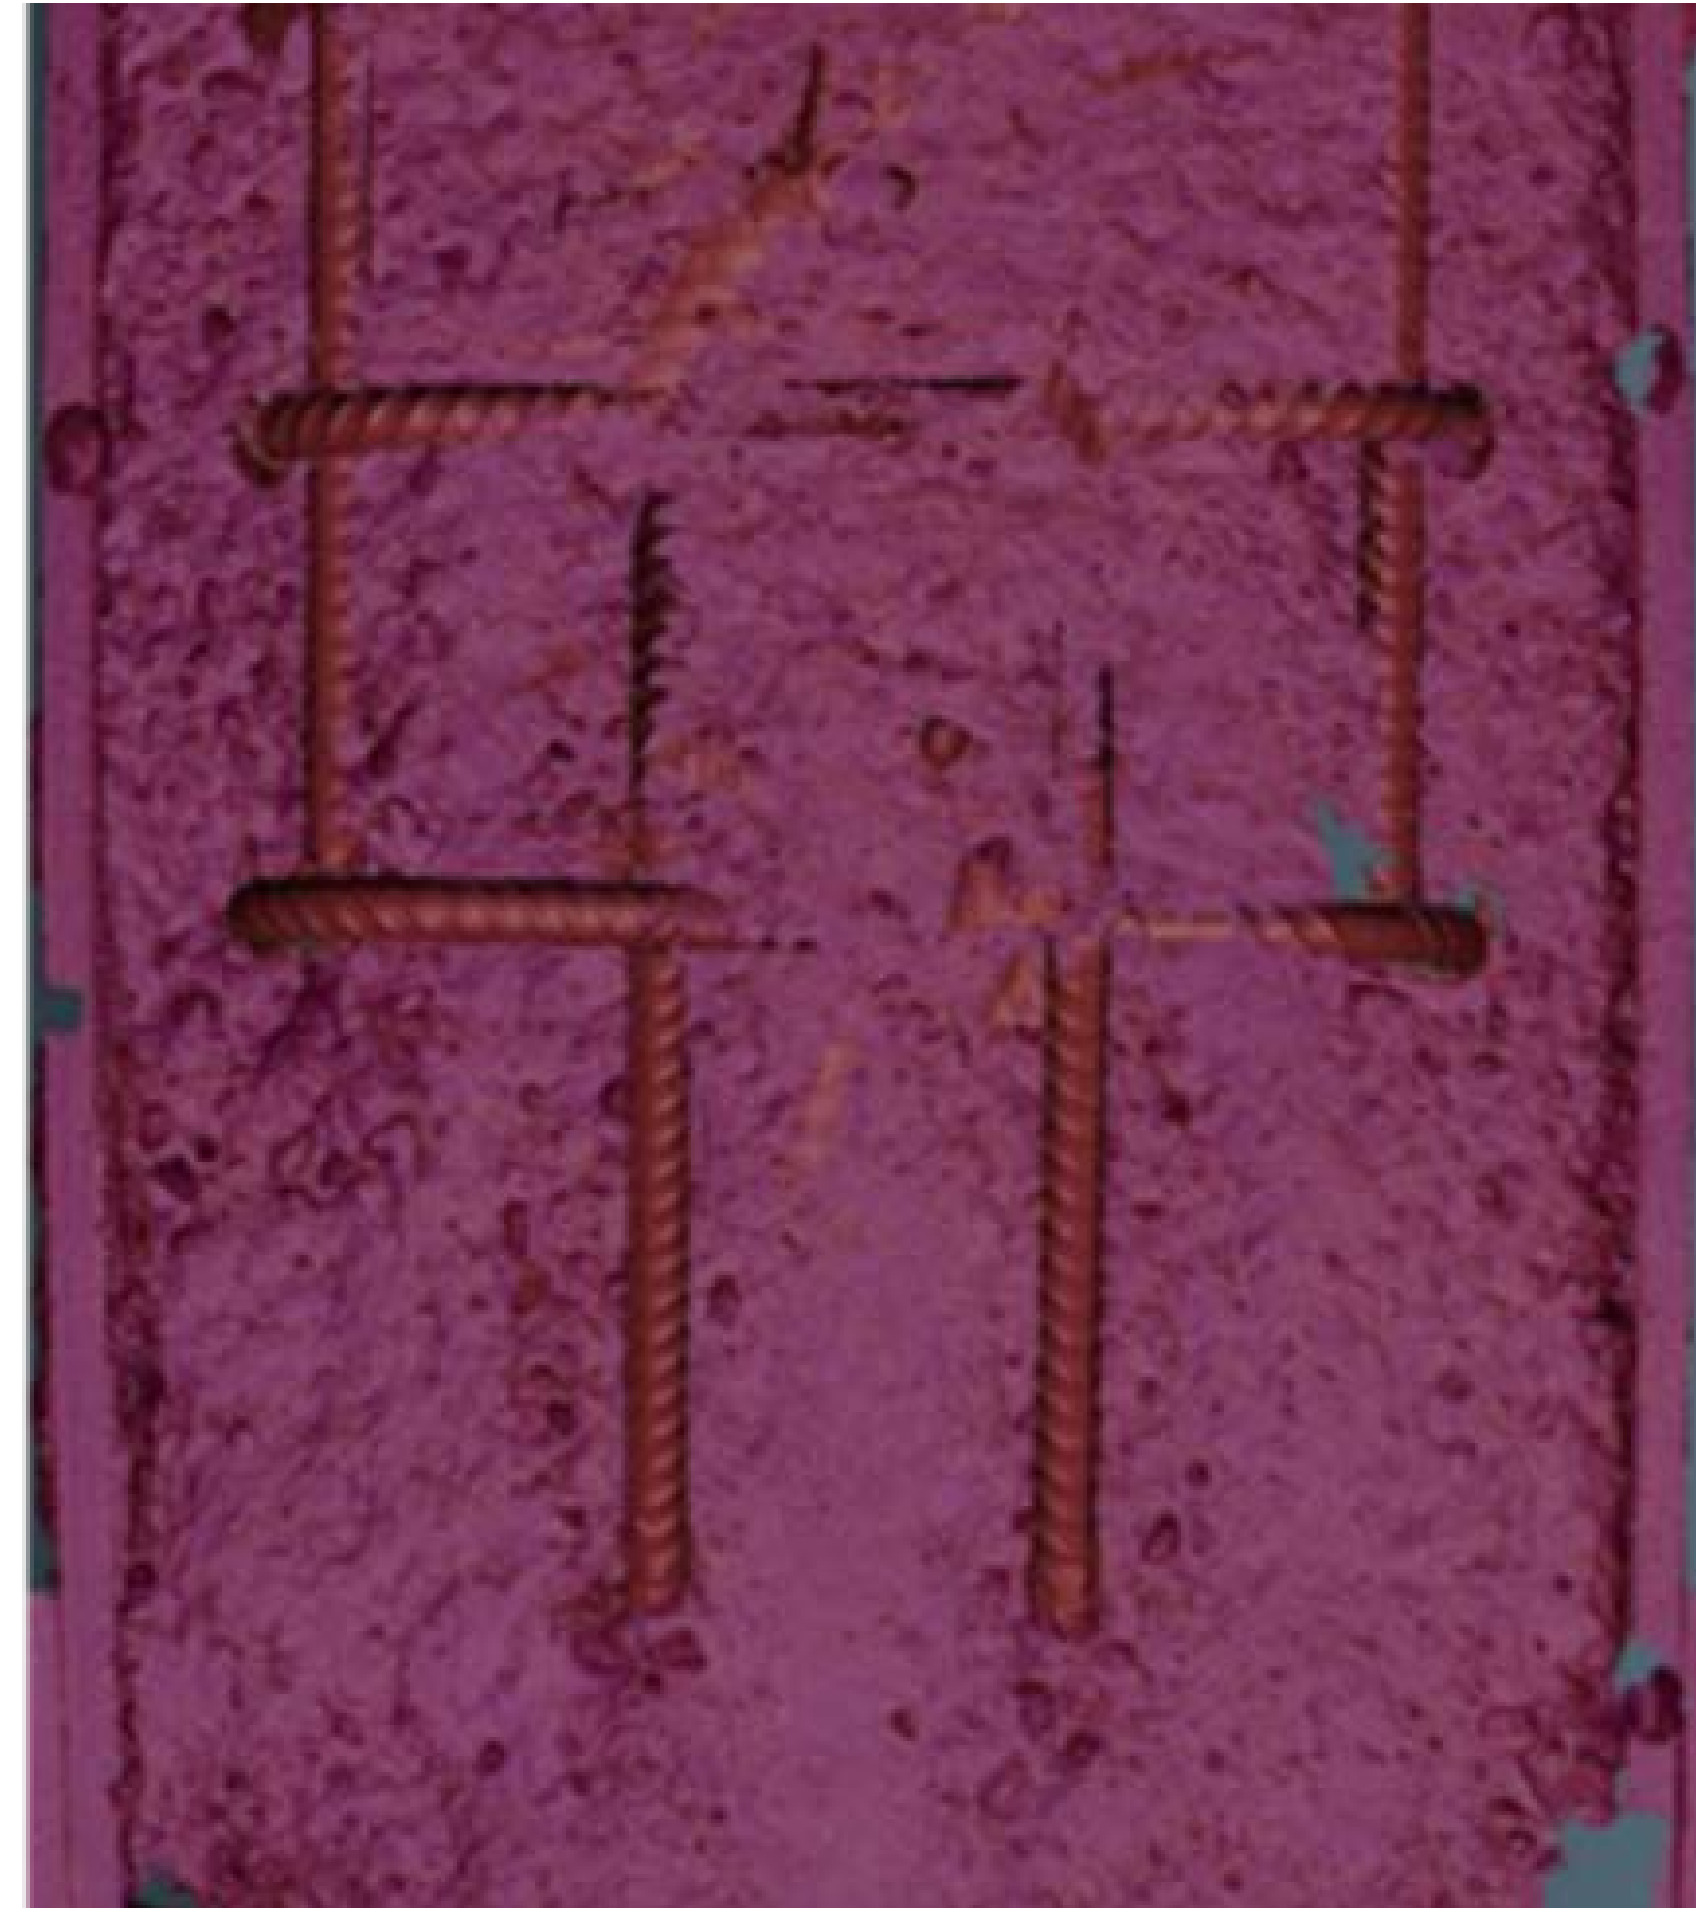
Photograph and laser scan of WJE Specimen 3 (As-placed)
