FIU UNIVERSITY CITY PROSPERITY PEDESTRIAN BRIDGE PROJECT

FIU Pedestrian Bridge Collapse: *Testing of Full-Size Replicas of Failed Connection*

Presented by Gary J. Klein, SE, PE

Presented July 23, 2020
Minnesota Concrete Council

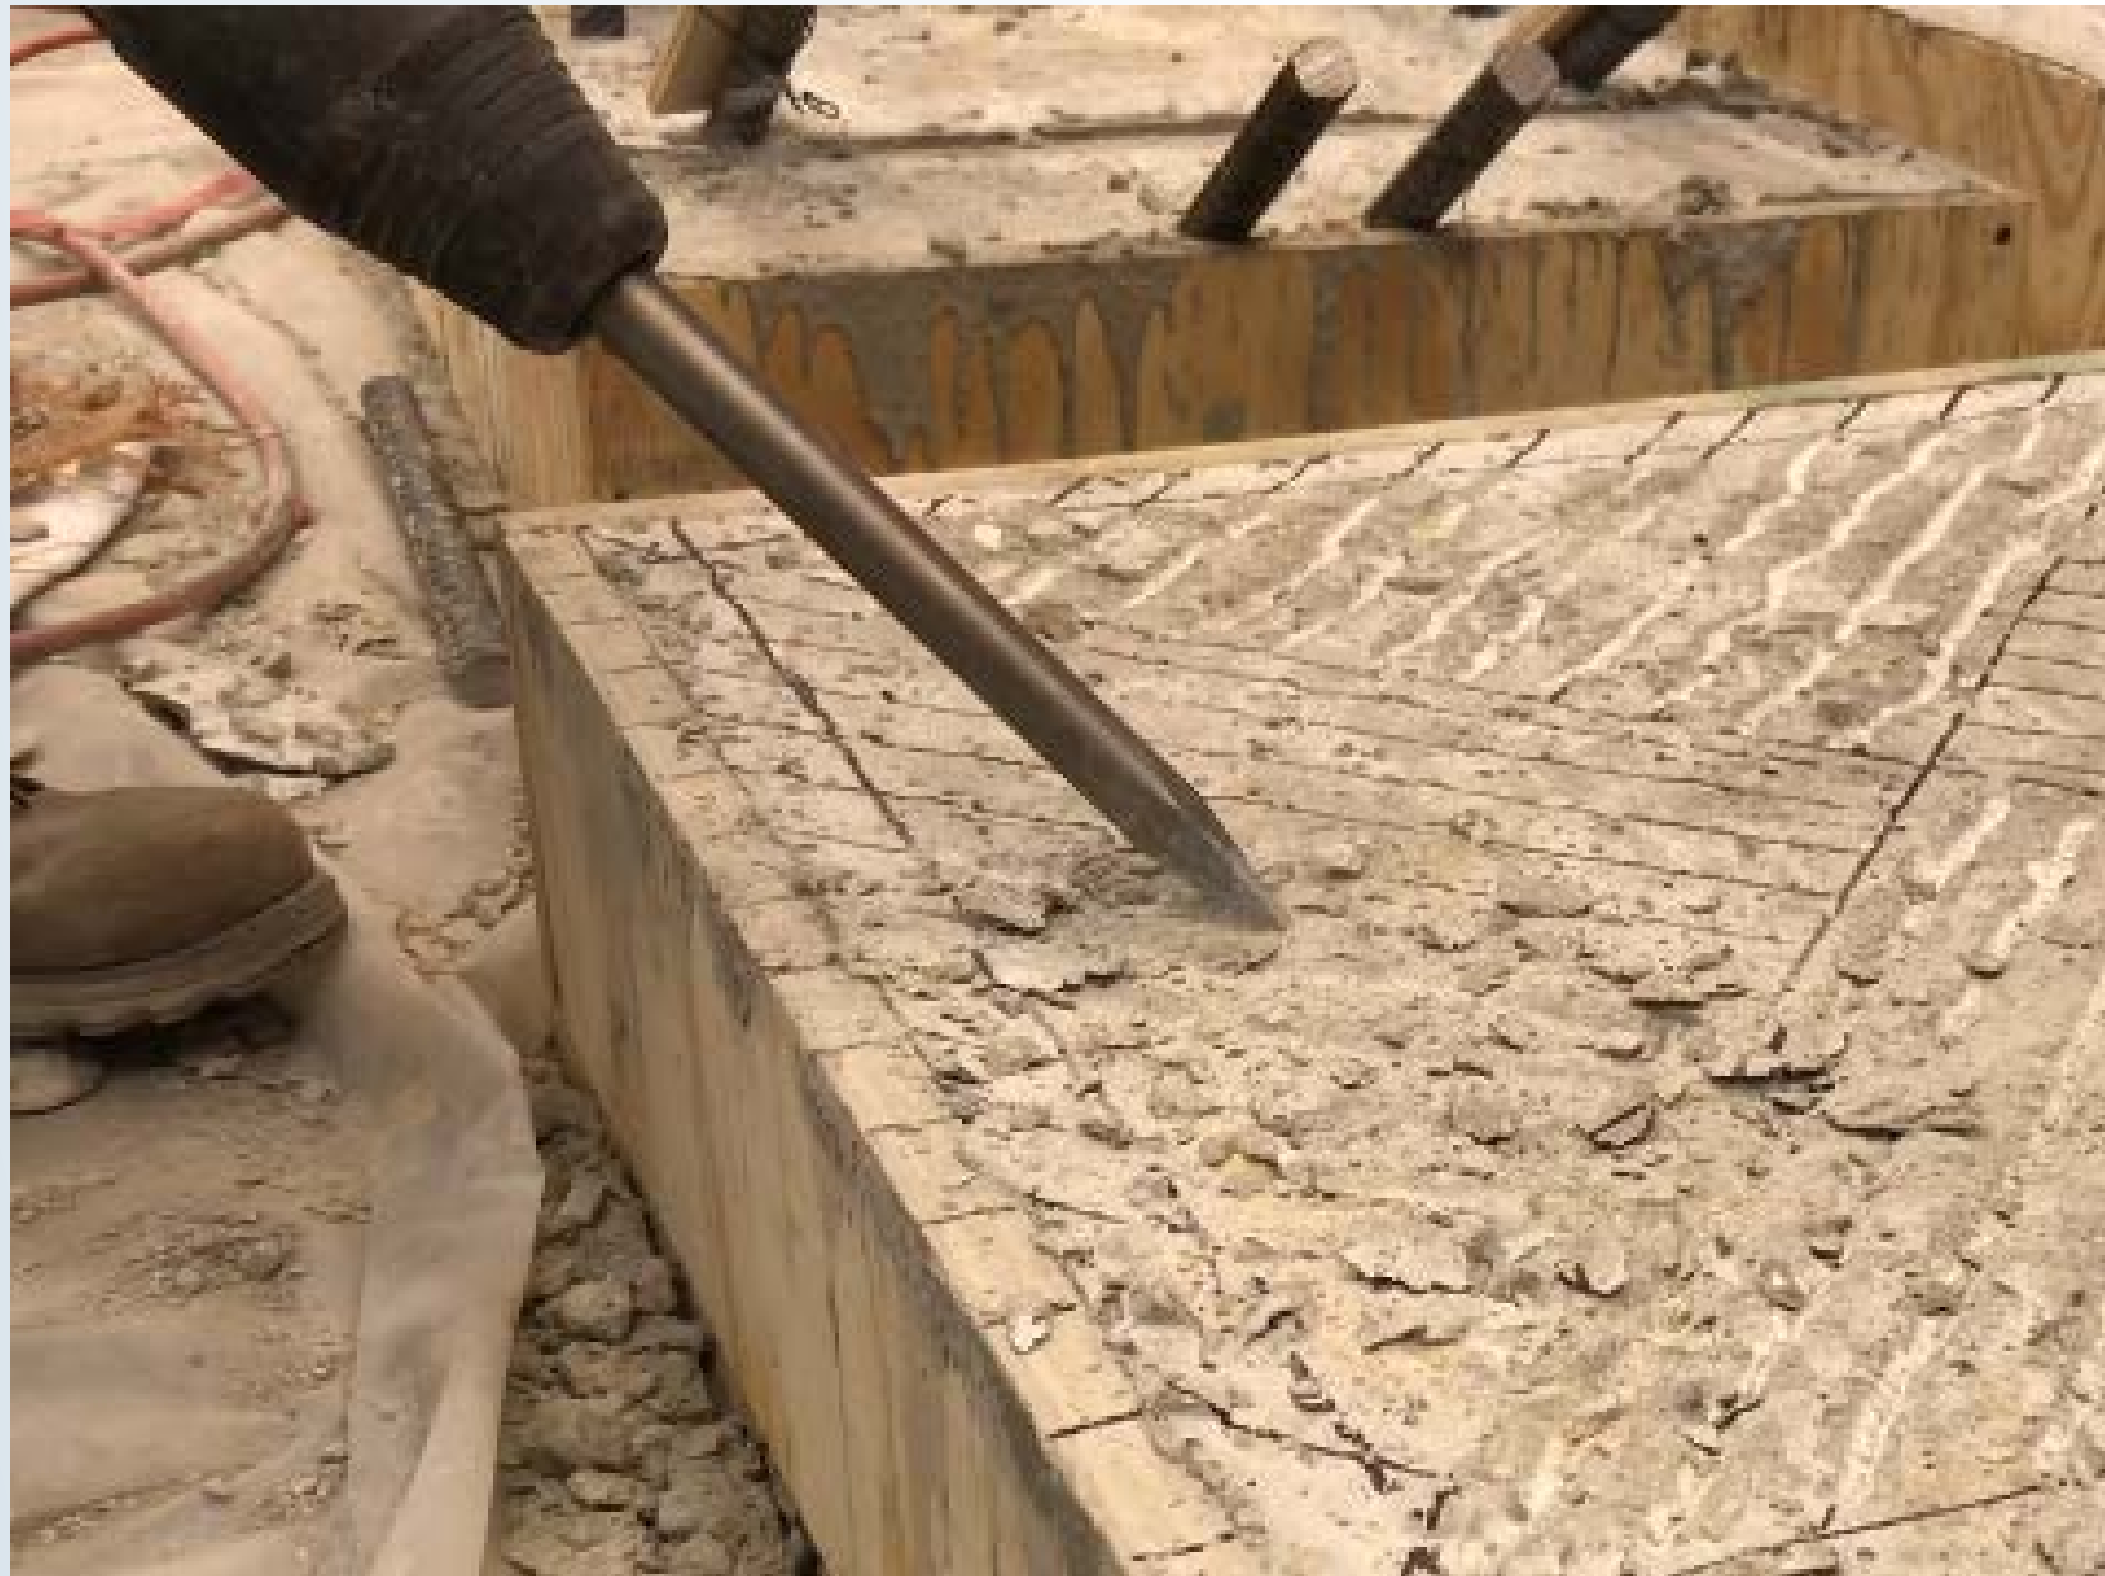
Surface roughening trials

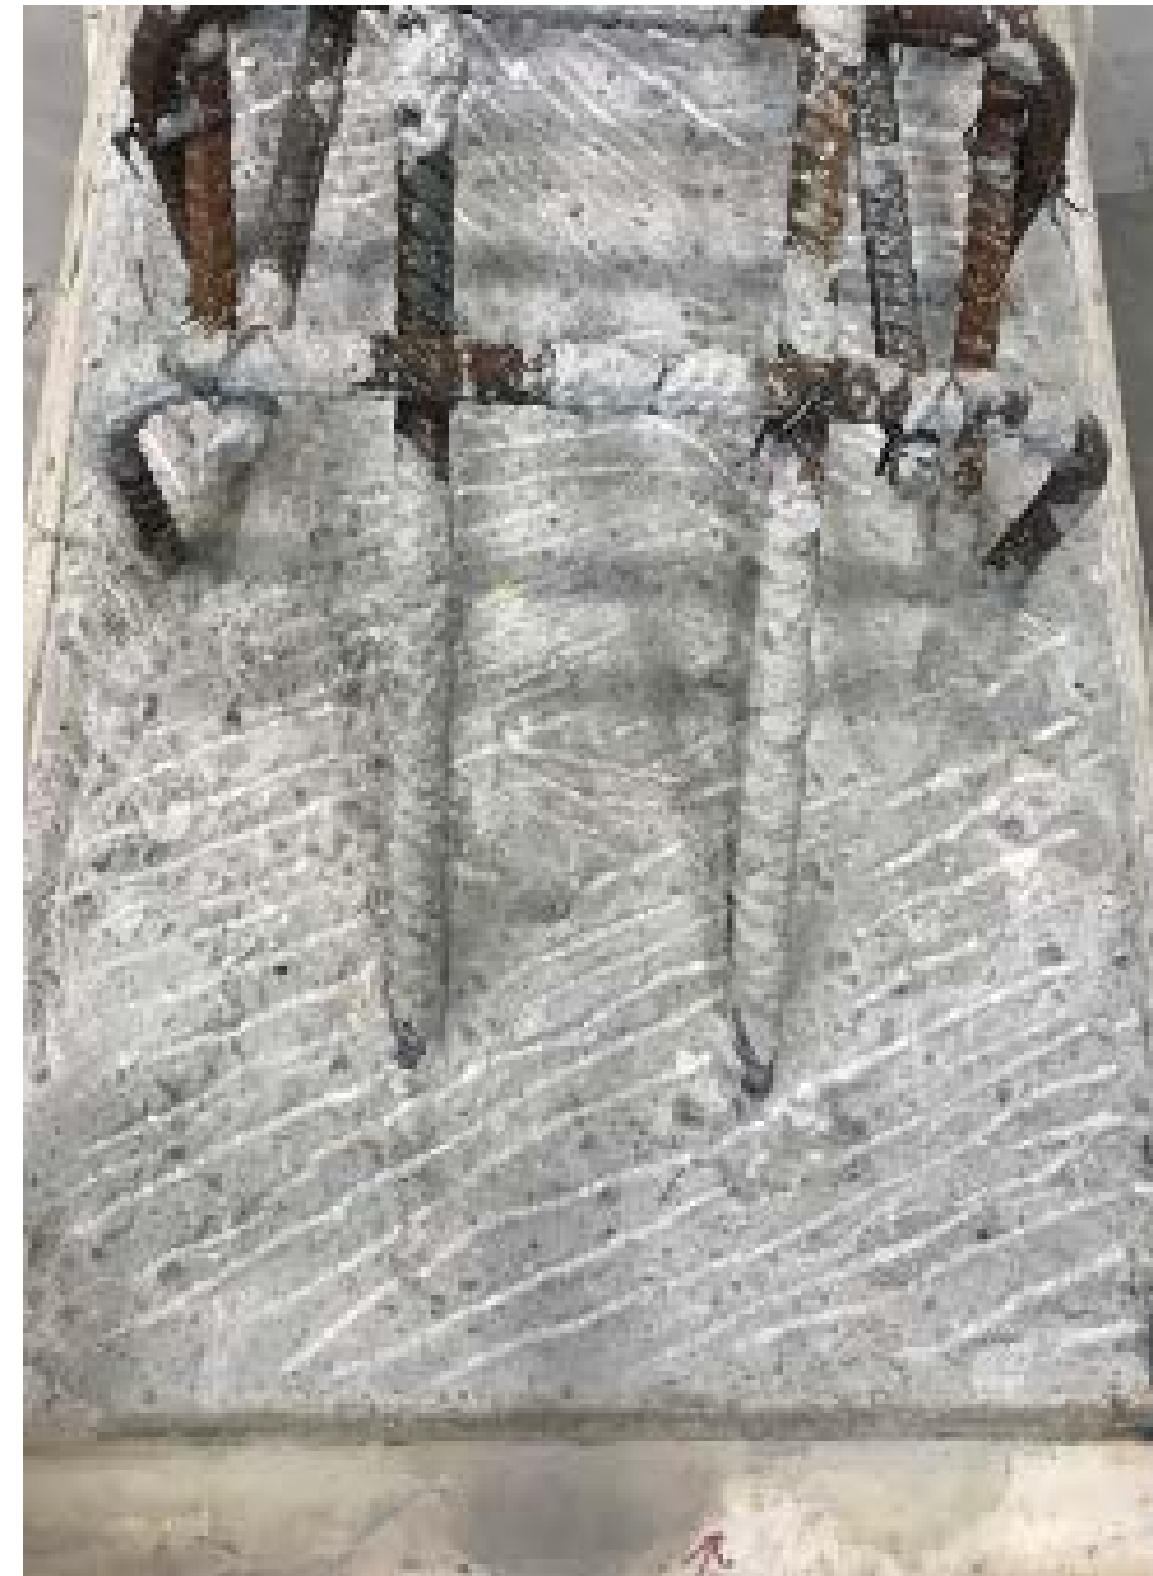
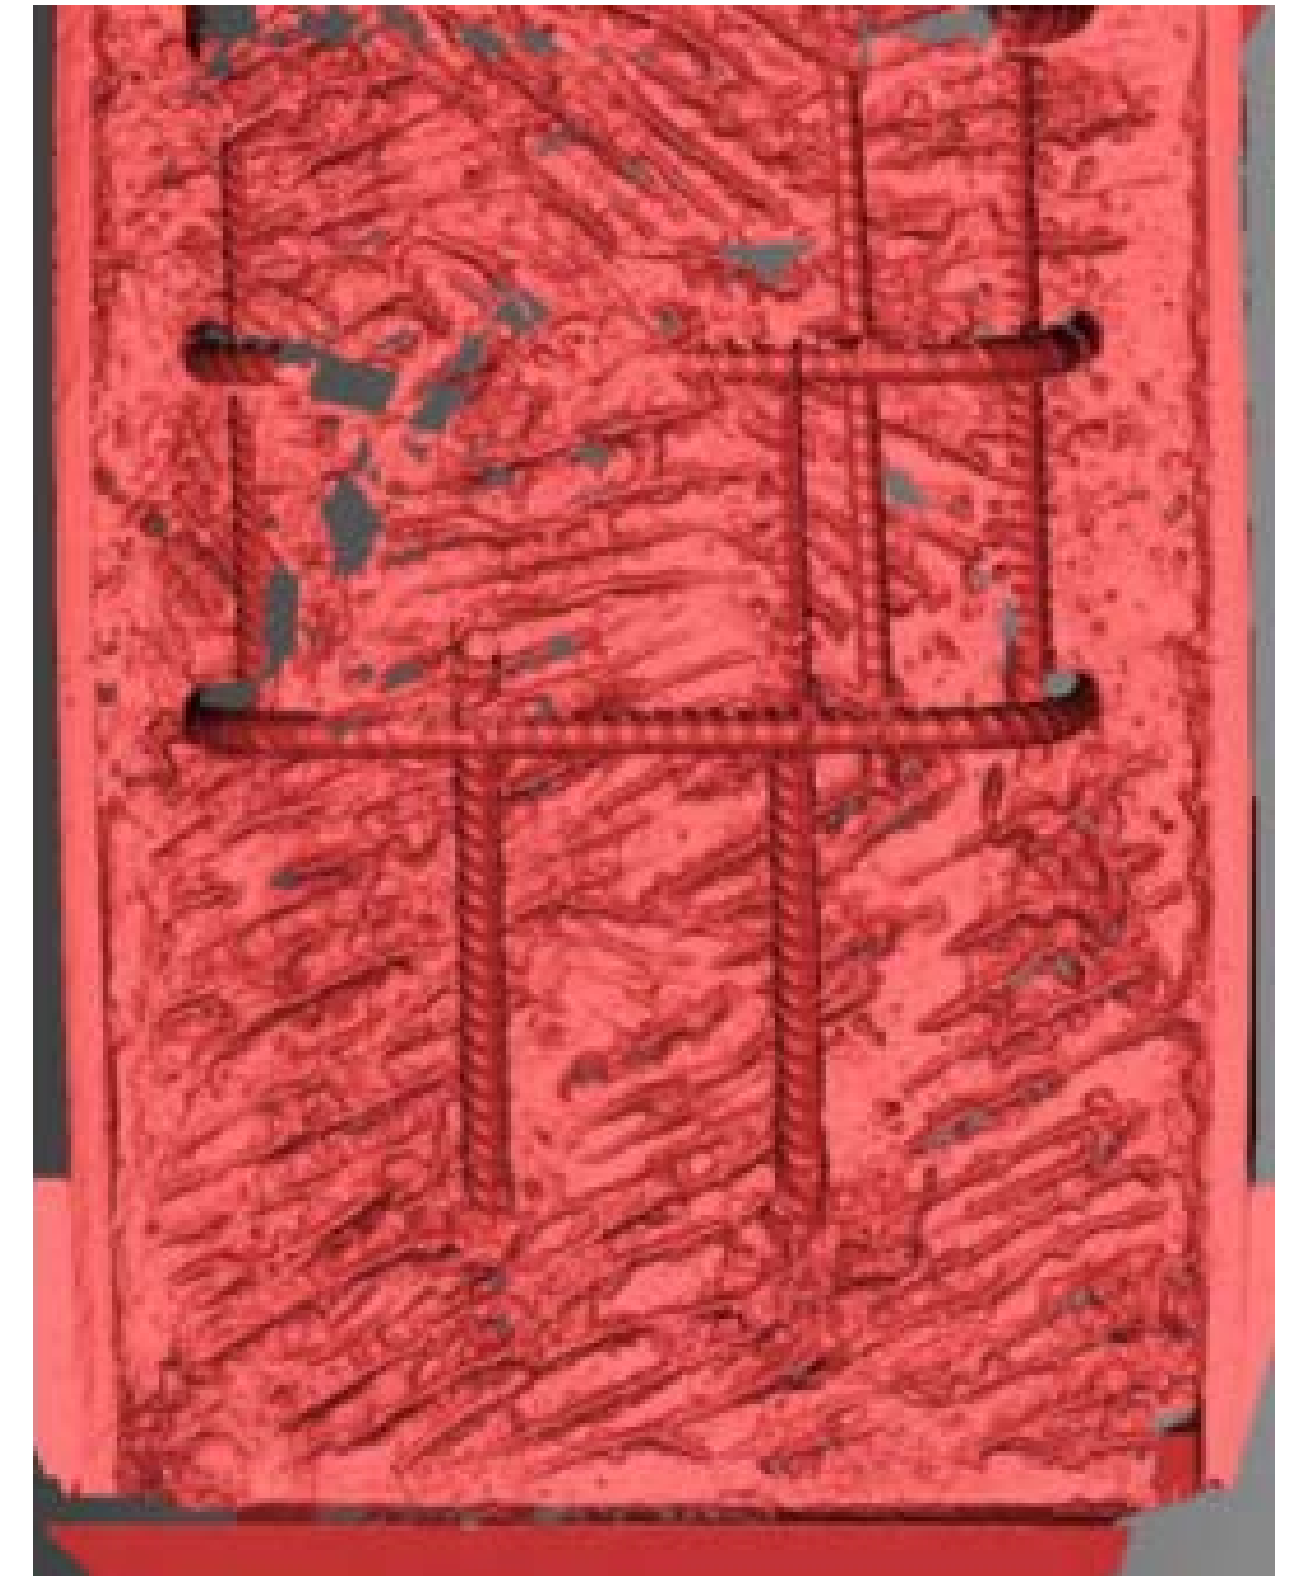
Photograph and laser scan of WJE Specimen 4 (Roughened)

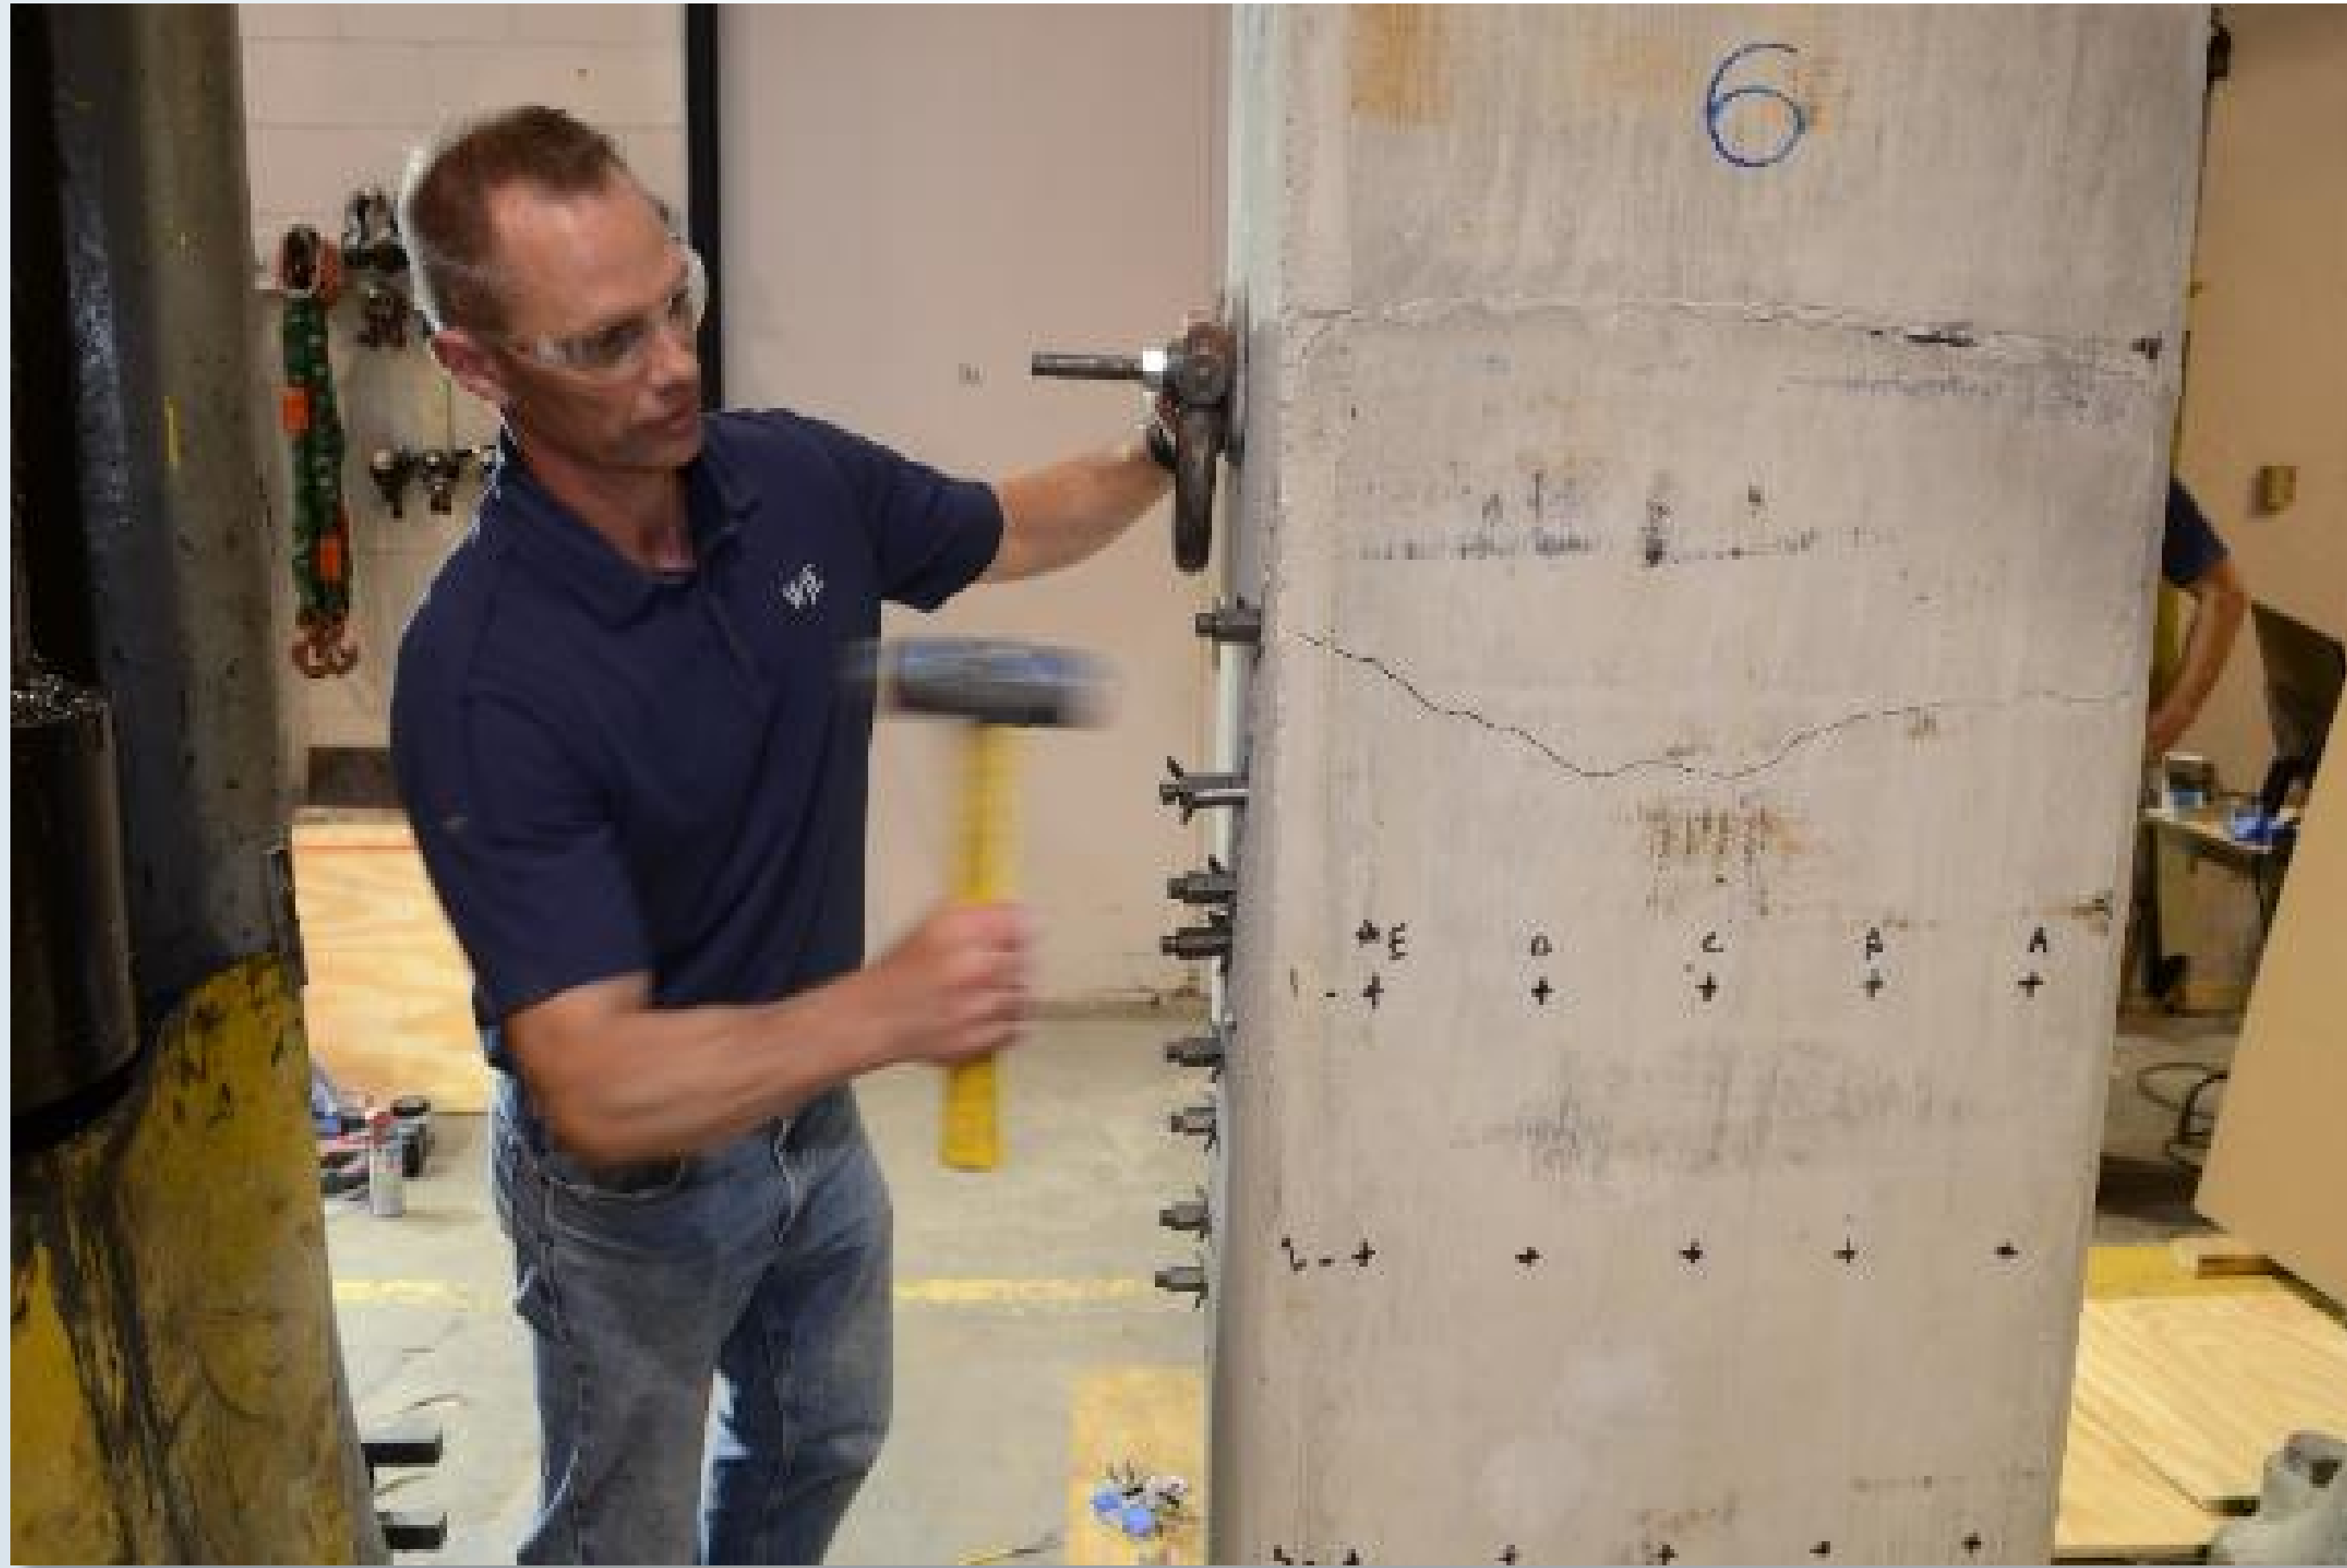
Stone-splitting wedge sets being used to create a crack across the construction joint of Specimen 6. Most specimens were pre-cracked.

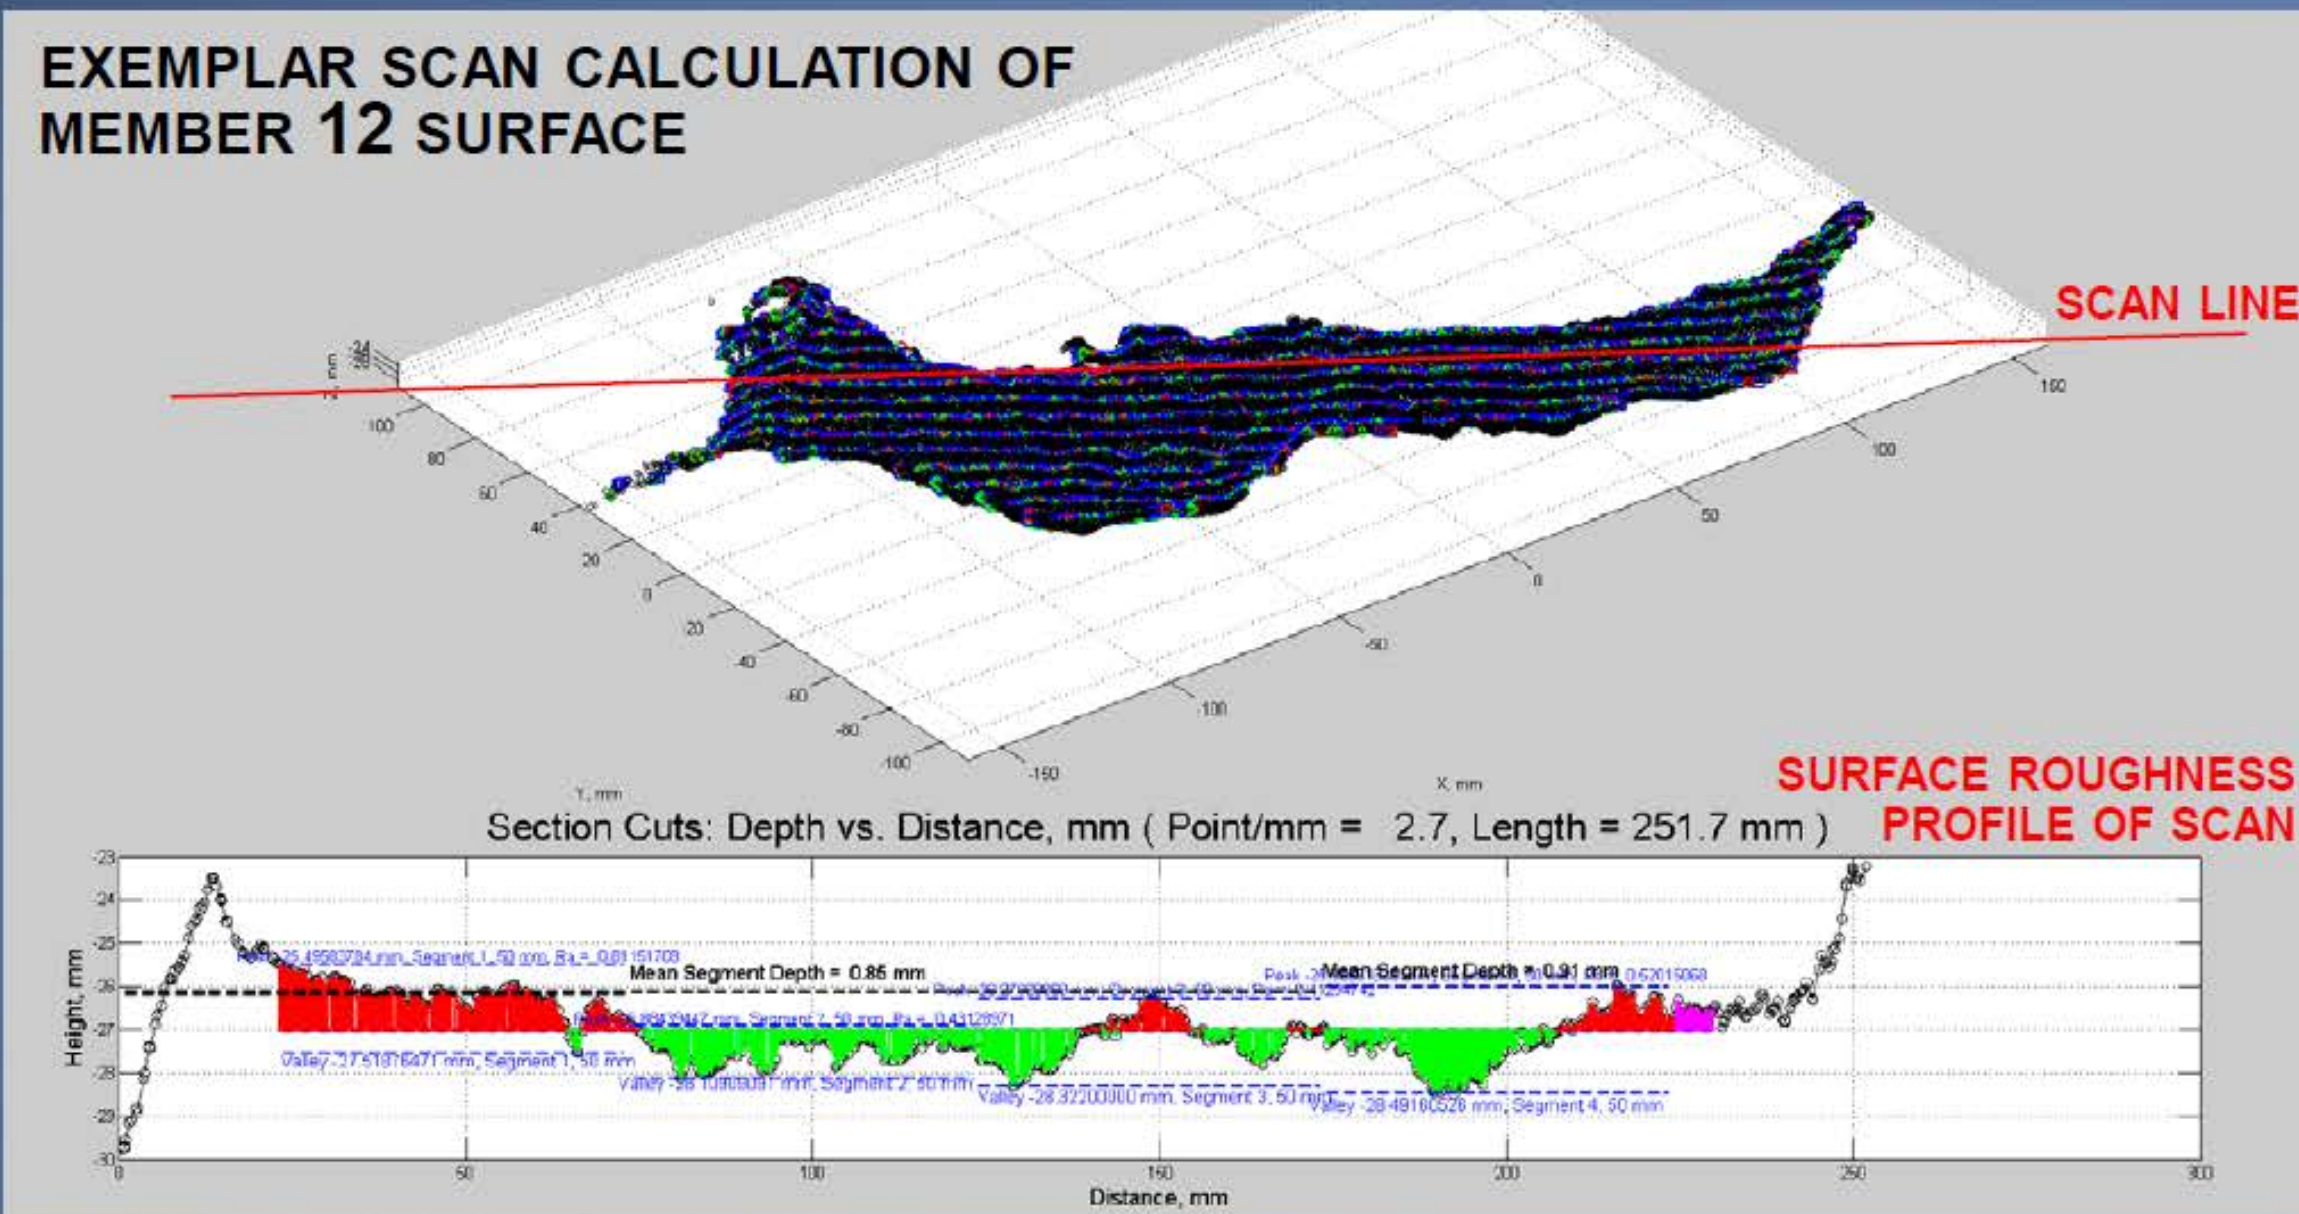
Surface Roughness Direct Measurement

- NTSB developed technique using data analysis of laser scans
- Calculations show cold joint not intentionally roughened

• Had cold joint been roughened, bridge could still have failed
