**GETTING THE MOST OUT
OF
NON-DESTRUCTIVE
TESTING**

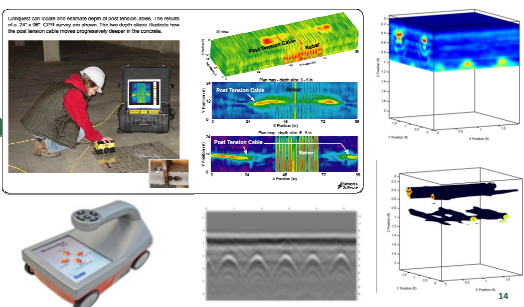
GROUND PENETRATING RADAR (GPR)

Computer can collect and analyze data in 3000 profiles/minute. The results are 100% 100% 100% accuracy. The data can be used to locate the steel rebar and other objects buried in the concrete.

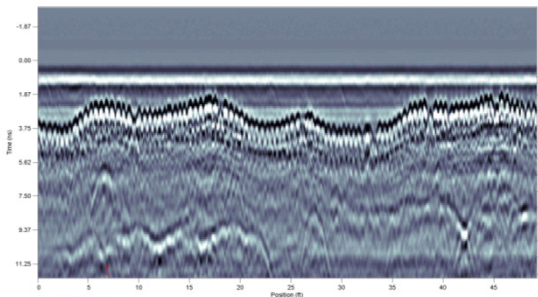
REINFORCING VERIFICATION

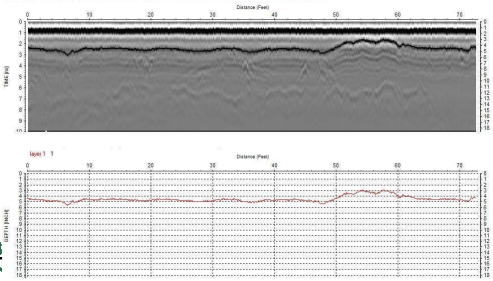
GPR – CONCRETE THICKNESS

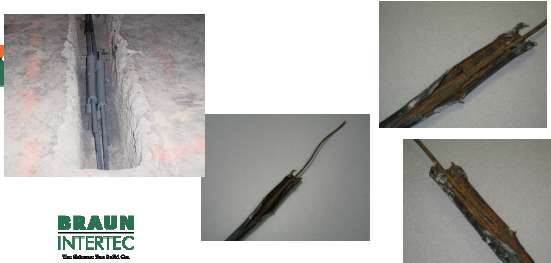
RADIOGRAPHY

- Concrete Imaging – Broken PT Cable

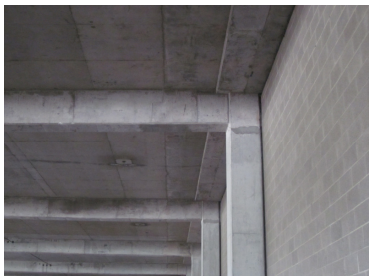
RADIOGRAPHY

- Concrete Imaging – Finding the Details

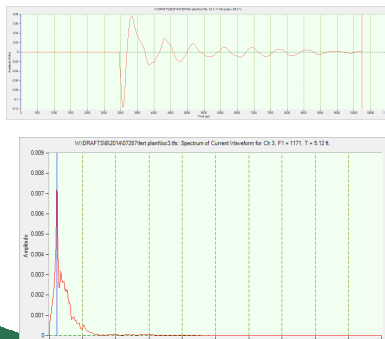
Wave analysis

- Wave
- Spectrum

The top graph shows a waveform with a sharp initial peak followed by several smaller, decaying oscillations. The bottom graph is a spectrum plot with a high peak at low frequency (around 500 Hz) and a long tail extending to 5000 Hz.

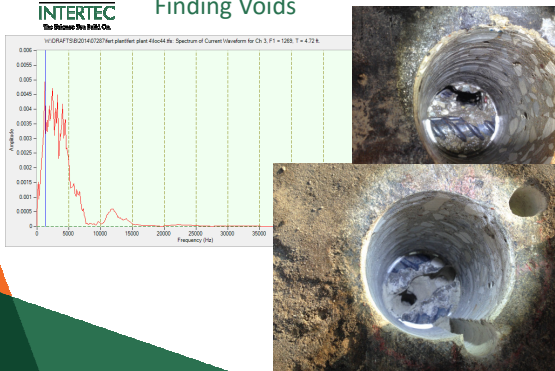
Finding Voids

The spectrum graph shows a peak at approximately 500 Hz. The two images show the interior of a pipe with a dark, irregular void or hole in the wall.

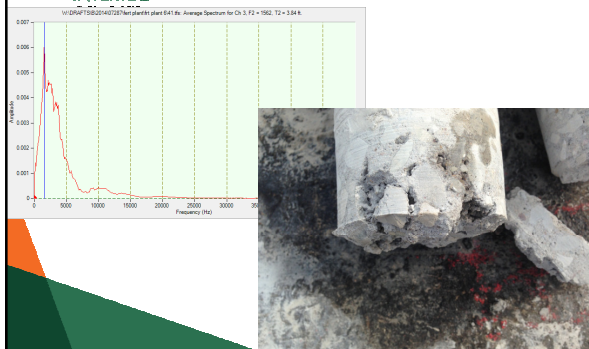
A little Different

The spectrum graph shows a peak at approximately 500 Hz. The image shows a pipe with a hole, and a cylindrical object is being used to probe the hole.

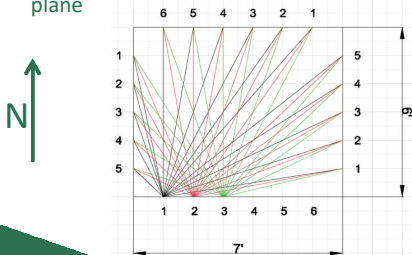
Collection Patterns

- Method 1 (Baseline) – 192 paths through plane

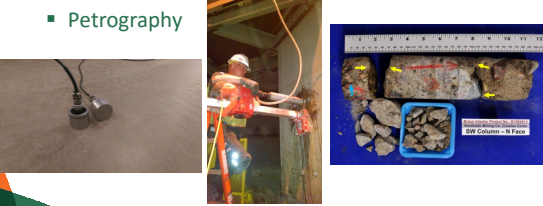
BRAUN INTERTEC Approach

- Non-Destructive Testing (UPV)
- Core samples
- Petrography

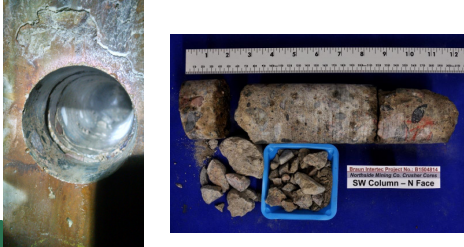
BRAUN INTERTEC Southwest Column Core Sample

- Surface-parallel cracking

- Cracking occurring near rebar cage
- No significant microcracking
- Damage on the west columns extends beyond the surface
