Concrete Failure Analysis: What you don't know CAN hurt you.

Kevin MacDonald
Beton Consulting Engineers LLC

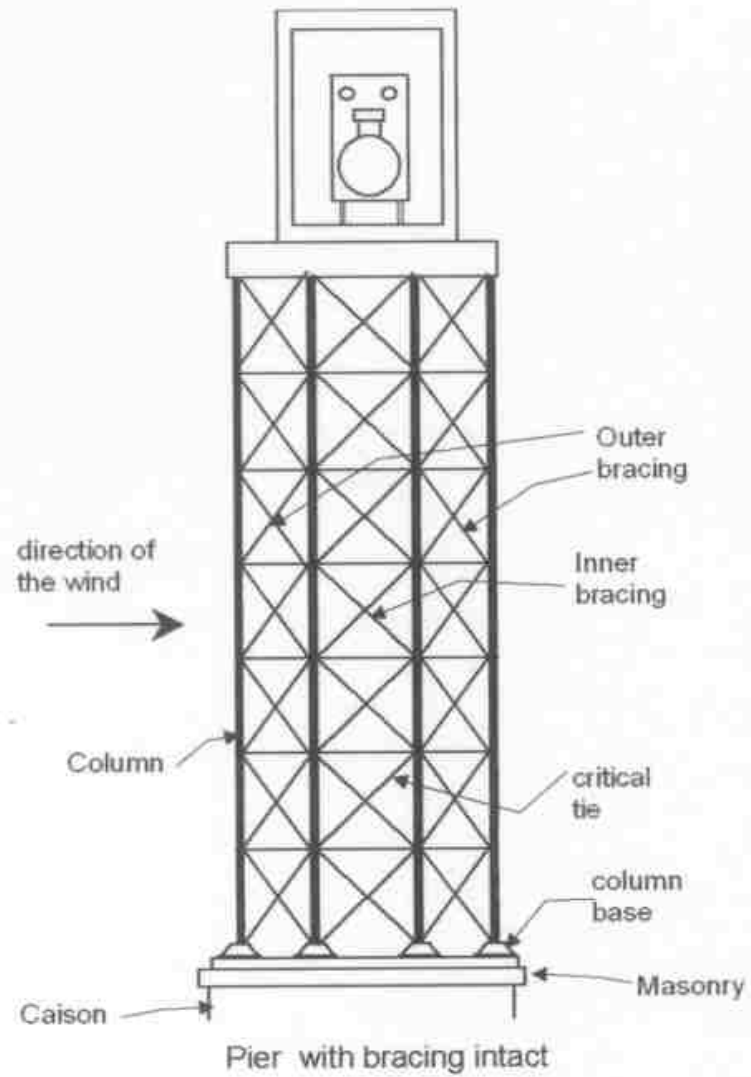
Pier with bracing intact

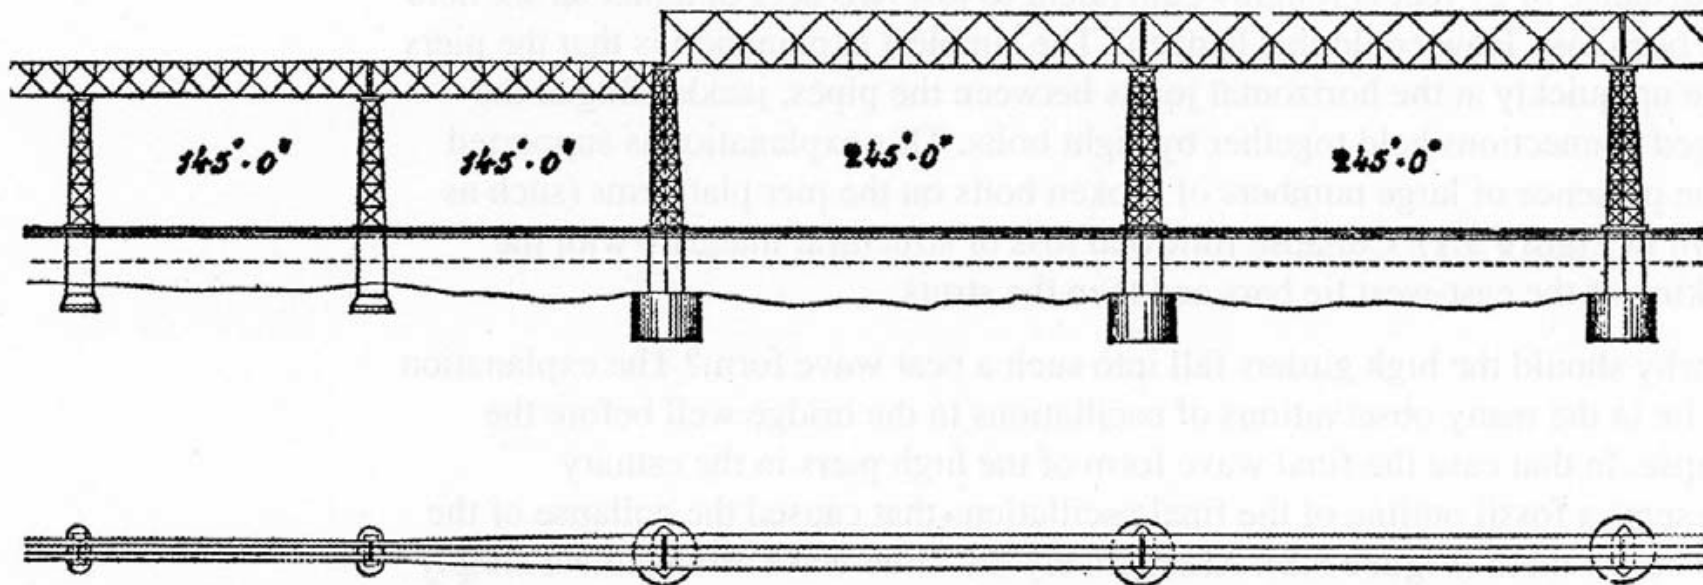
TAY BRIDGE, ARRANGEMENT OF PIERS & GIRDERS.

-
- The Tay bridge was nearly two miles long, consisting of 85 spans and at the time was the longest bridge in the world. The spans carried a single rail track; 72 of these were supported on spanning girders below the level of the track; the remaining 13 navigation spans were spanning girders above the level of the track (i.e. the train runs through a tunnel of girders).

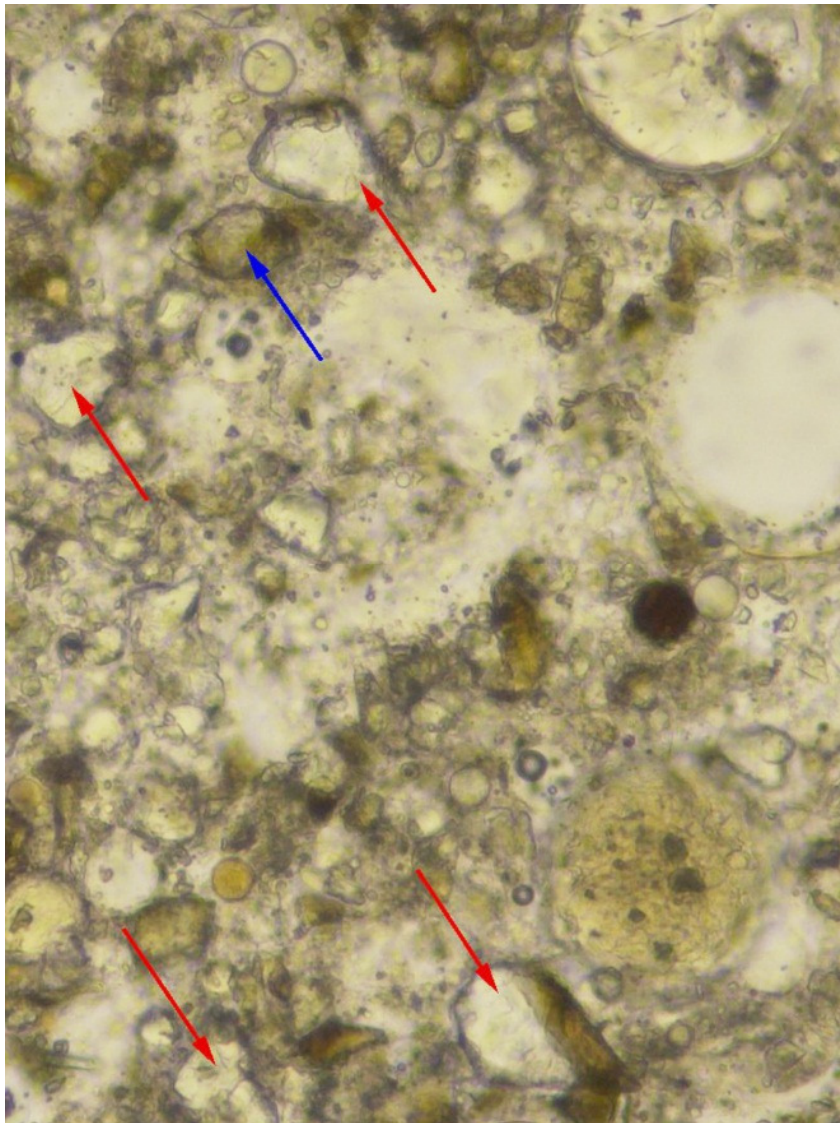
Low
Replacement

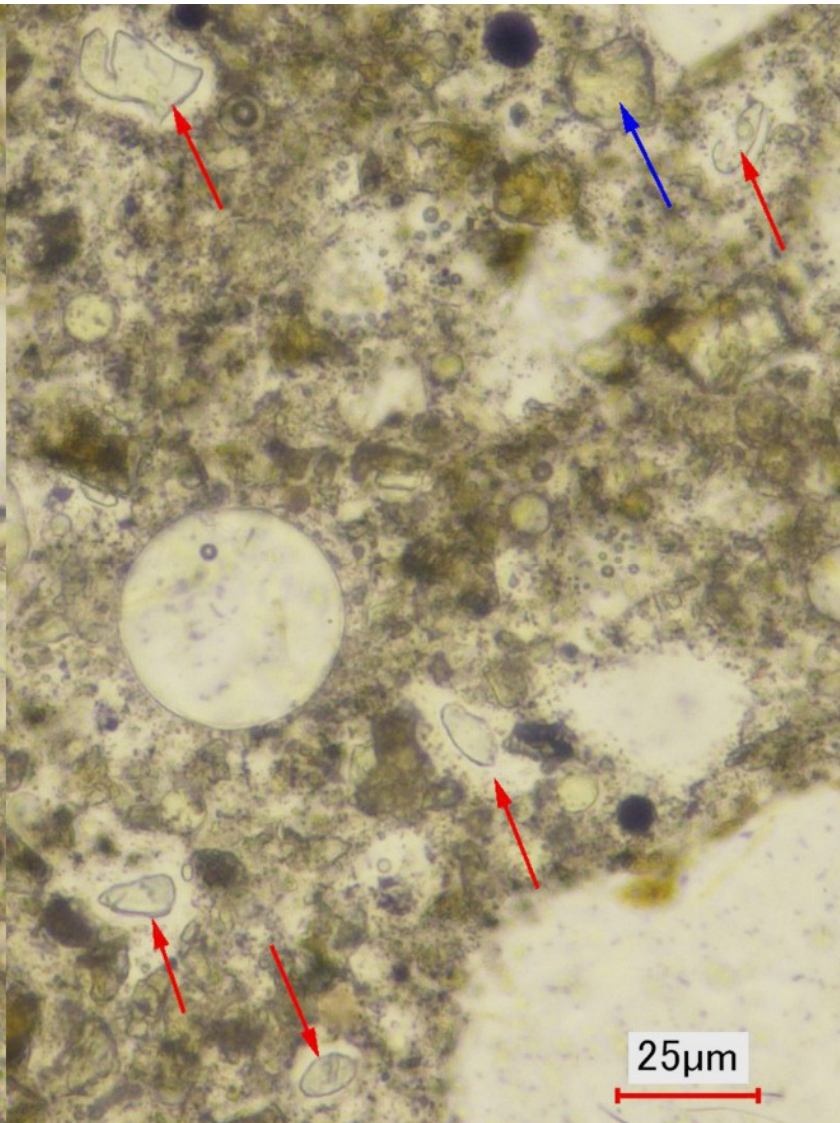
High
Replacement

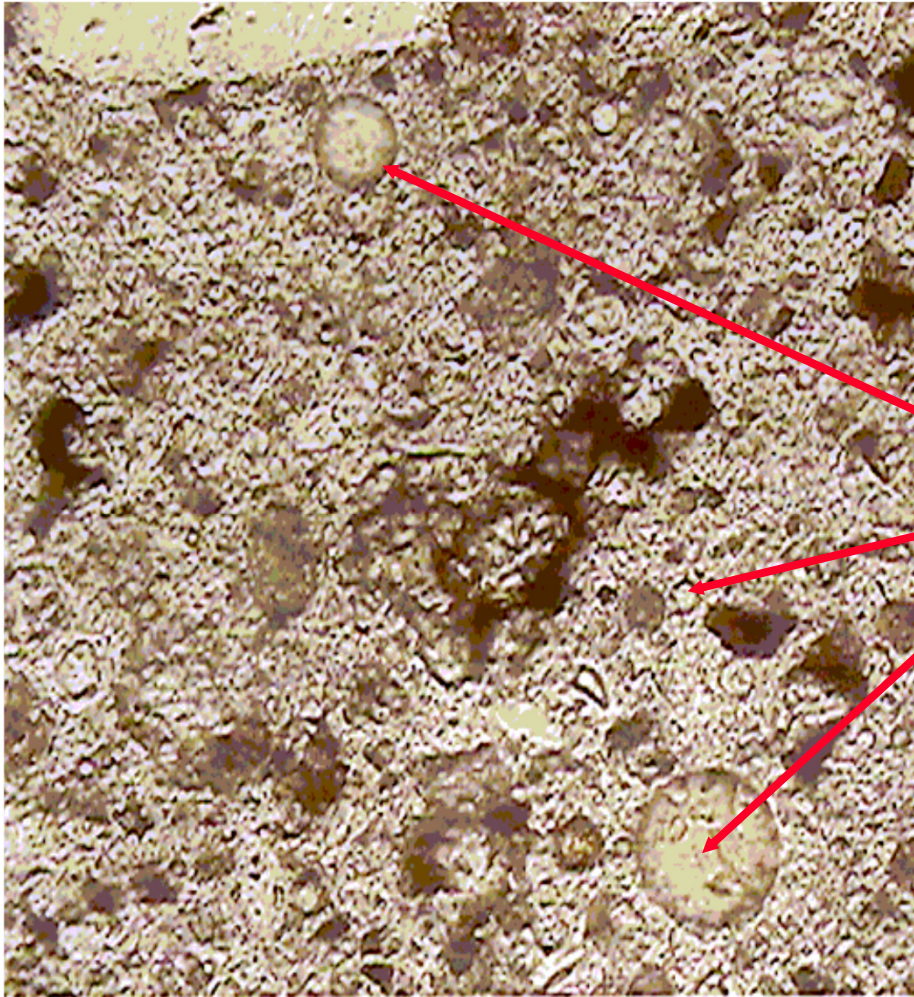
Flyash
Particles
