SCALING OF LATE SEASON CONCRETE PLACEMENTS

Mid-Winter Update – February 12, 2015

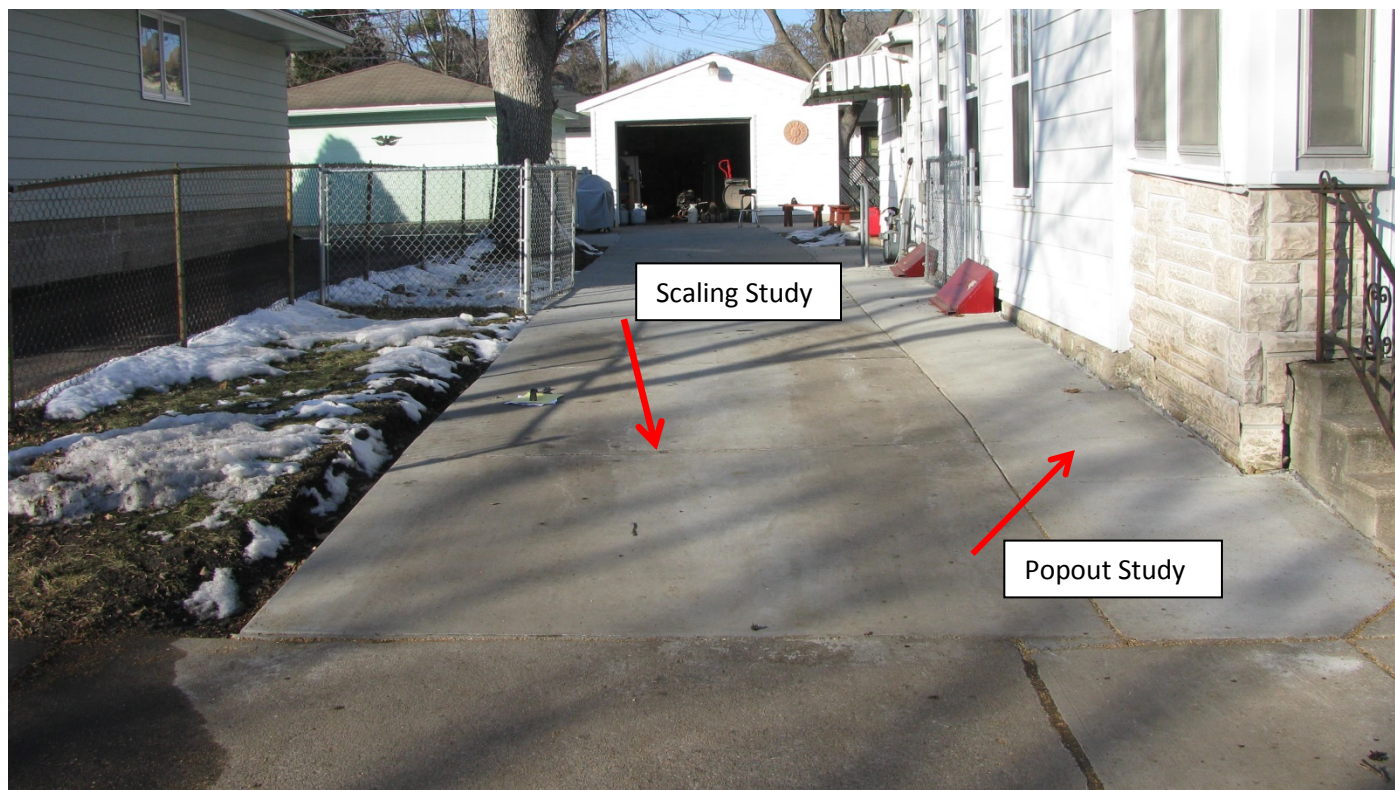
Photo 1: Overall view of research slabs.

The 10 x 100 foot slab-on-grade was placed on October 31, 2014 during subfreezing weather. The 3 x 70 foot walkway was placed on November 1, 2014 (see Photo 1). As of February 11, 2015, no scaling has occurred on the main slab. The walkway, which has a mix that has a high potential for resulting in popouts, is just starting to show popouts (the first popout was observed on January 3, 2015) (see Photo 2).

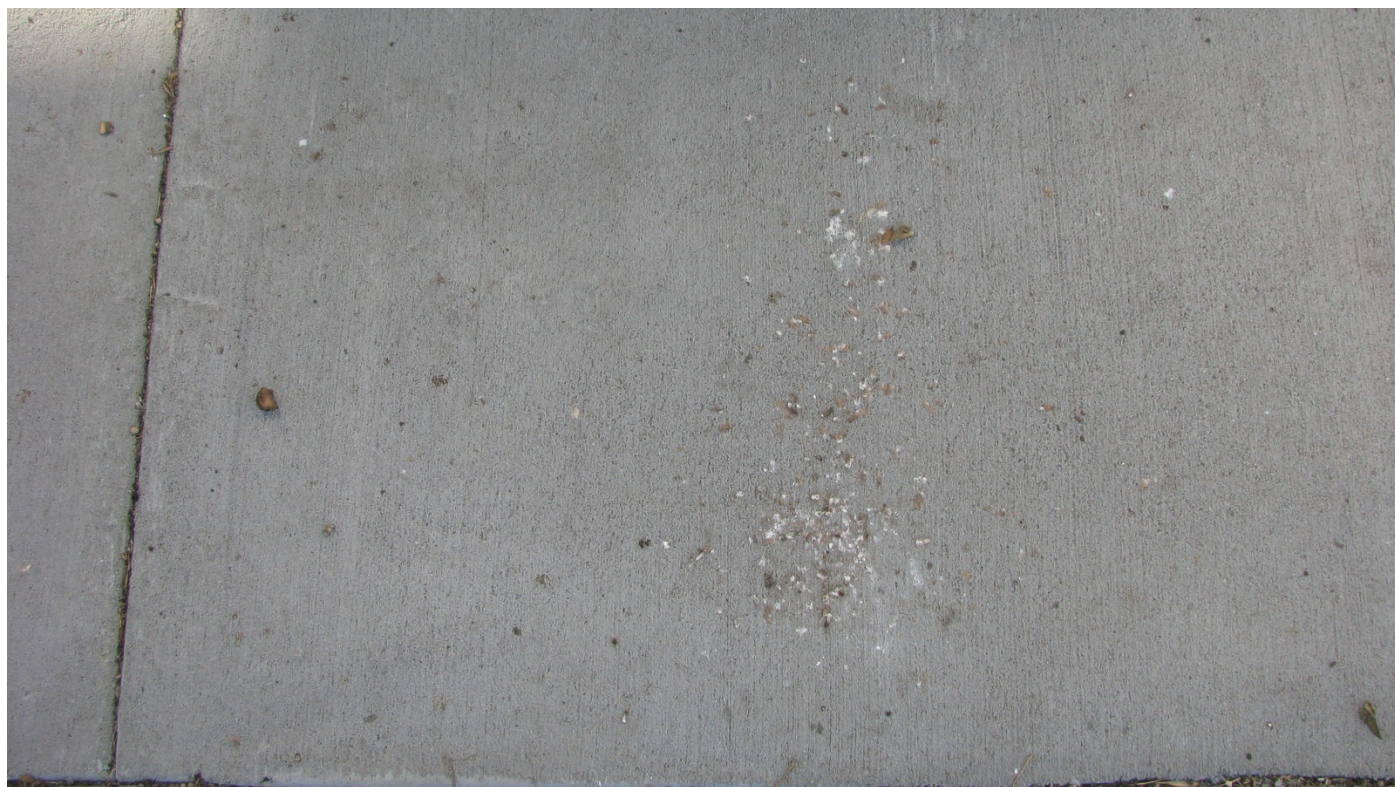
Photo 2: Showing initial popouts in slab #7 of the popout study.

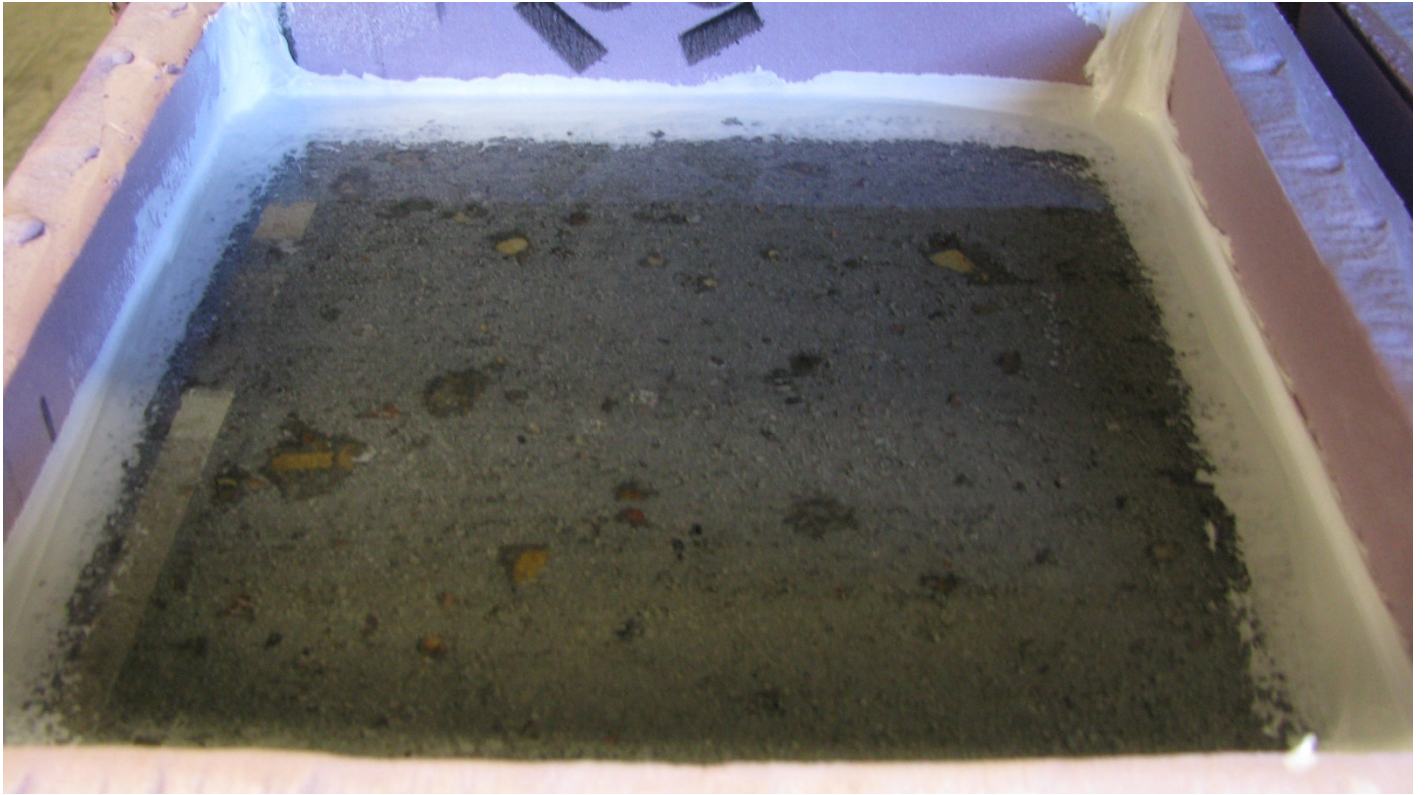
Photo 3: Showing scaling of ASTM C672 panel #7 after 50 cycles.

Dependent Variables (See Photos 3 and 4)

The two dependent variables (responses) are scaling, which is being determined by ASTM C672, "Standard Test Method for Scaling Resistance of Concrete Surfaces Exposed to Deicing Chemicals," and chloride ion ingress, which will be determined by performing ASTM C1218, "Standard Test Method for Water-soluble Chloride in Mortar and Concrete."

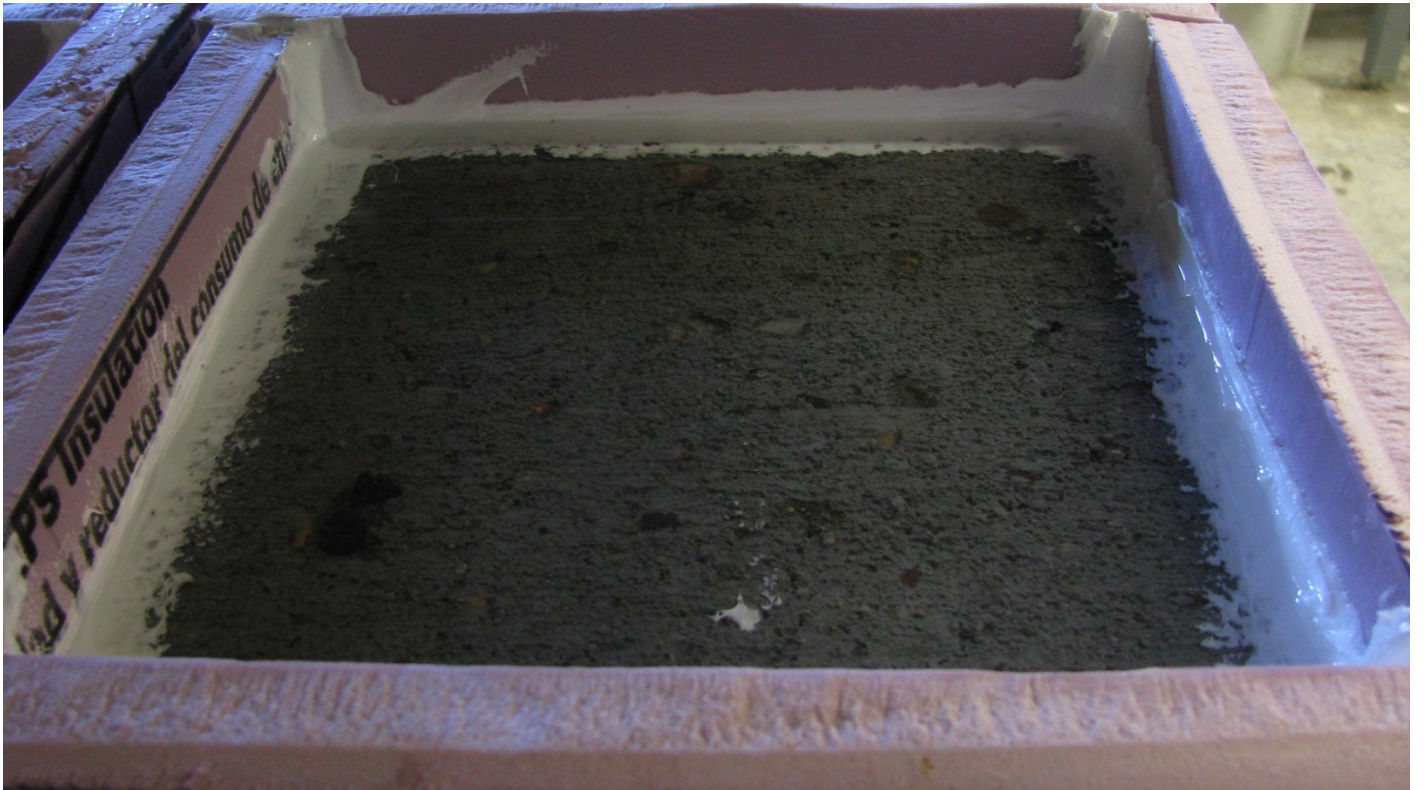
Photo 4: Showing scaling of ASTM C672 panel #4 after 50 cycles.
