**NON-DESTRUCTIVE TESTING – ADVANCED TECHNOLOGY
AND A PRACTICAL REVIEW OF HOW TO USE IT**

July 22, 2021

Larry D. Olson, P.E.
President and Chief Engineer
Larry.Olson@OlsonEngineering.com

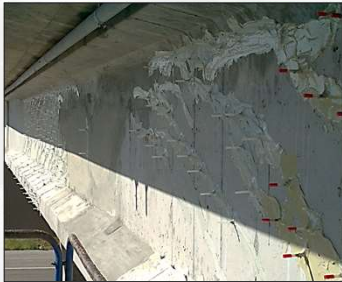
Concrete Repair Procedures for Truck Impacted Bridge Girder

- Chipped out loose and damaged concrete
- Pre-saturated the surface with water
- Used structural repair mortar to patch the spalling damage
- Used epoxy injection for filling cracks

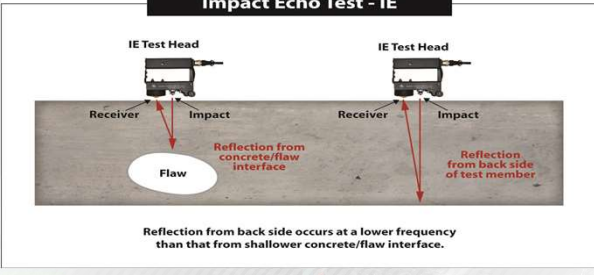
Impact Echo Method

Impact Echo Test - IE

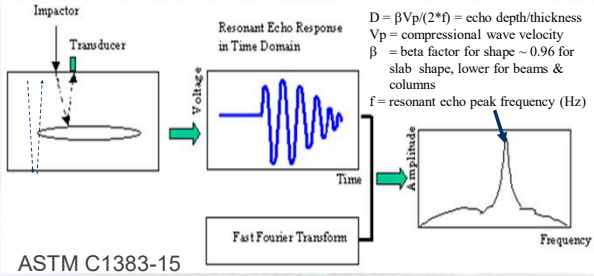
Impact Echo Data Analysis

ASTM C1383-15

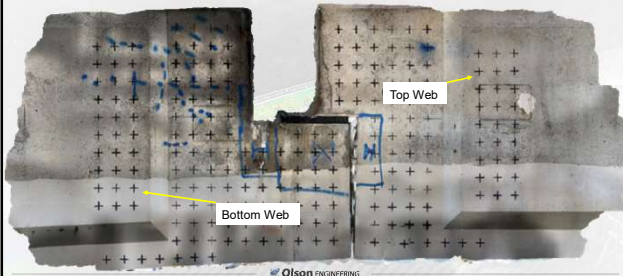
Digital Photogrammetry Example Data Bridge Girders with 6 inch NDE Grid marked out on Webs and Ends

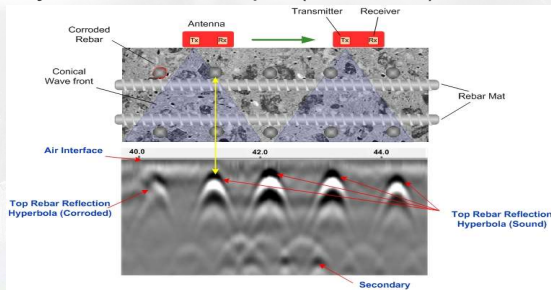
Physical GPR Principle (continued)

Physical Principle of GPR - ASTM D6087 - 08(2015)e1

- ▶ GPR antenna is in contact with test surface while moving and pulsing
- ▶ The electromagnetic pulses reflect back from embedded features
- ▶ Distance measured
- ▶ Data plotted as waterfall plots
- ▶ Measures responses caused by variations in electrical properties of the materials and metals are strong reflectors

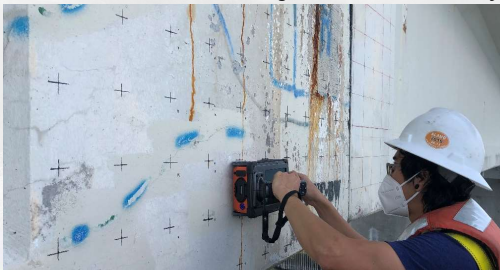
GPR scanning with GSSI StructureScan Mini XT unit (2700 MHz Antenna). Note the 6 inch "+" grid marks to guide horizontal and vertical GPR scan lines on a 3 inch grid for 3D GPR data analyses

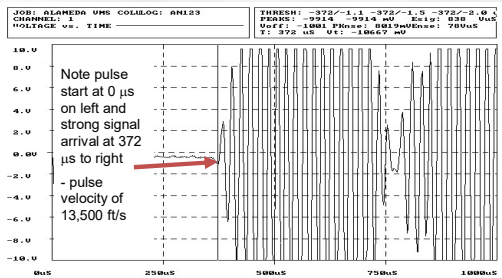
UPV Example from Sound Concrete

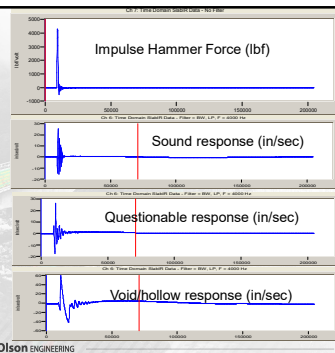
SIR Example Time Domain Data

Impulse hammer force & Sound, Questionable and Void/Hollow velocity transducer responses for support conditions of steel-lined concrete pipe conduit

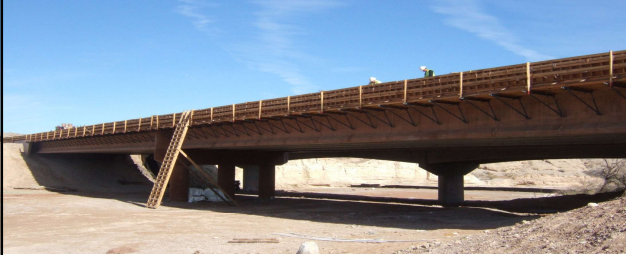
S³-IE scanning to check for Void/Honeycomb in new Bridge Decks

Total size of both decks was approximately 180 x 11 m (600 ft x 36 ft) – 42,000 Impact Echo tests in for a test every 0.05 m² (0.5 ft²) – Test ~10,000 ft² / hr at 1 ft spacing

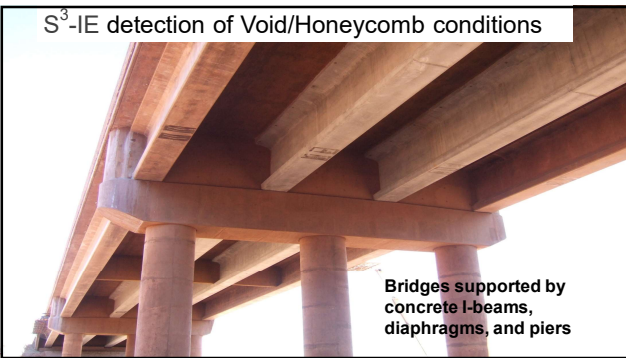
S³-IE detection of Void/Honeycomb conditions

Bridges supported by concrete I-beams, diaphragms, and piers

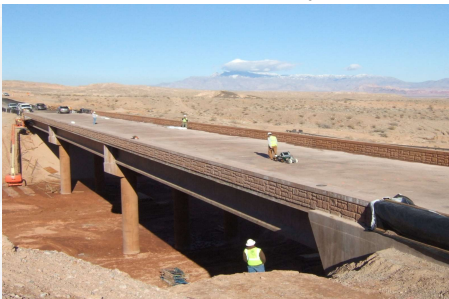
S³-IE detection of Void/Honeycomb conditions

Tests on Grid Lines at 0.3 m (1 ft) spacing across width of decks with early wagon cart

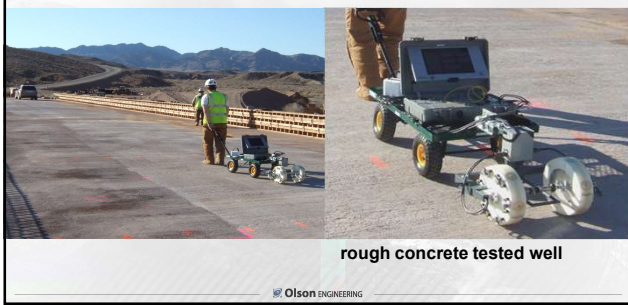
S³-IE detection of Void/Honeycomb conditions

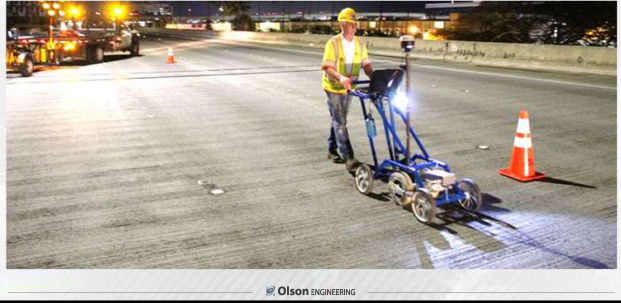
S³-IE Scanning - 2 miles of Interstate Bridge Deck+GPS

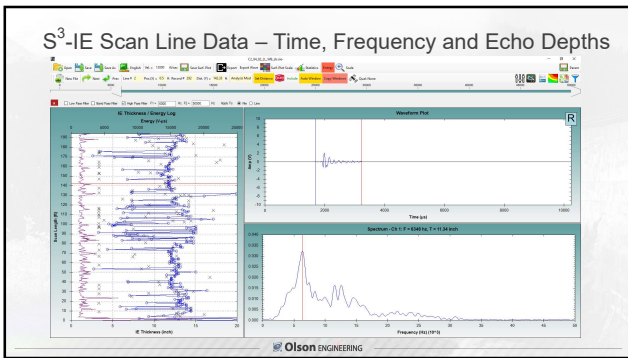
S³-IE Scan Line Data – Time, Frequency and Echo Depths

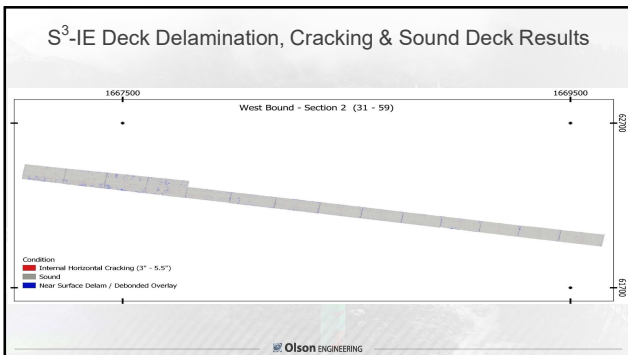
S³-IE Deck Delamination, Cracking & Sound Deck Results

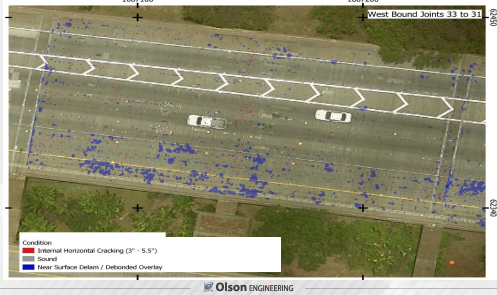
S³-IE Delamination, Cracking and Sound Deck Results for 200 ft Section overlaid on Google Earth View

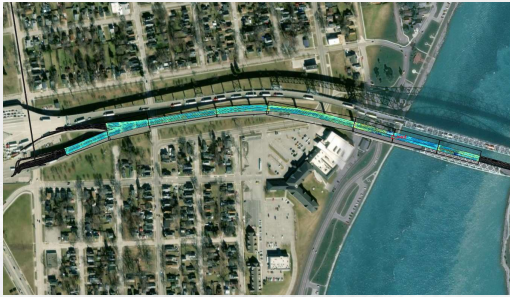
Google Earth View of Bridge Deck with GPR Scan Results

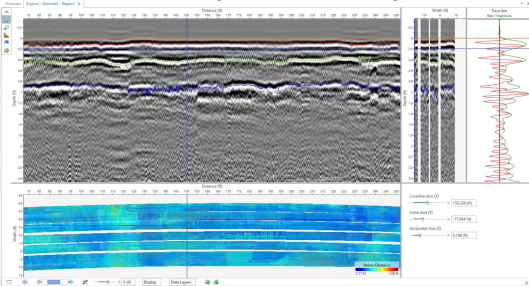
3D Radar Layer Thickness Analyses
