FIU UNIVERSITY CITY PROSPERITY PEDESTRIAN BRIDGE PROJECT

FIU Pedestrian Bridge Collapse: *Testing of Full-Size Replicas of Failed Connection*

Presented by Gary J. Klein, SE, PE

Presented July 23, 2020
Minnesota Concrete Council

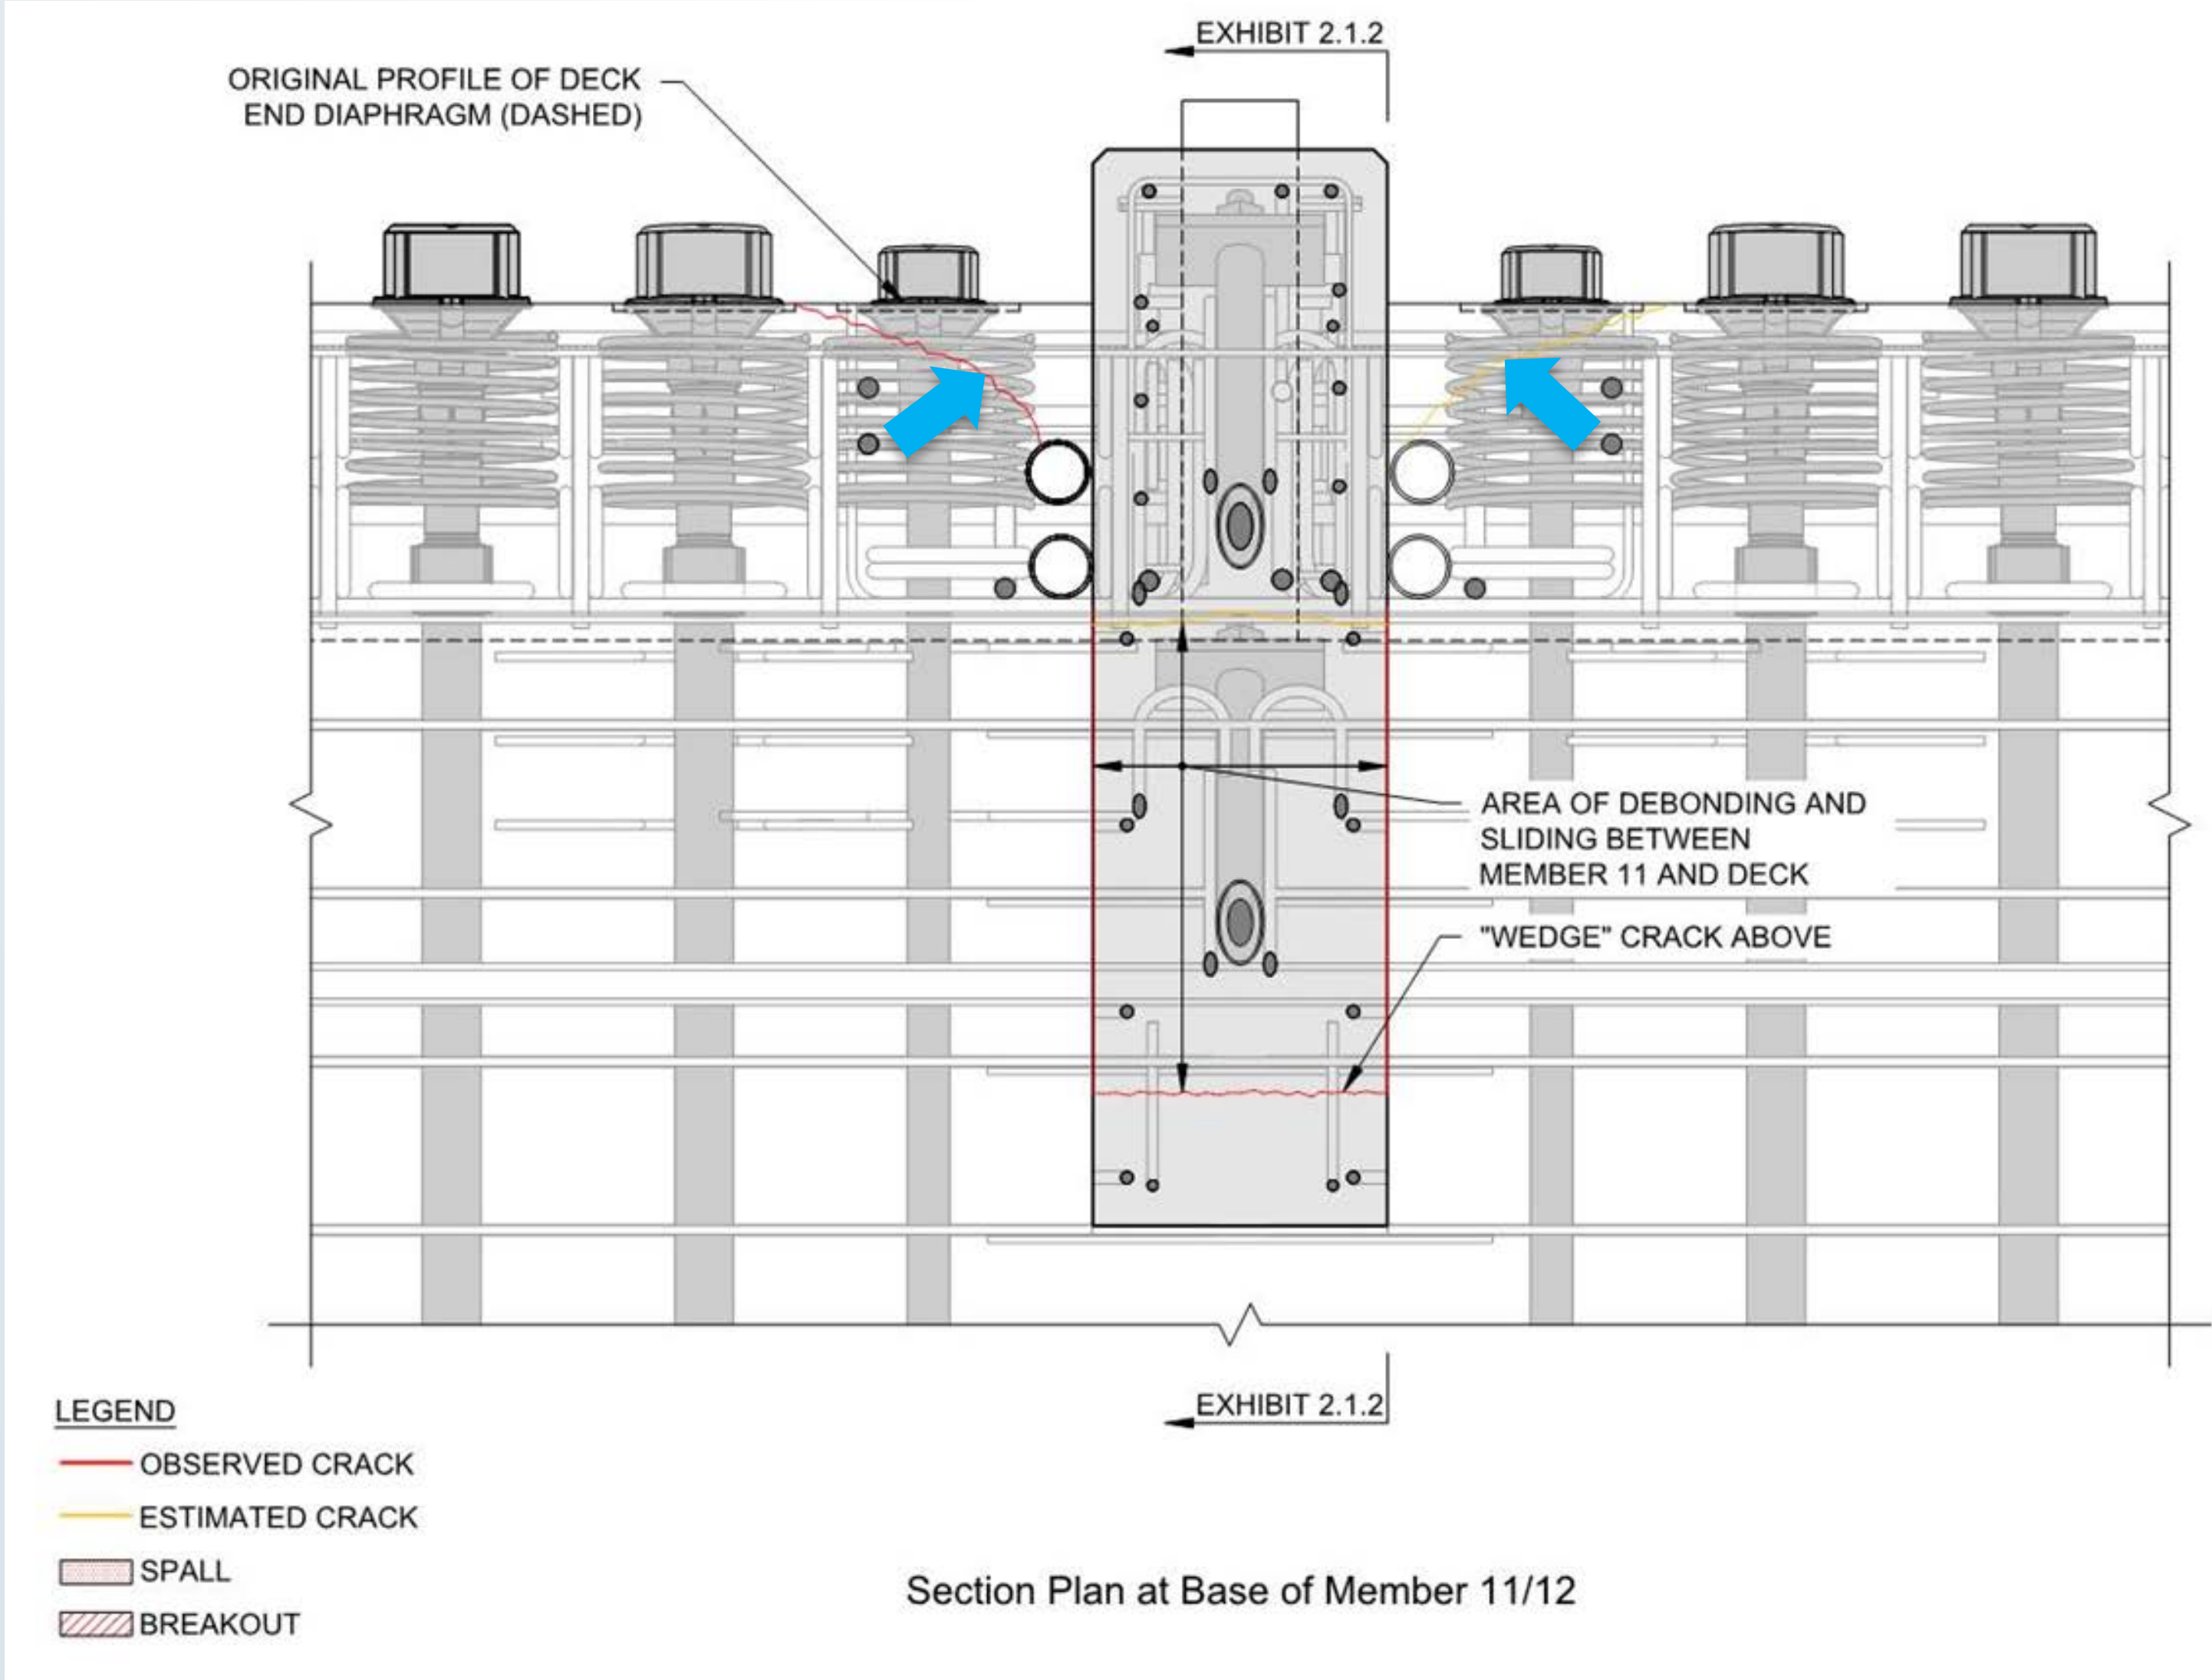
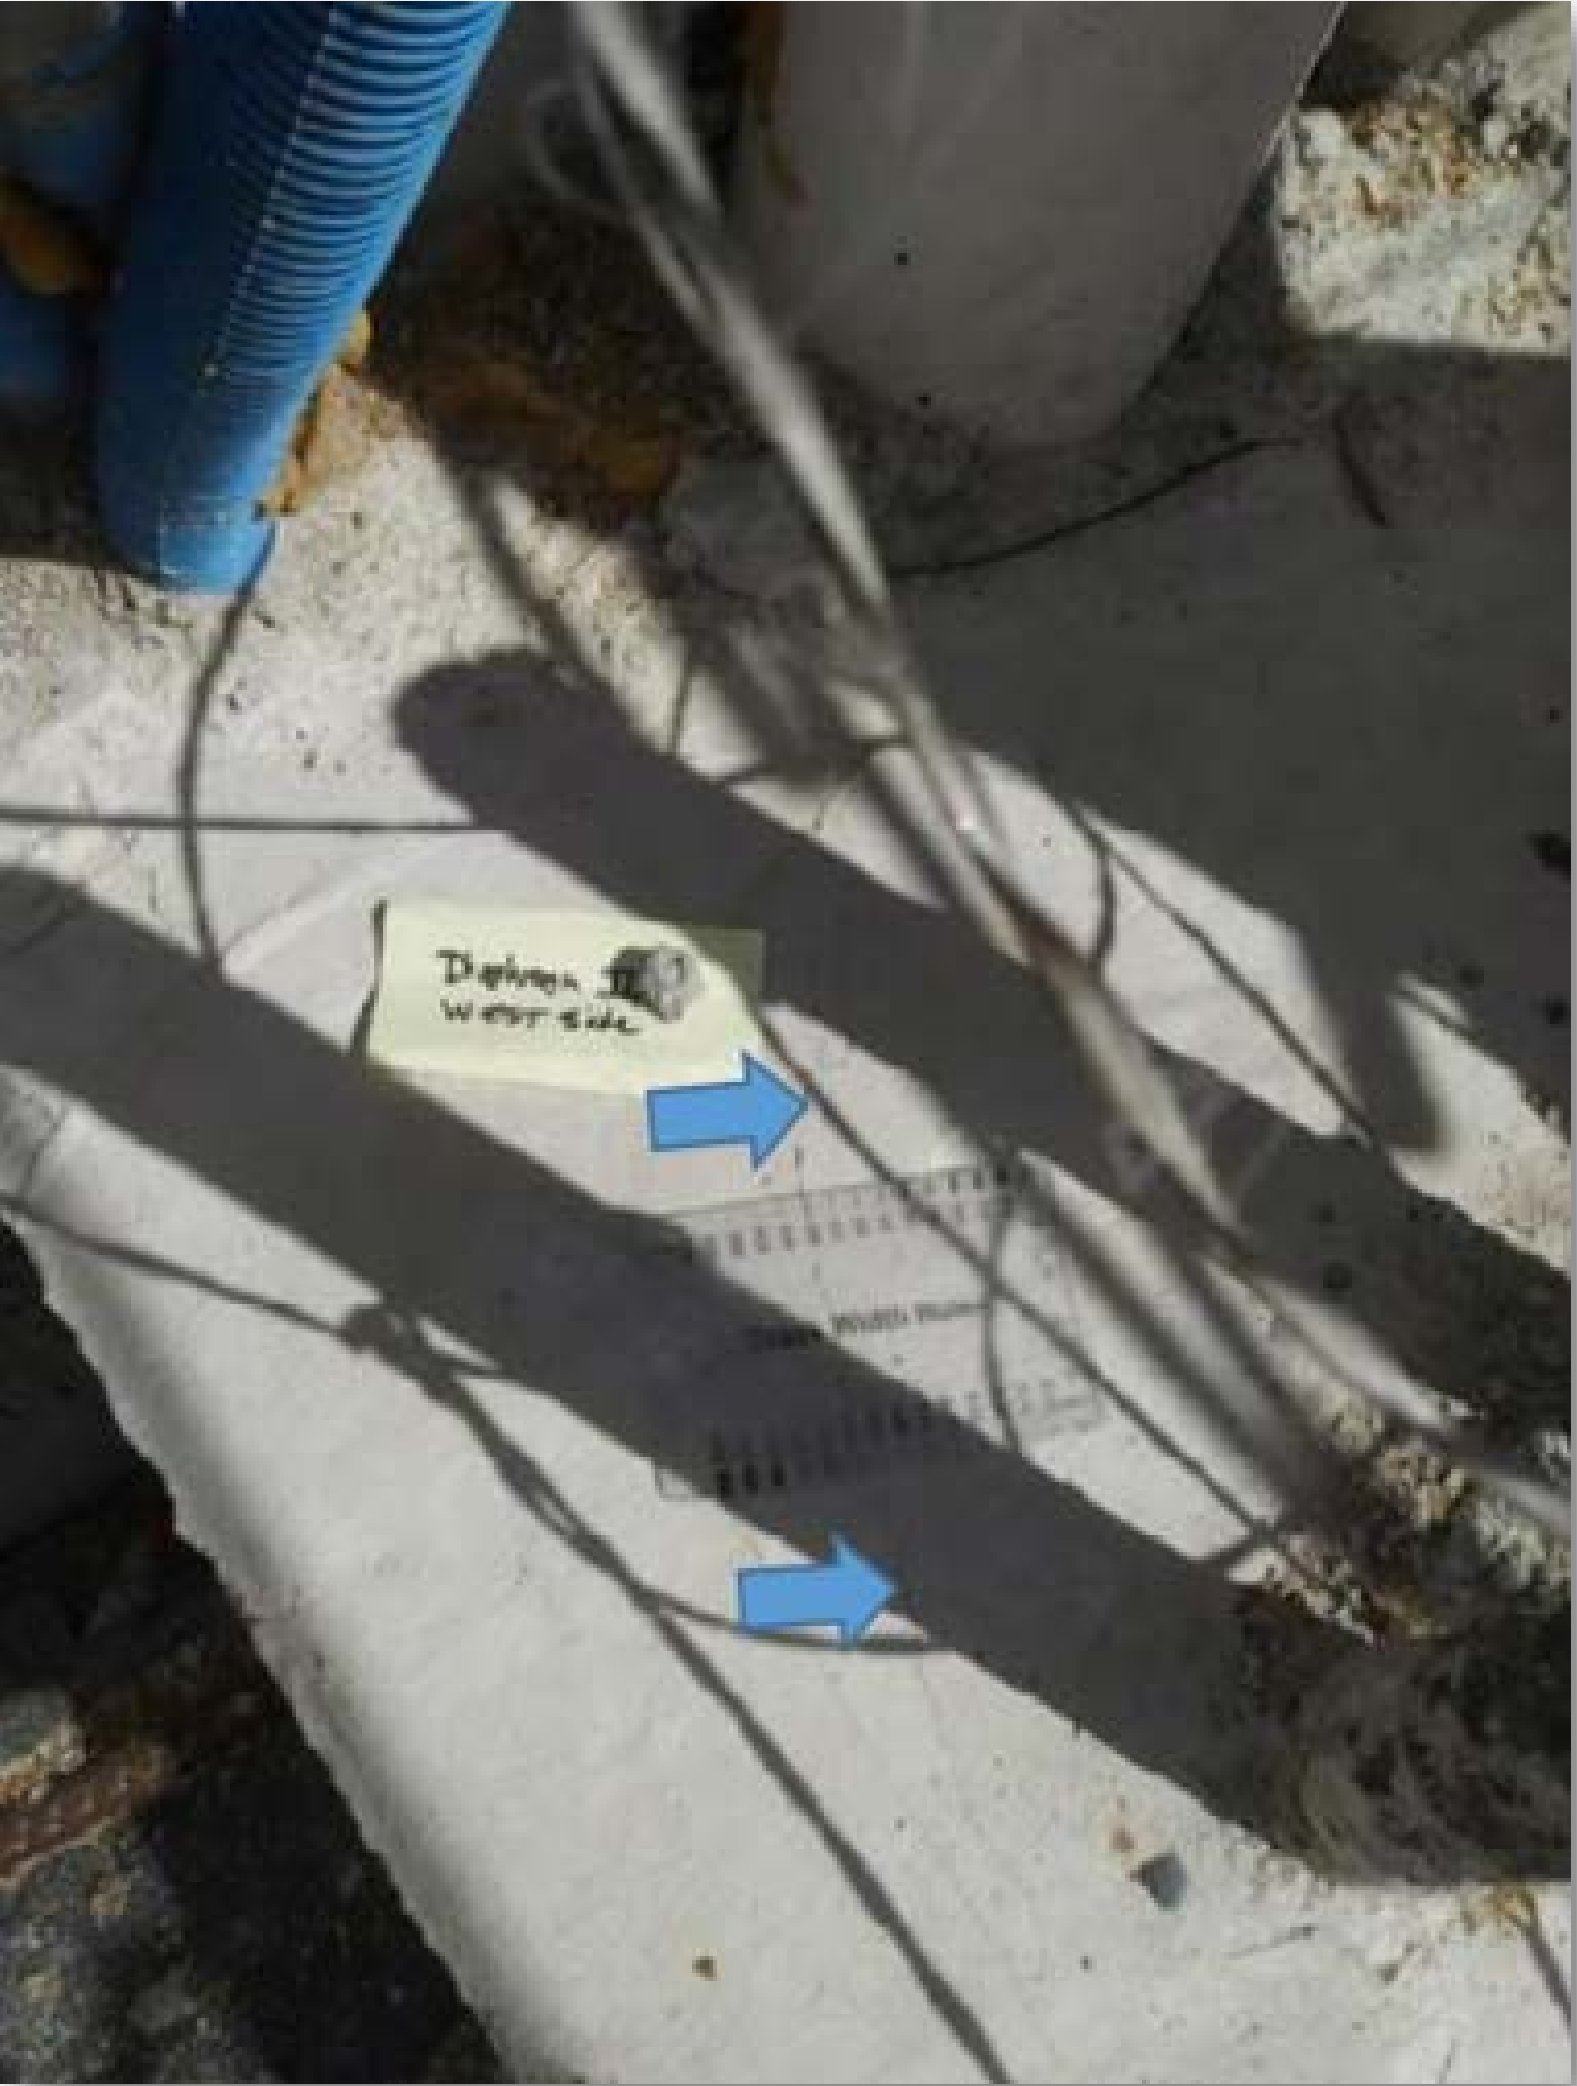
After Shoring Removal and Before Move (February 12-March 9, 2018)

- October 19, 2017 Deck concrete casting
- February 24, 2018 Shoring removal (cracking observed)
- March 10, 2018, 12:30 PM Main span moved into final position
- March 10, 2018, 3:07 PM Very significant widening of cracks observed
- March 15, 2018, 11:49 AM Re-tensioning of member 11
- March 15, 2018, 1:45 PM Main span collapses

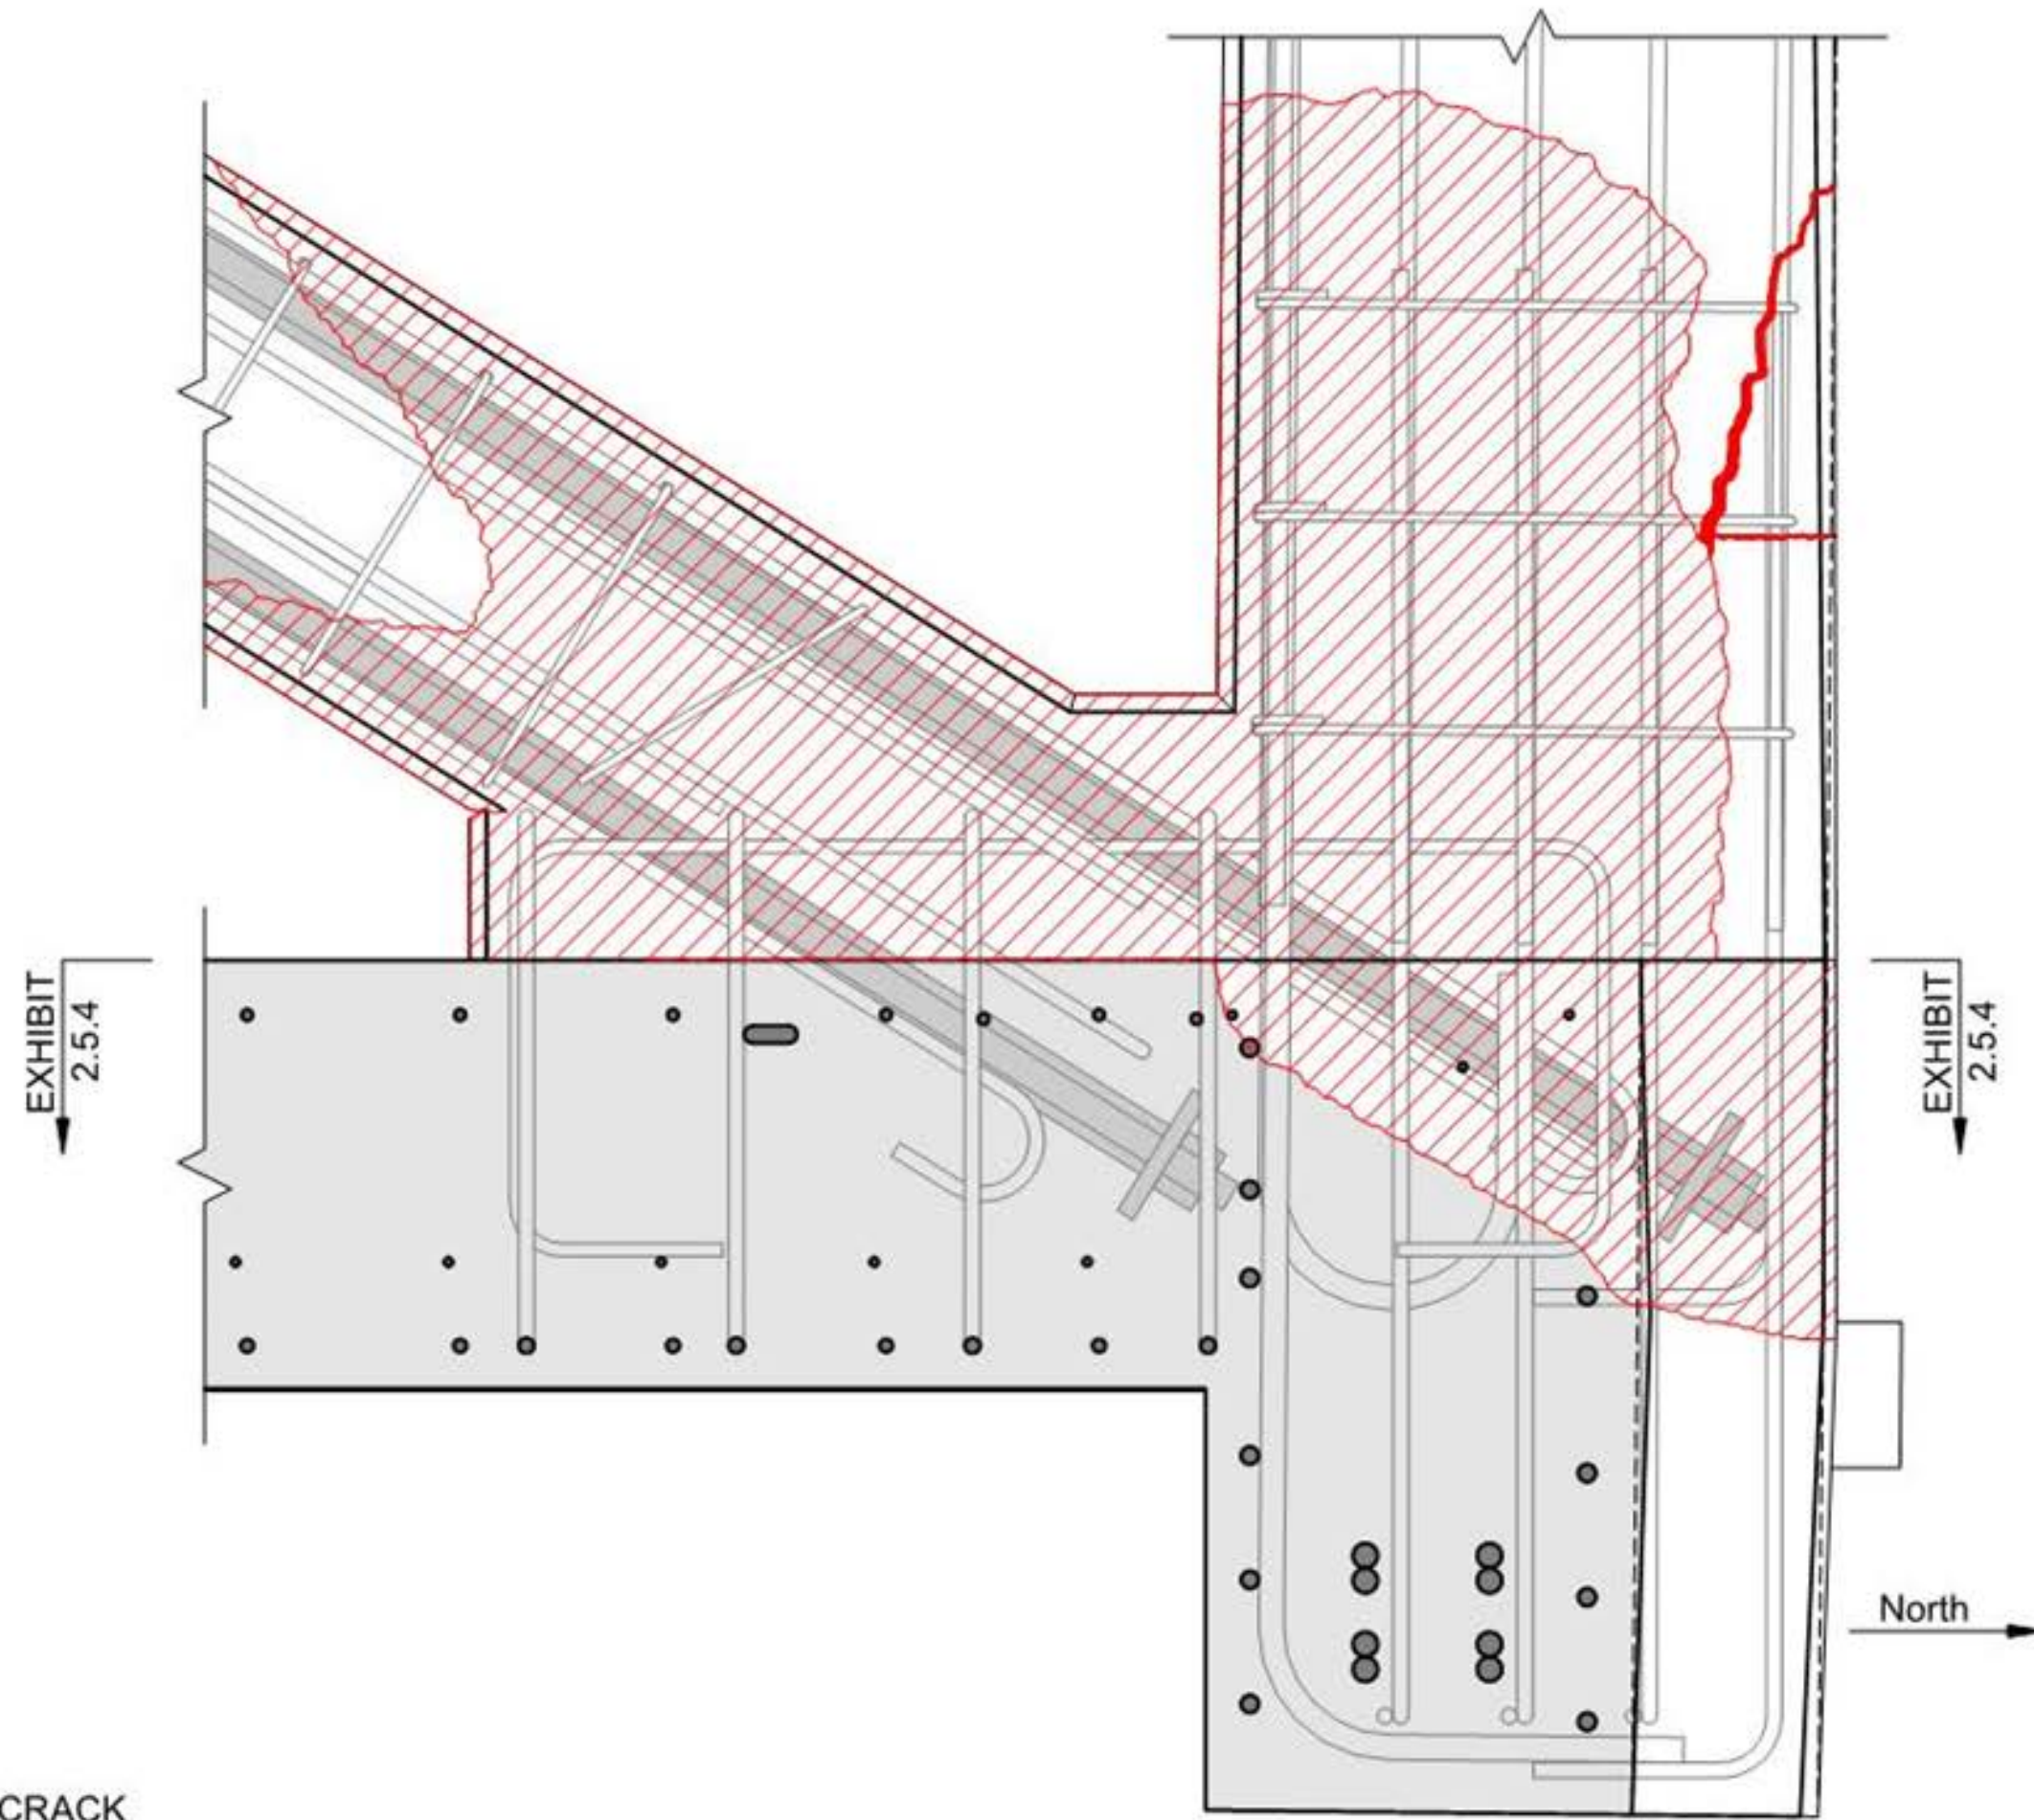
After Collapse (March 15, 2018)

Section At East Face of Member 11/12

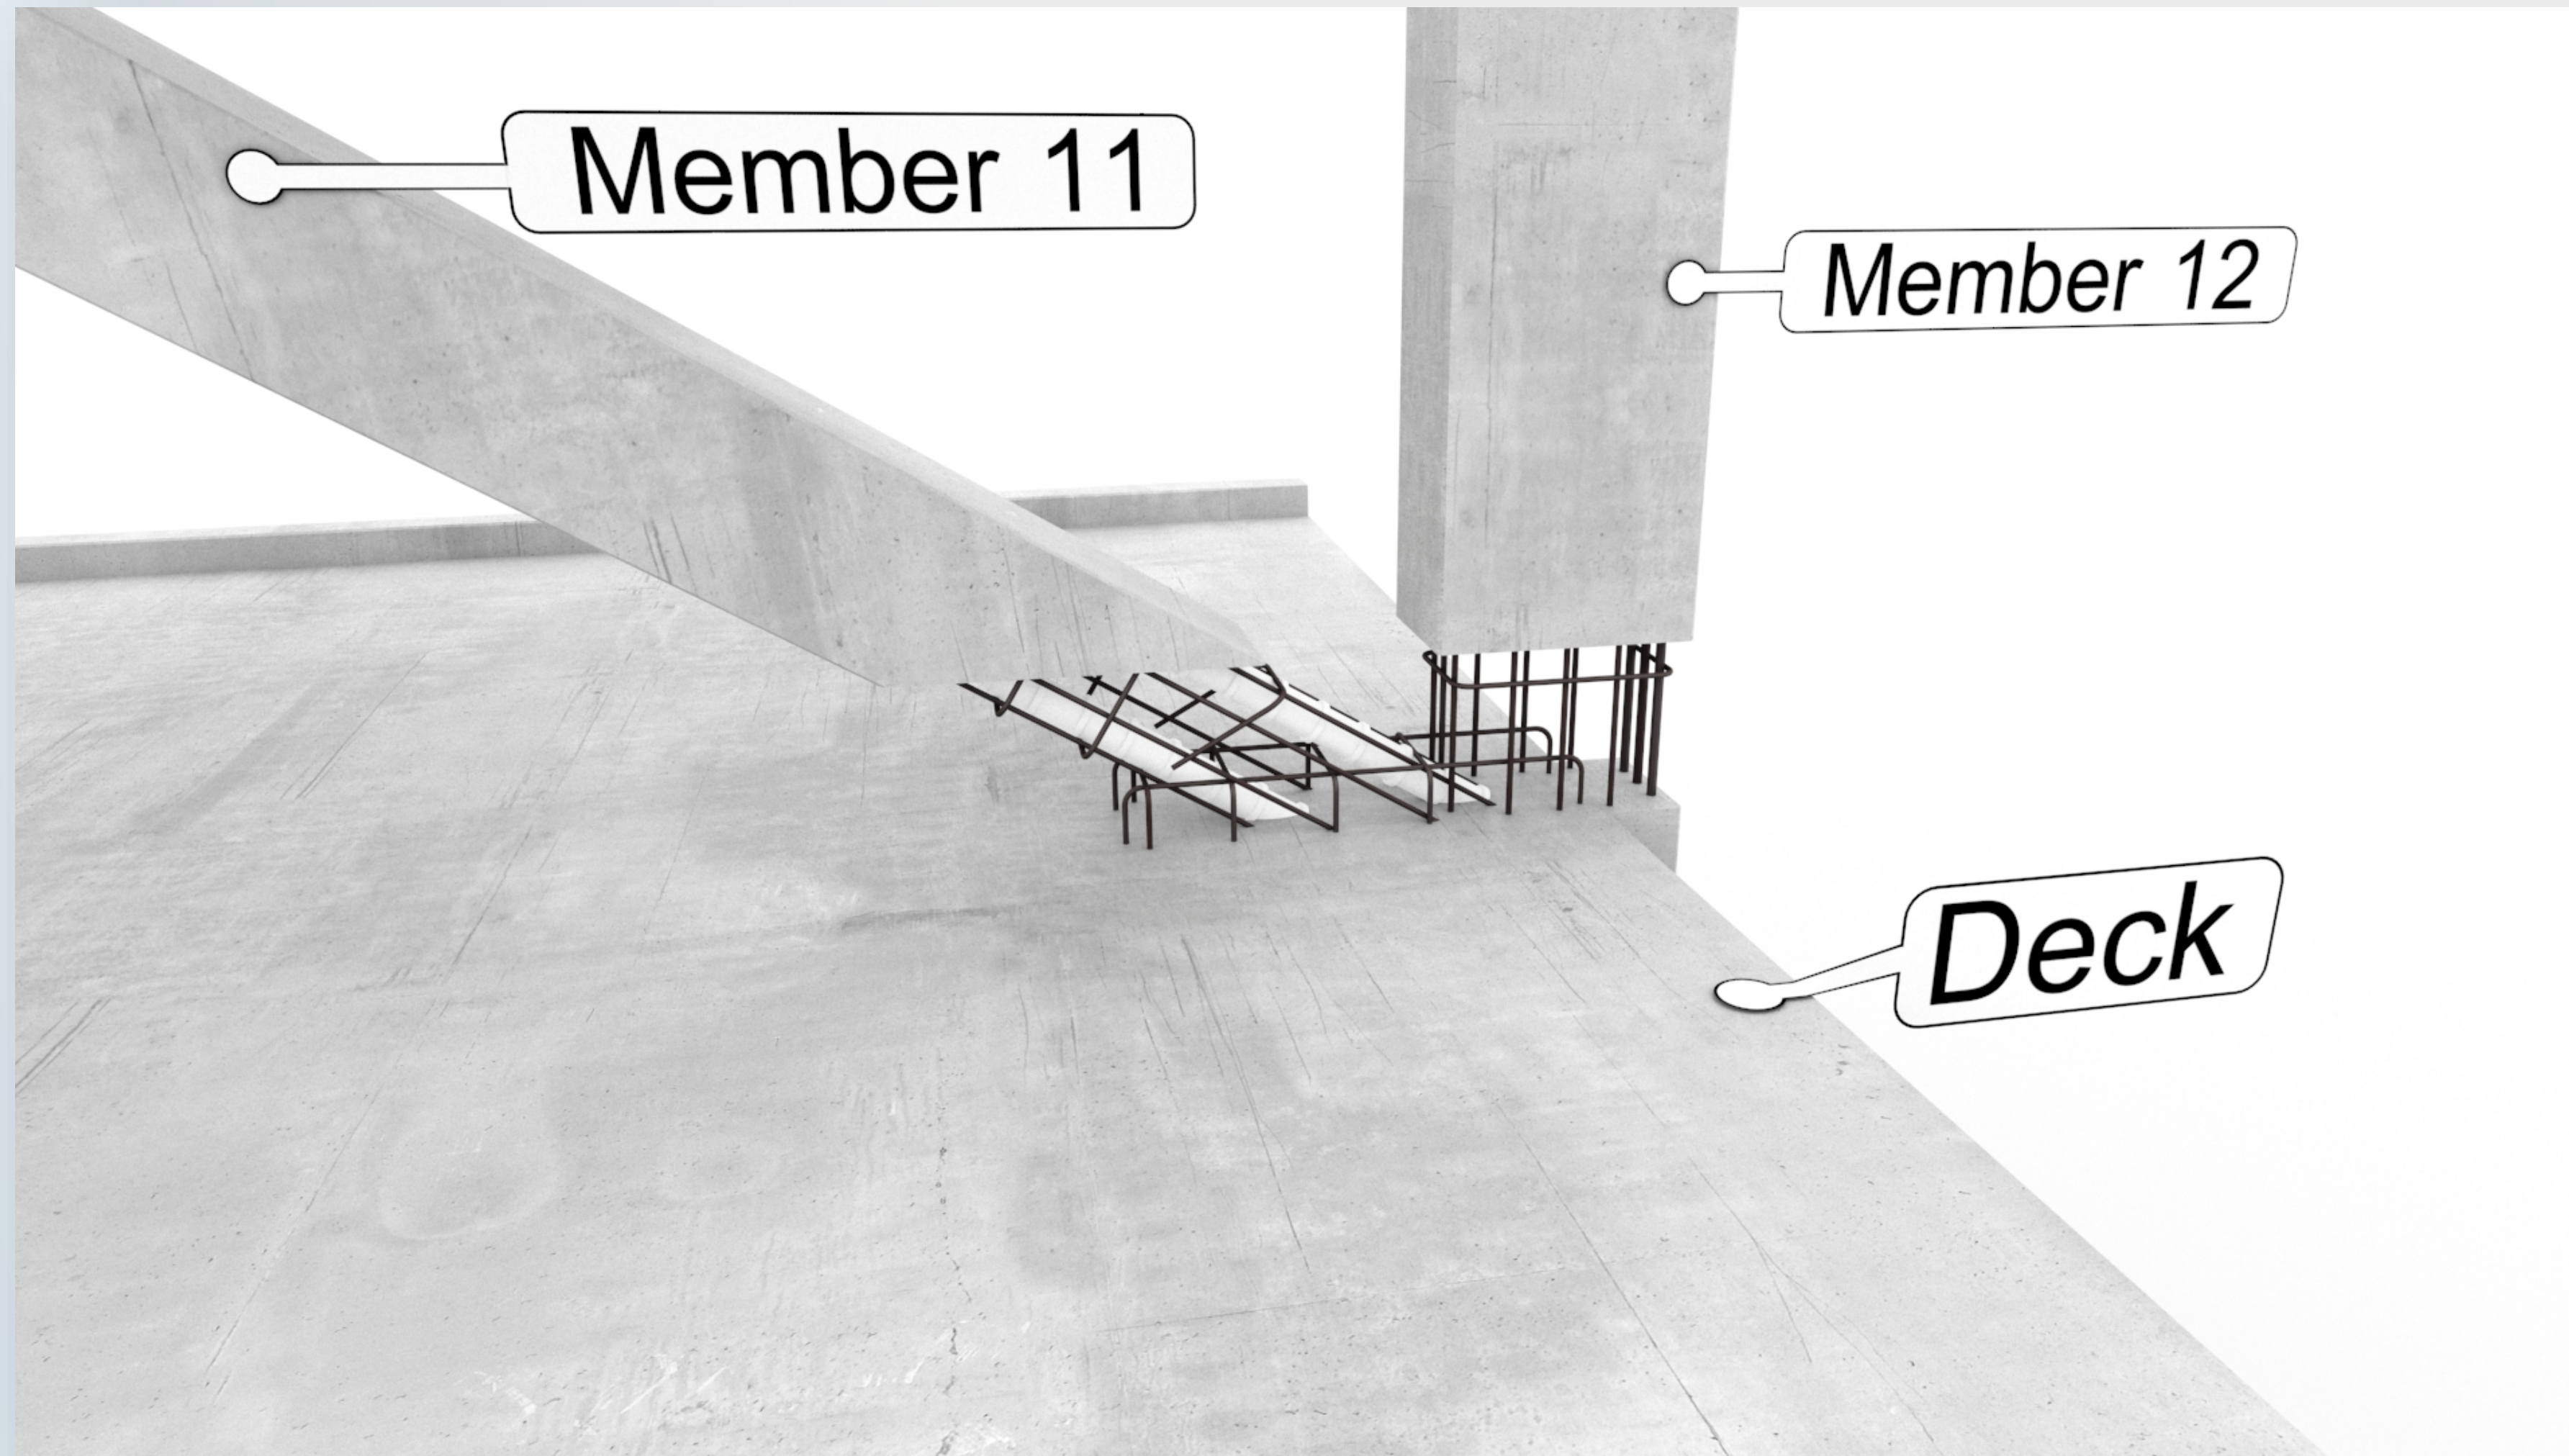
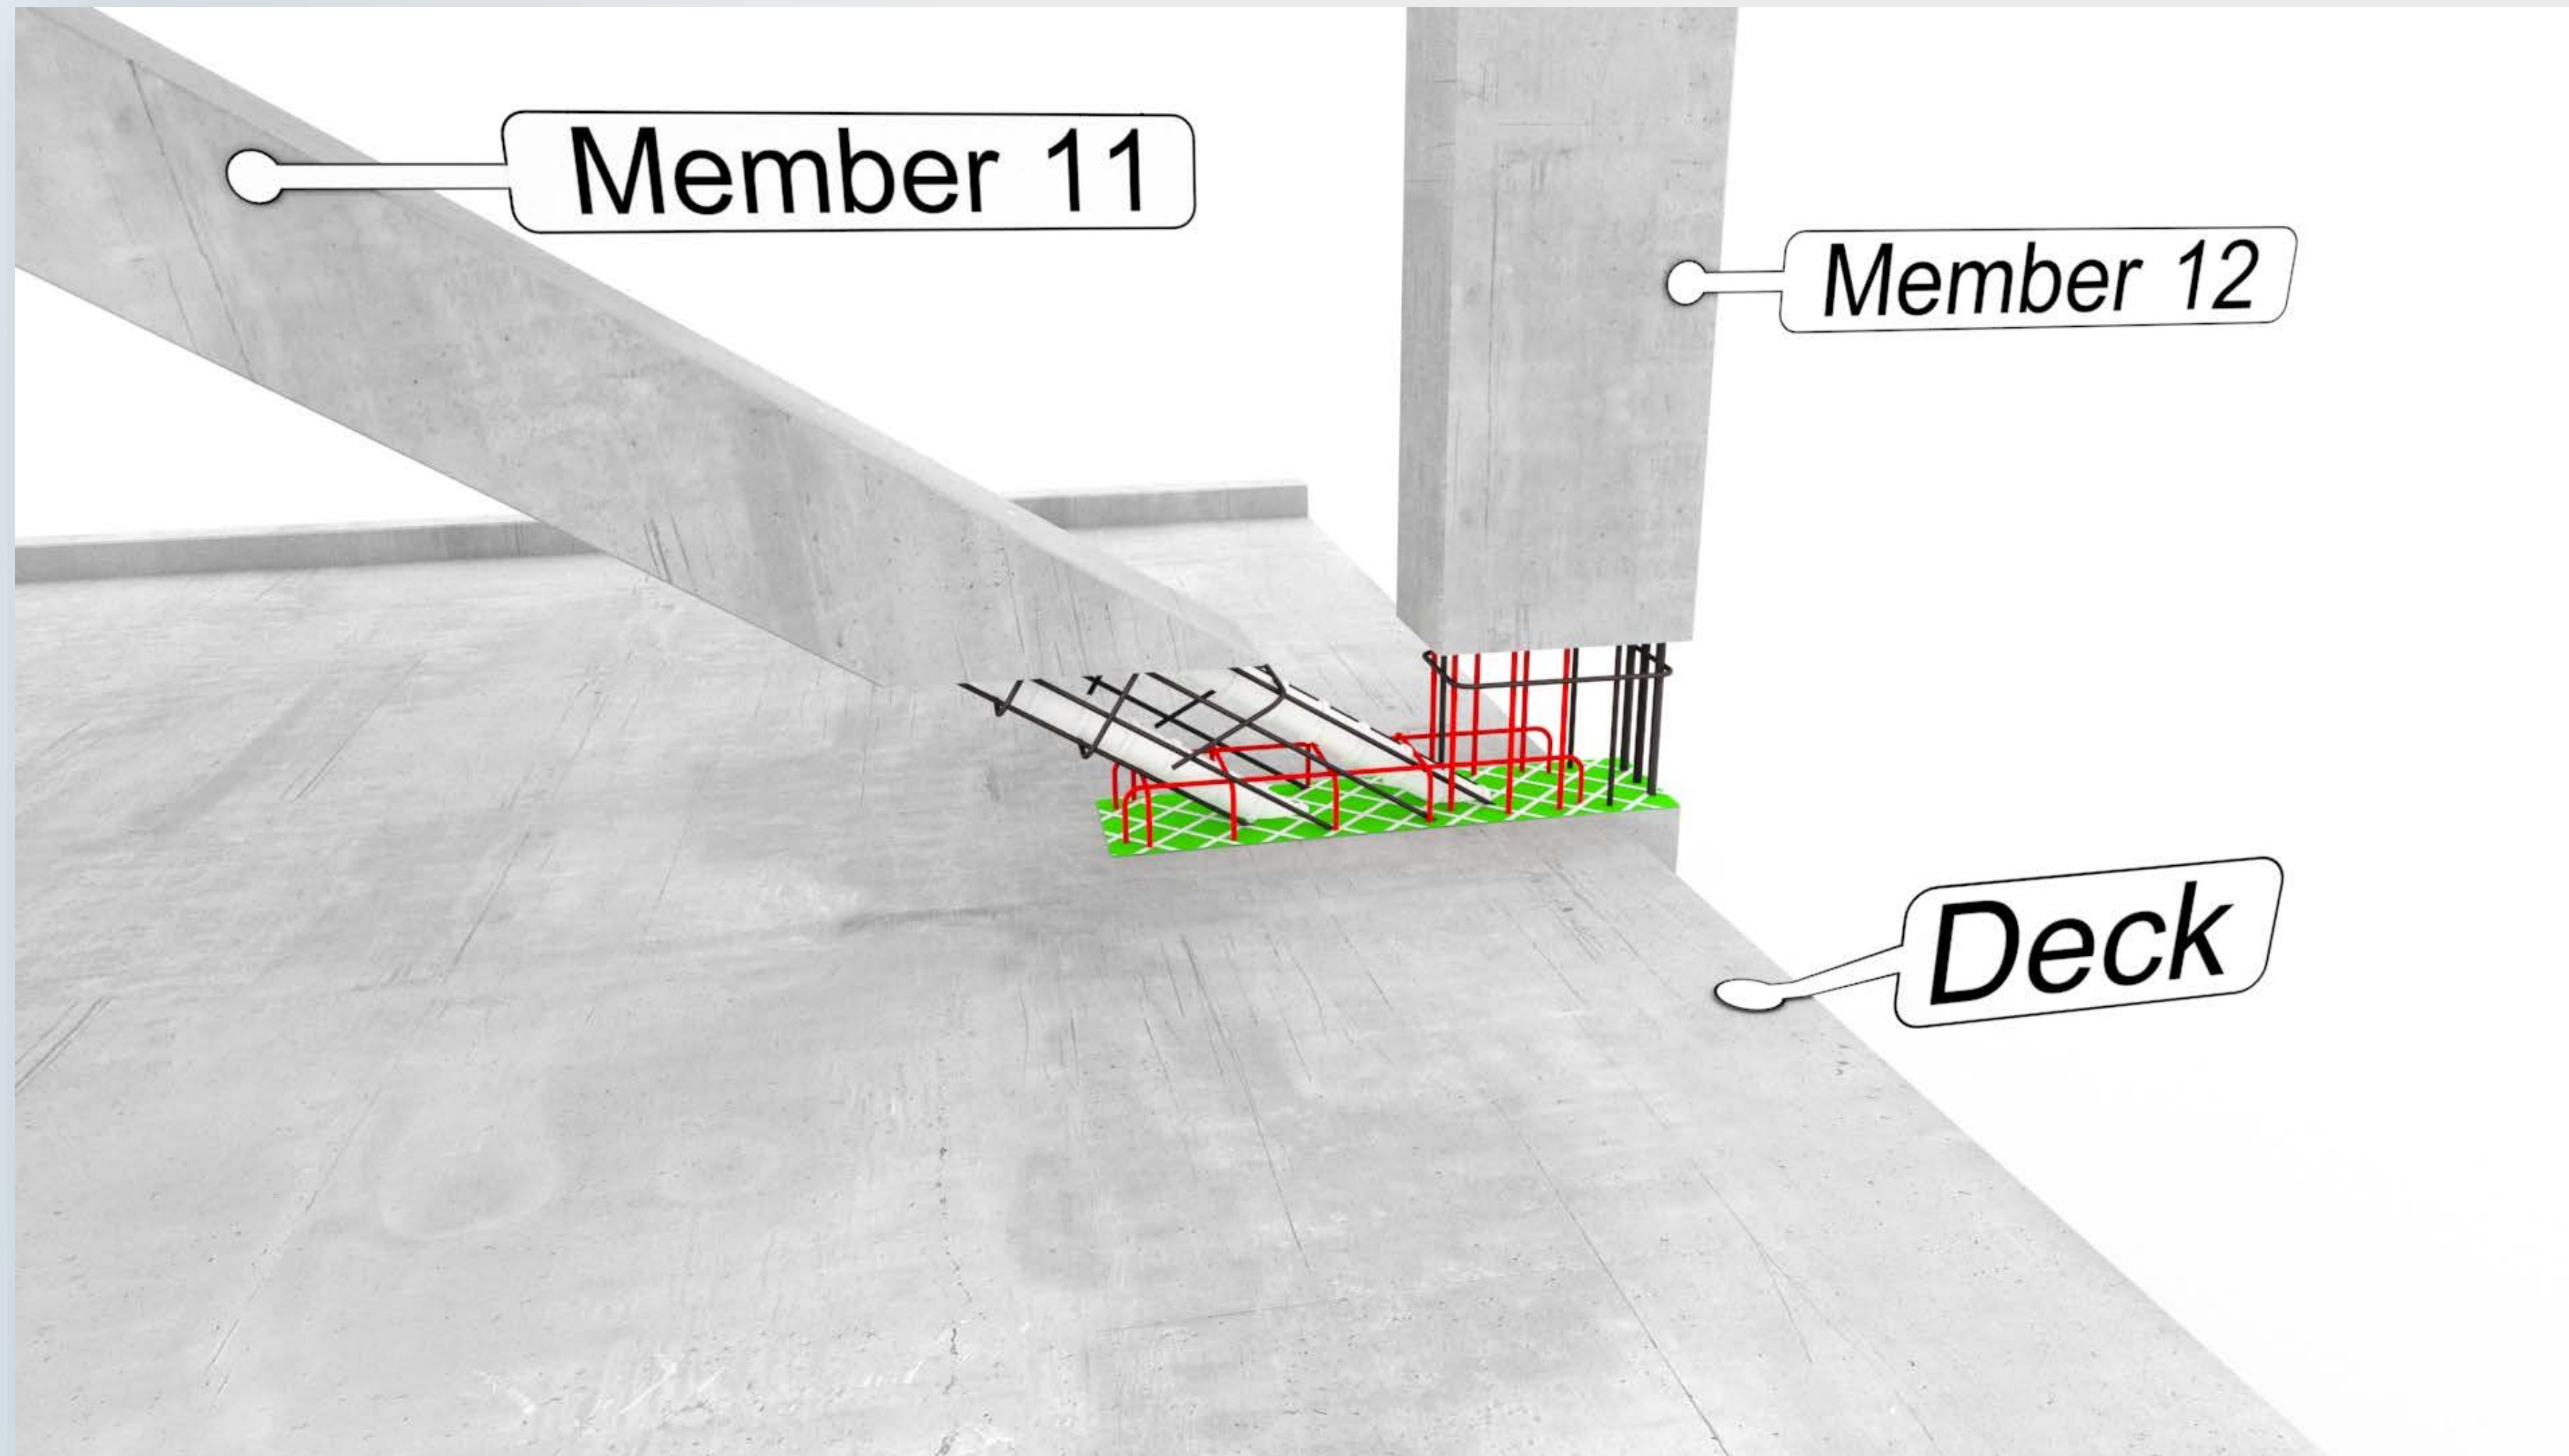
Code Evaluation of Member 11/12 Deck Connection

Design mistakes by FIGG as to the load and capacity of the Member 11/12 deck connection

- 1.** Considering the entire construction joint between member 11/12 and the deck, the design as shown on the contract documents meets the AASHTO Code.
- 2.** If the construction joint were roughened as required by the project specifications, which were reconfirmed by email, the collapse would not have occurred.

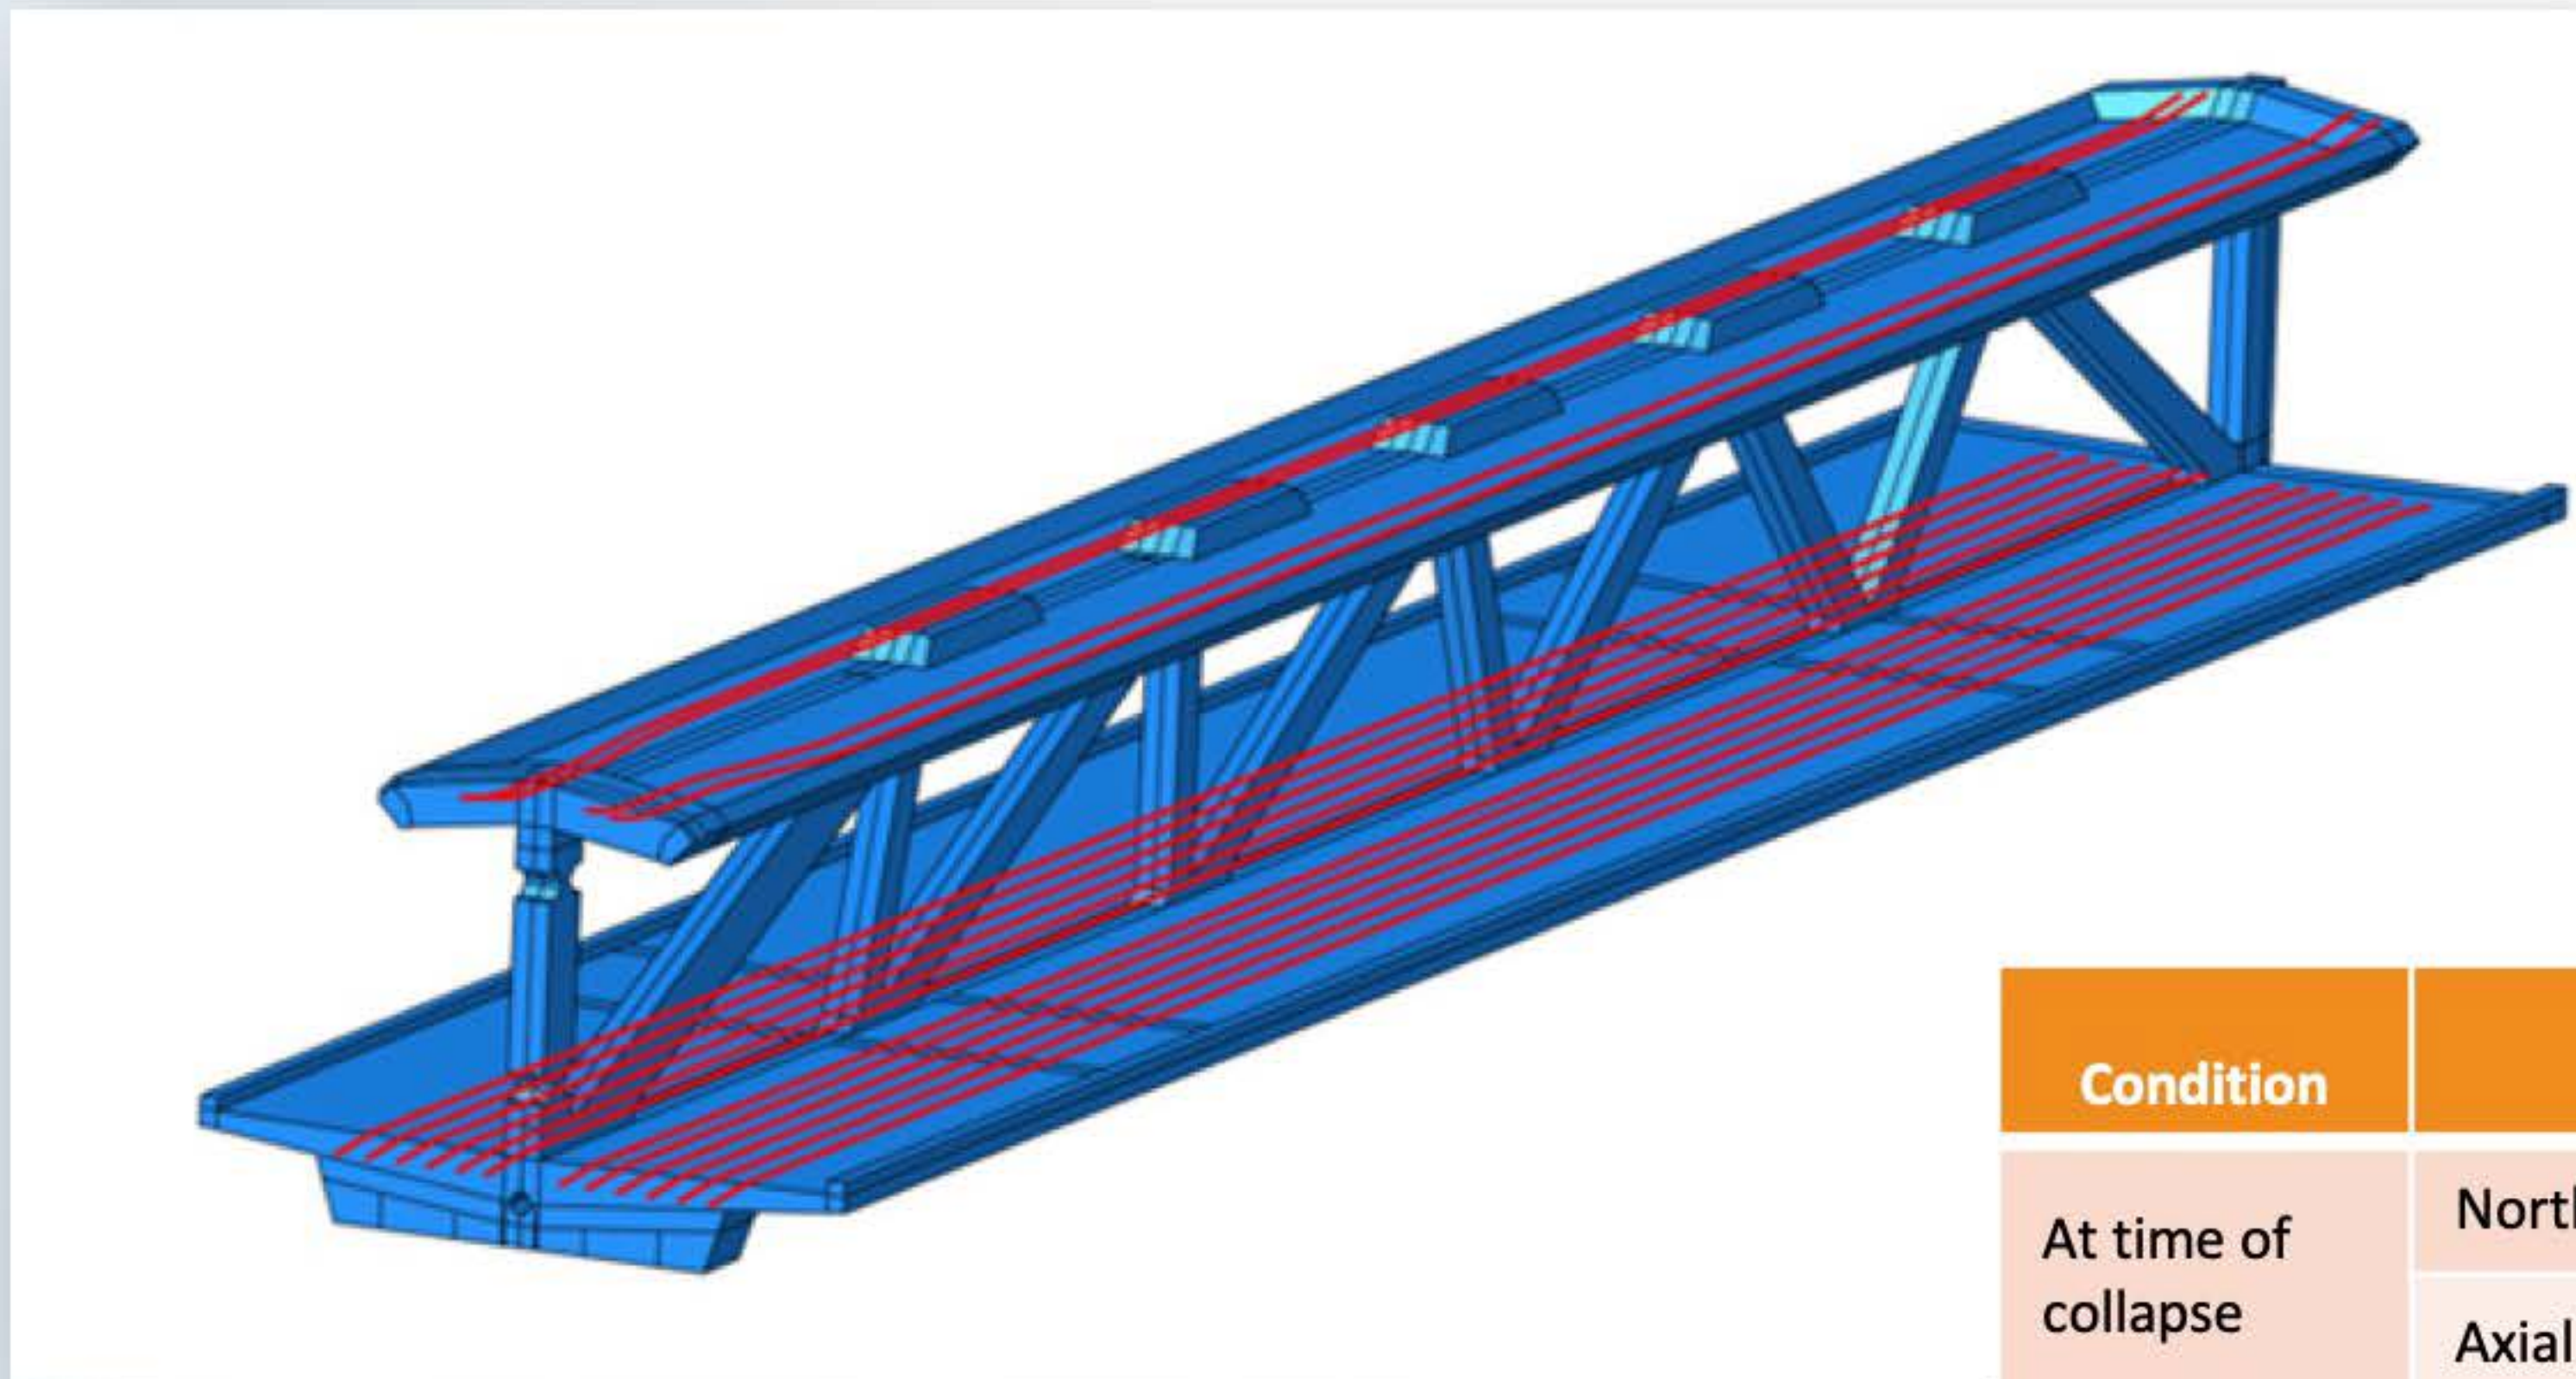
Abaqus Finite Element Model

Condition	Calculated Demand (kips)	WJE	FHWA
At time of collapse	Northward force at M11/12 connection	1677	
	Axial compression in member 11	1743	
Factored per AASHTO	Northward force at M11/12 connection	1979	1835*
	Axial compression in member 11	2236	
*Does not include construction live load

Factored Northward Force (kips)	Surface Condition	Factored Resistance	Capacity/Demand Ratio (CDR)
1979	Roughened	2150	1.09
	Not Roughened	1157	0.58
