FIU UNIVERSITY CITY PROSPERITY PEDESTRIAN BRIDGE PROJECT

FIU Pedestrian Bridge Collapse: *Testing of Full-Size Replicas of Failed Connection*

Presented by Gary J. Klein, SE, PE

Presented July 23, 2020
Minnesota Concrete Council

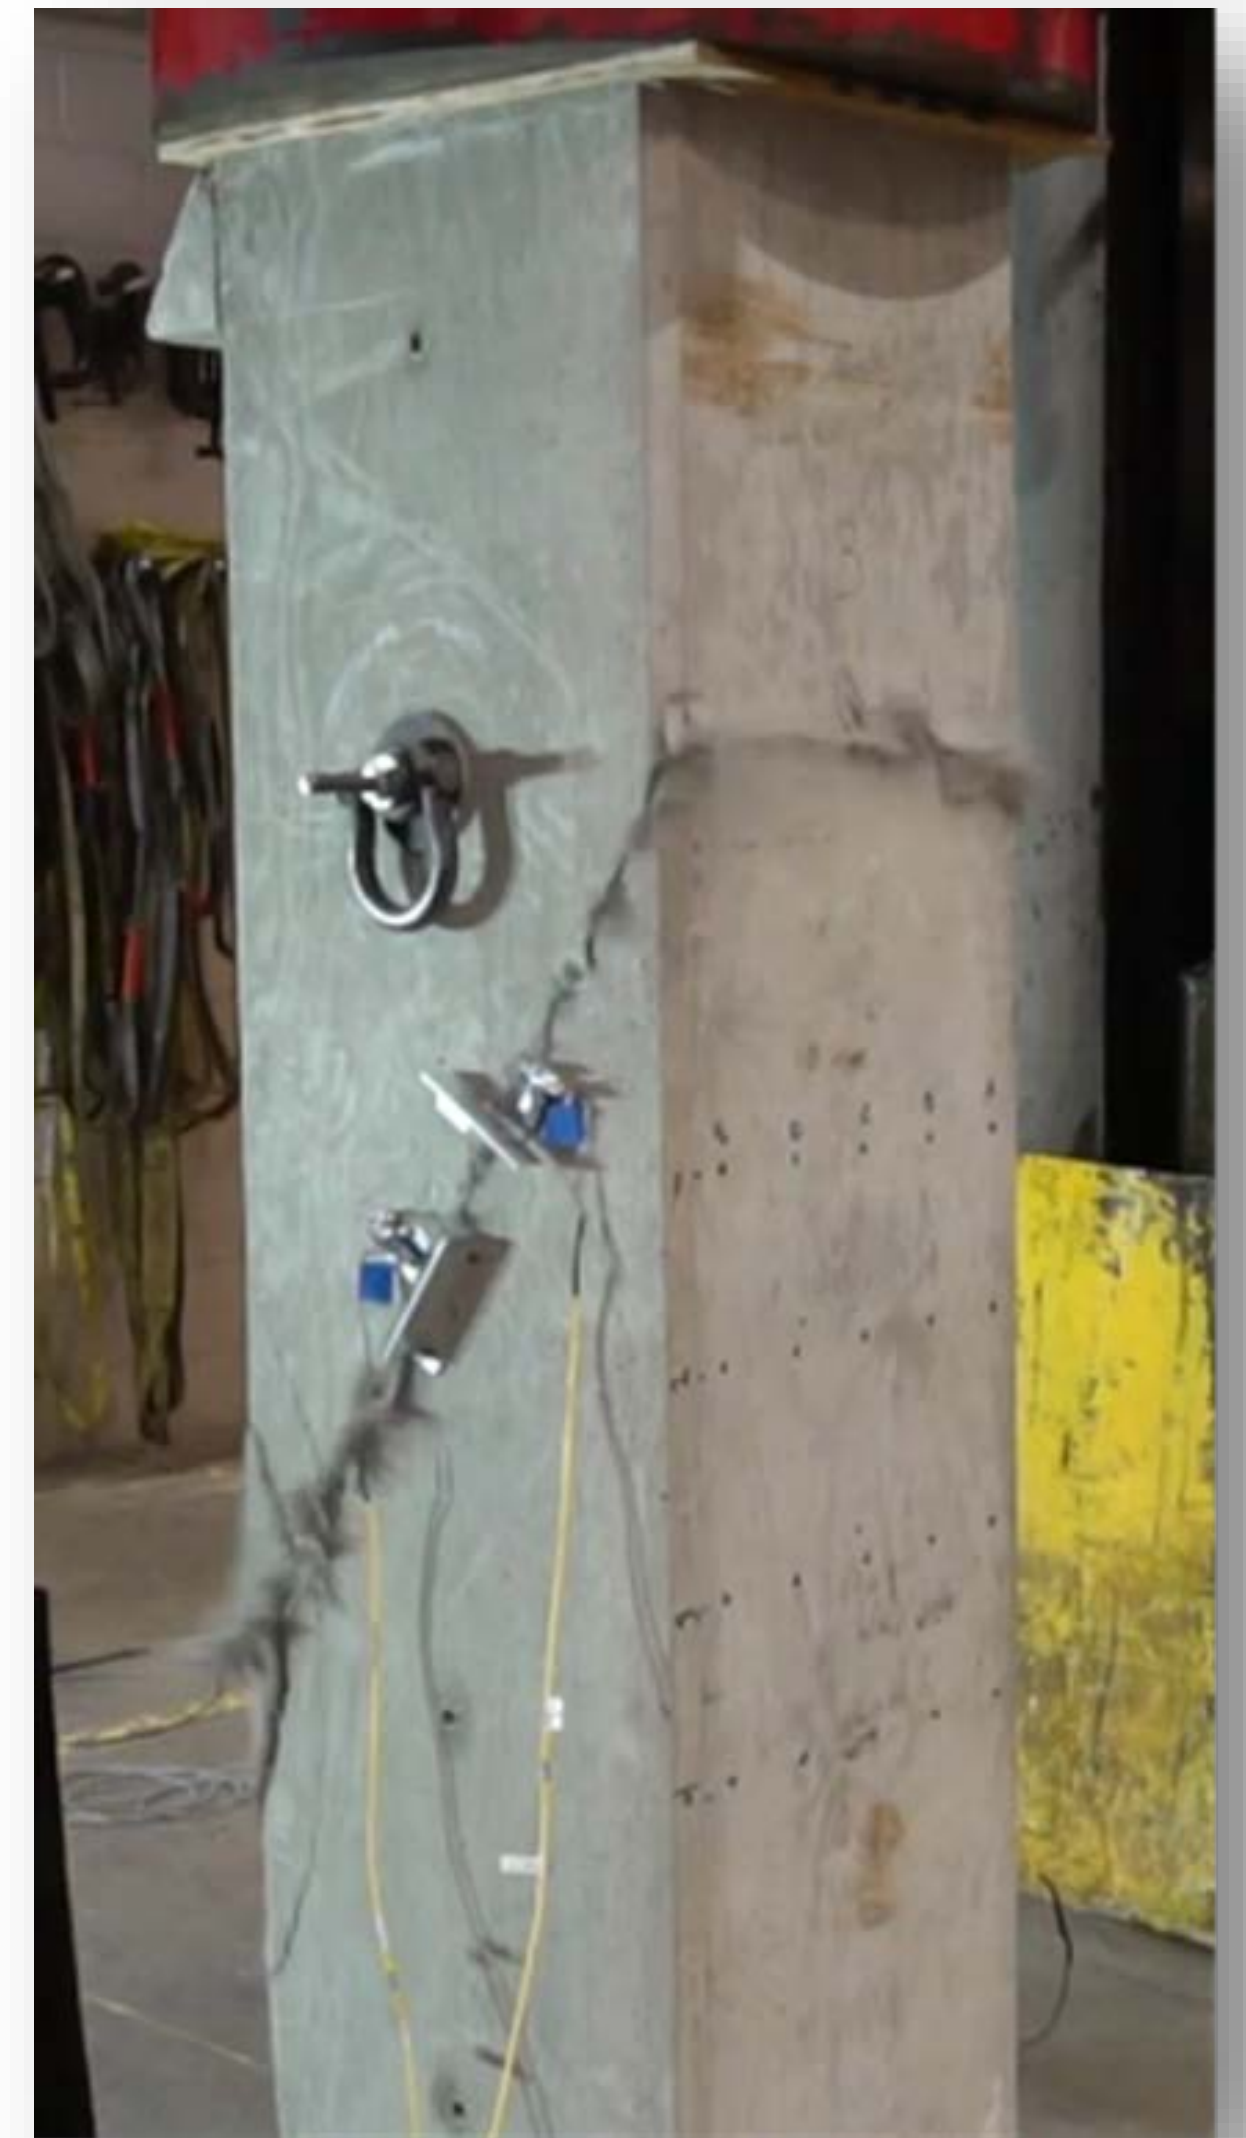
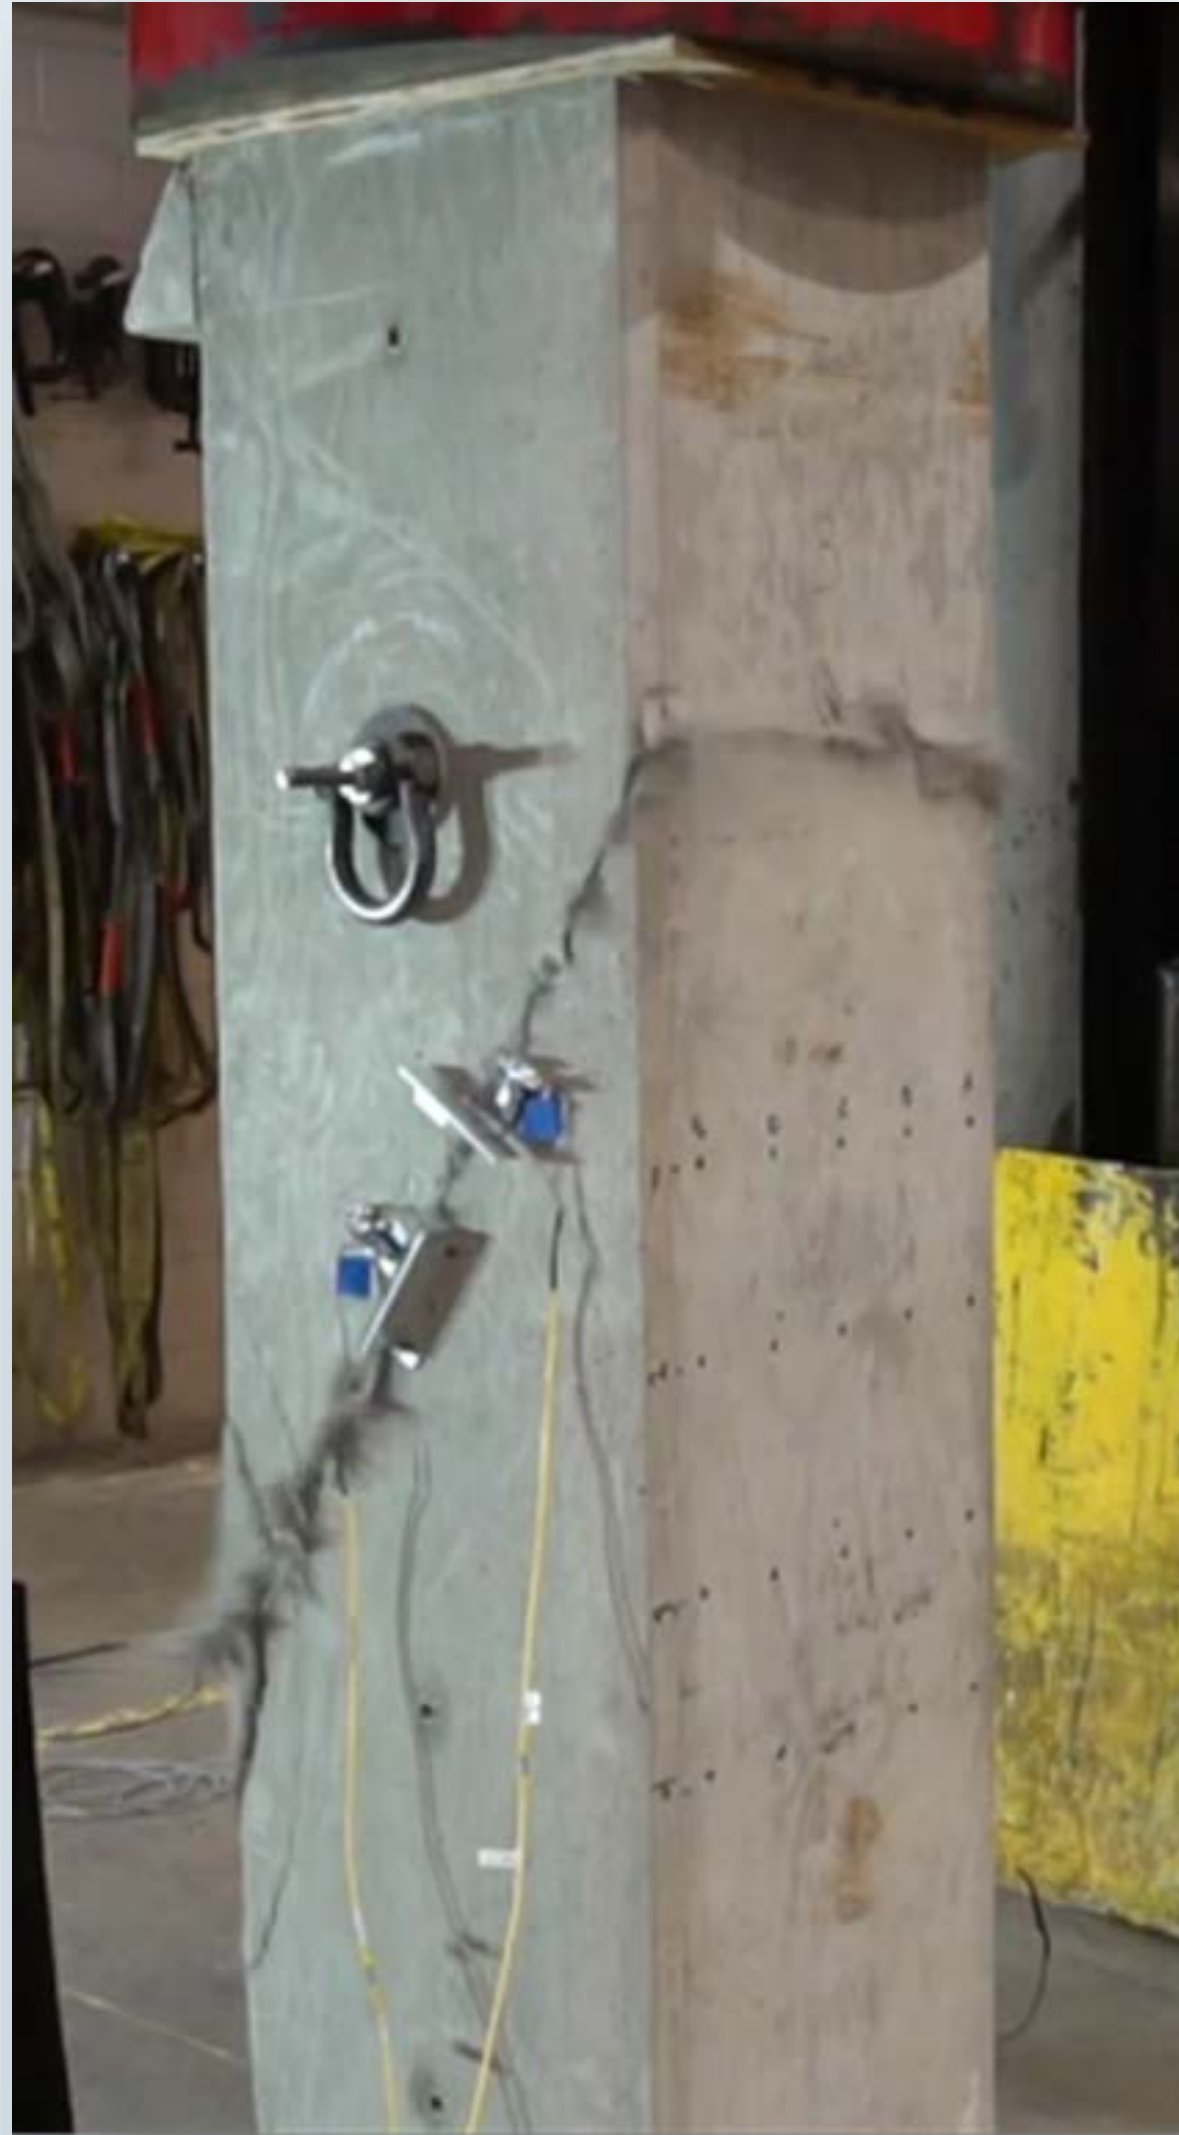
Interface Shear Transfer Testing: Results

Specimen	Peak Load (Average)	Member 11 Load at Failure	%
Roughened	2,594 kips	1,743 kips	149%
Non-roughened	1,455 kips	1,743 kips	83%

- ***Intentional roughening improved the shear capacity of the cracked interface by a factor of 1.78 compared to the as-placed specimens with a cracked interface.***
- ***If the construction joint were roughened as required by the project specifications, which were reconfirmed by email, the collapse would not have occurred.***
