**WJE** **Parking Garages:  
Common Problems and  
Best Practices**

Michael W. Lee, P.E.  
Wiss, Janney, Elstner Assoc., Inc.  
August 10, 2021

A continuing education webinar  
Sponsored by: Minnesota Concrete Council  
Co-sponsored by: PCI Midwest

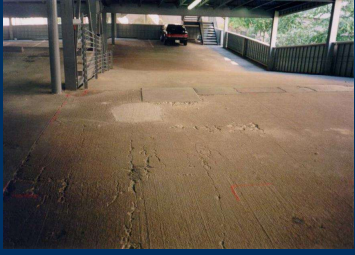
Problems

- Extensive cracking
- Excessive vibration
- Crunching noises
- Ineffective repairs
- Within 5 years of construction

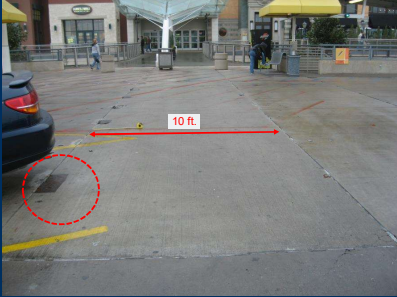
### Problem

- Excessive vibration
- Banging noises
- Flange connection damage
- Ineffective repairs
- Main entrance

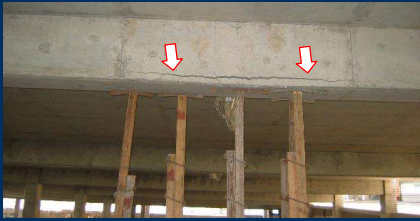
Problem

- Girder cracking
- Near mid-span
- After stressing
- Atypical crack pattern
